Housing Authority  
Surprise Safety Inspection Programme (SSIP)  
Good & Bad Practices for 2025 Q2 & Q3  
香港房屋委員會  
突擊安全巡查計劃  
2025 Q2 & Q3 良好及不良作業

## SSIP Median Scores at a Glance

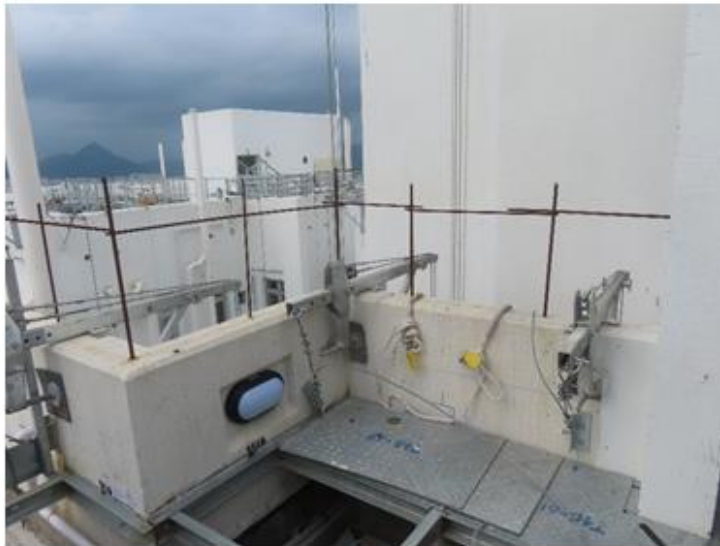
在矮牆安裝額外的防護欄杆以防止下墮。

Provision of additional guard-rails for fall protection at the parapet wall.

For example, in relation to work at height  
where the existing guardrails were not high enough  
they proactively raised the guardrails  
to ensure the height complied with  
the standard requirement of 900 to 1,150 millimetres

For example, at the higher positions shown on the left  
if the parapet wall is not high enough  
there will be a risk of falling

So the contractor added guardrails

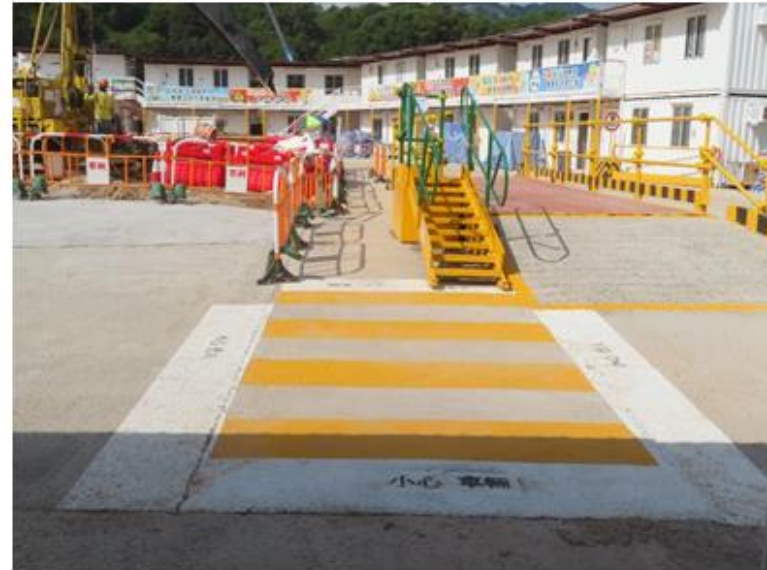
清晰的人車分路設施。

Clear demarcation of pedestrians and vehicles was seen on site.

In terms of pedestrian and vehicle segregation,  
visualised work procedure instructions were adopted  
making the pedestrian and vehicle segregation layout  
very clear and easy to understand

In terms of pedestrian and vehicle segregation,  
the pedestrian and vehicle separation facilities are also very clear

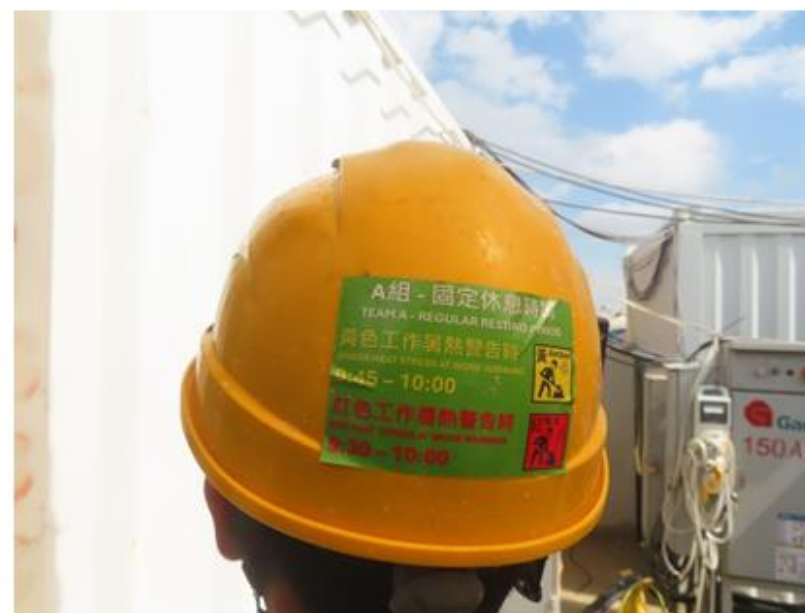
在酷熱天氣下工作，將工友分成不同組別休息。

Workers were divided into assigned groups to take breaks during working in hot weather.

As everyone can see, the system can clearly show  
the worker lists of different groups  
and their corresponding rest time arrangements

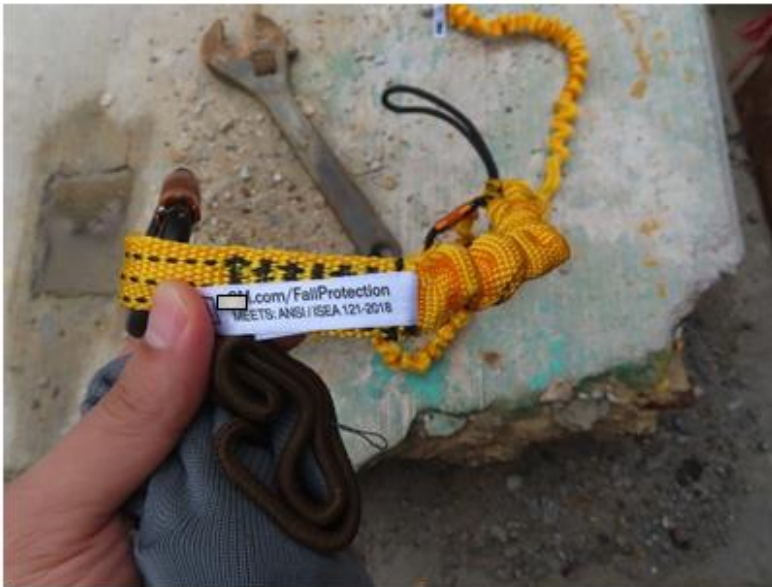
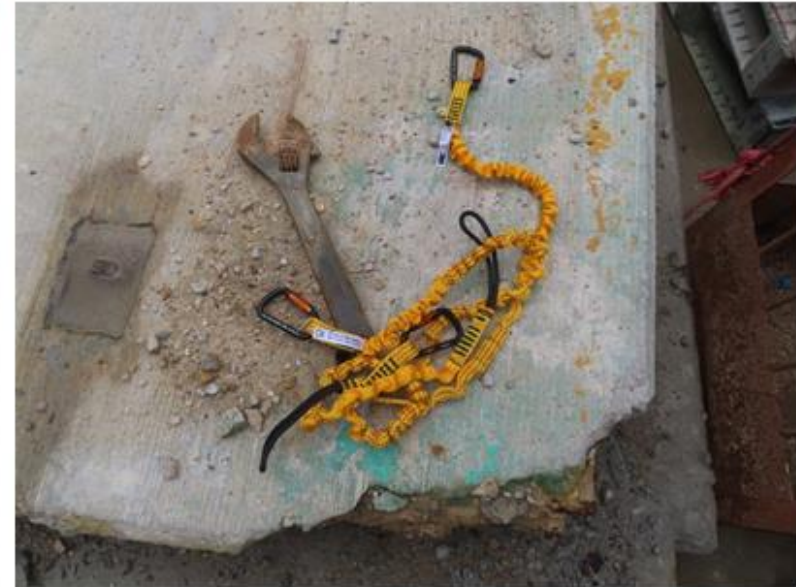
提供符合國際/國家標準的工具手繩，例如ANSI/ISEA 121-2018。

A using tool strap with appropriate international/national standards such as ANSI/ISEA 121-2018 was provided.

In addition, compliant tool lanyards were also used

In addition, starting from this quarter  
compliant tool lanyards have been used  
to prevent the risk of tools falling from height

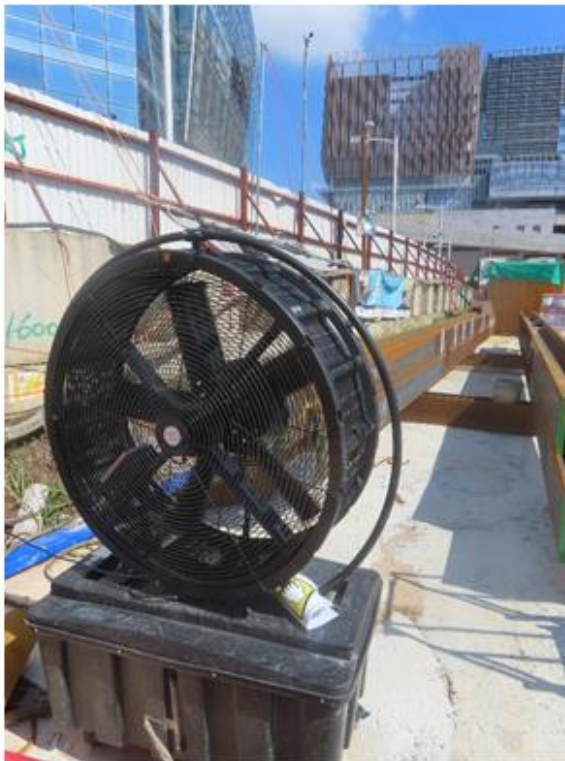
在工作位置提供大型風扇。  
Provision of large fans at working location.

Also, in response to the hot weather  
some sites have added large fans

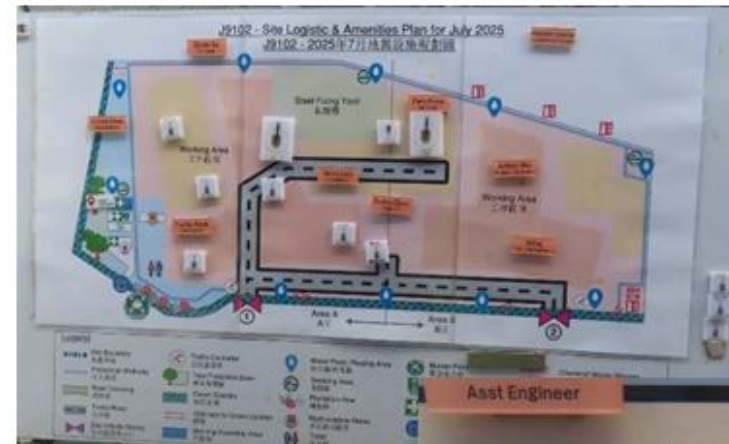
良好計劃工地內的機械分佈及運輸路線，並圖象化顯示於當眼位置。此外，安排指定管理人員管理不同的分區，並張其負責範圍顯示在計劃內。

A visualized planning for machinery distribution and transport routes at prominent location on the construction site. Additionally, assign designated personnel to manage different zones and incorporate this information into the plan.

In addition, there are some visual arrangements  
such as site layout plans, transport routes  
and machinery allocation plans
