Site Safety Seminar for Capital Works New Works Contract

Lesson Learnt from Accident & Incident

Presented by: Eric Wong (Unit Safety Manager, Gammon Construction Limited)

Date: 12 May 2014

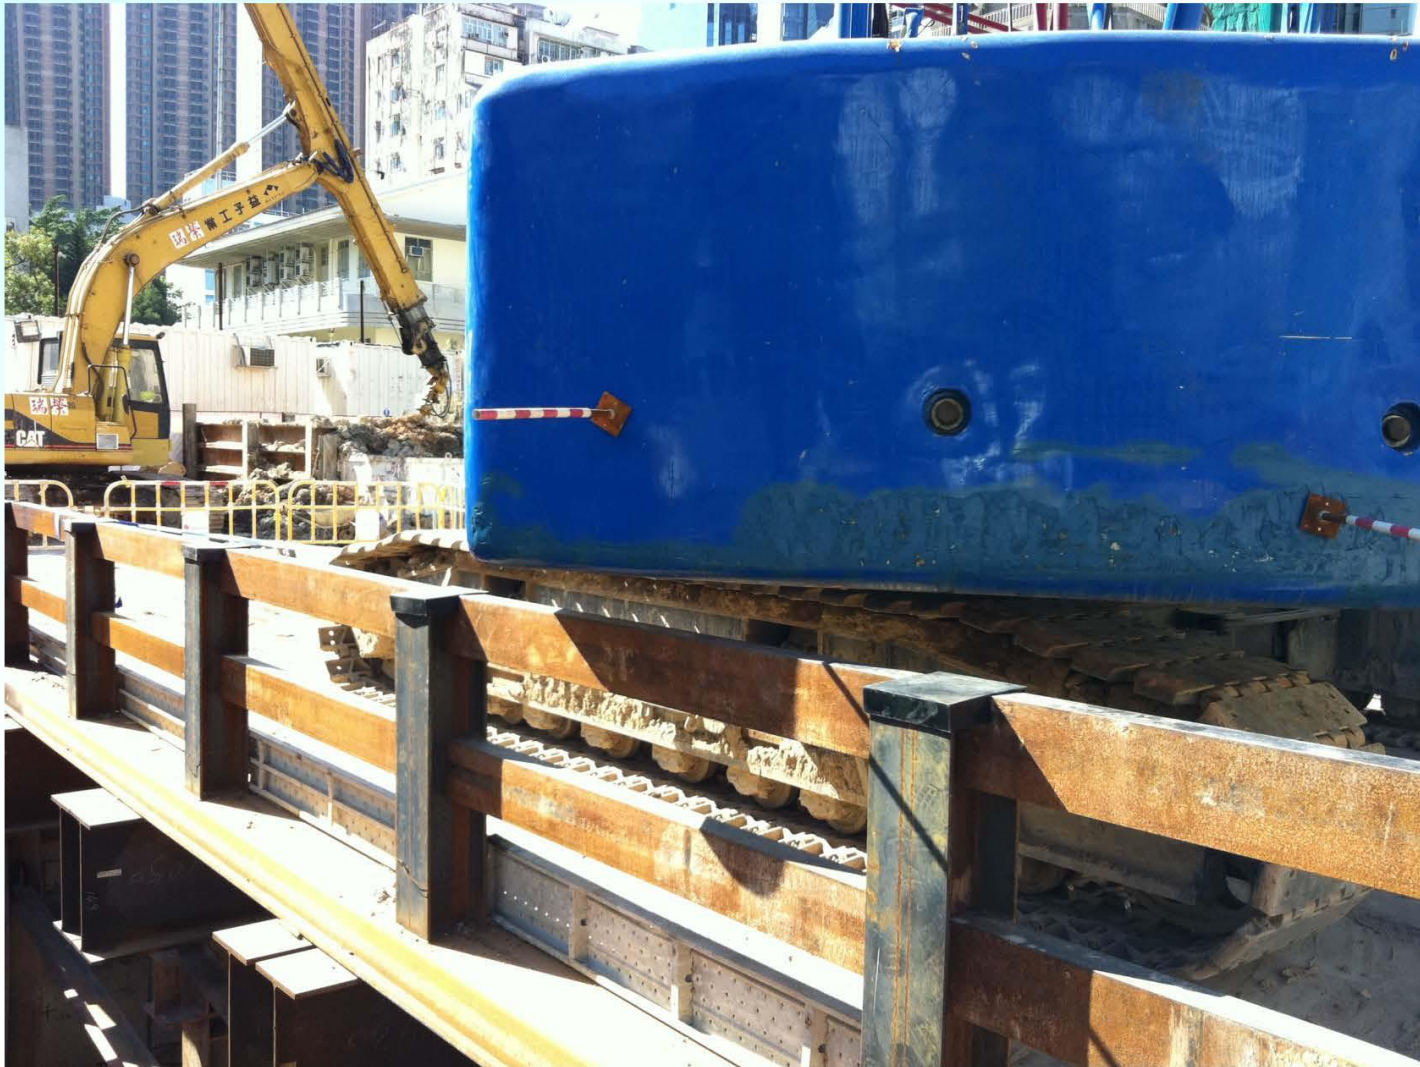
The incident was happened in the morning at a Foundations work site. A 54 yrs old rigger/banksman was crushed between the counterweight of a crawler crane and the steel railings.

Location of
second
banksman

Location of
deceased
