HASAS(NW) - 2021Q2-2021Q3

Summary on Audit Findings 安全稽核結果

Occupational Safety and Health Council 職業安全健康局

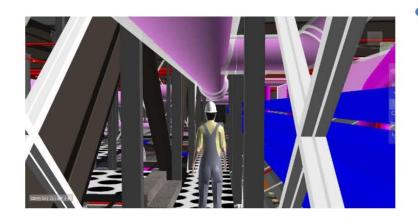
BIM for Safe Construction of Arena Roof

- BIM ensured the feasibility and accuracy of the "All-In-One Lifting" Method for the installation of Roof Steel Truss of GIC-Multi-Purpose Arena. It reduced enormous works at high level and aided rehearsal for workers to get familiarized with the working procedures.
- 透過使用建造資訊模型(BIM),確保使用創新方法於多用途體育館安裝天花鋼結構的可行性和準確性,大大減低高空工作的需要,而透過使用BIM進行安全訓練,能令工人更熟悉相關工作程序及安全措拖。
