Audit Unit Development & Construction Division

Experience Sharing Session with Building Contractors

QUALITY & WORKMANSHIP

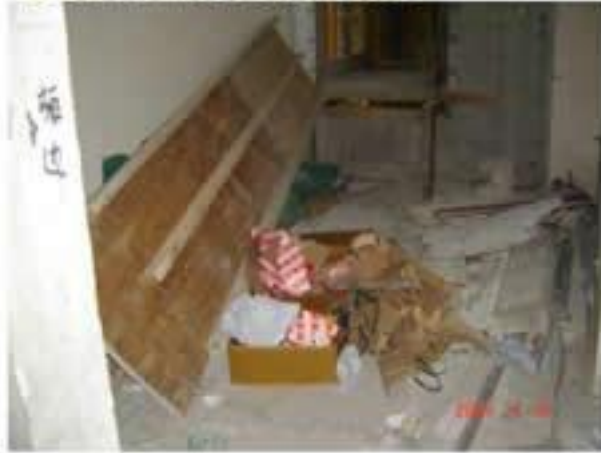
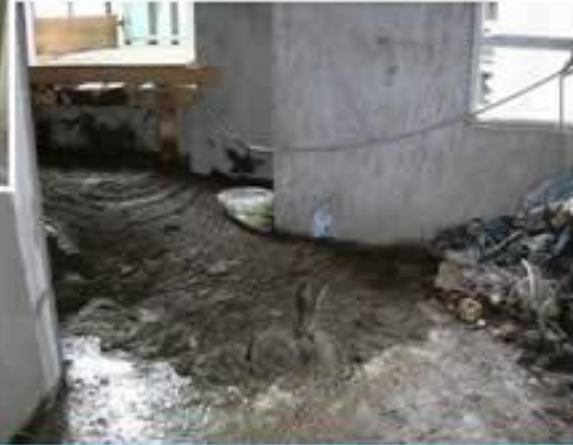
Housekeeping on Site

Debris inside flat

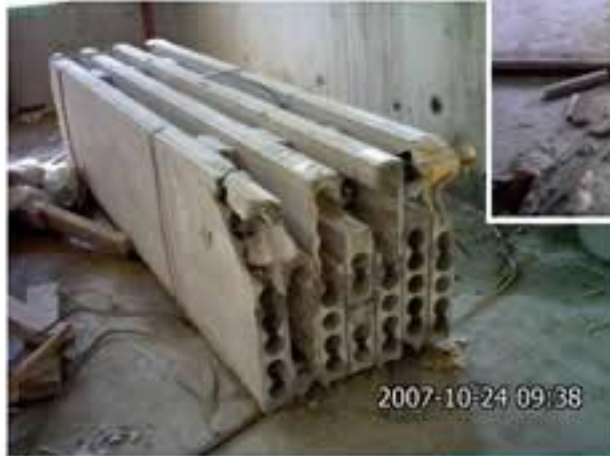
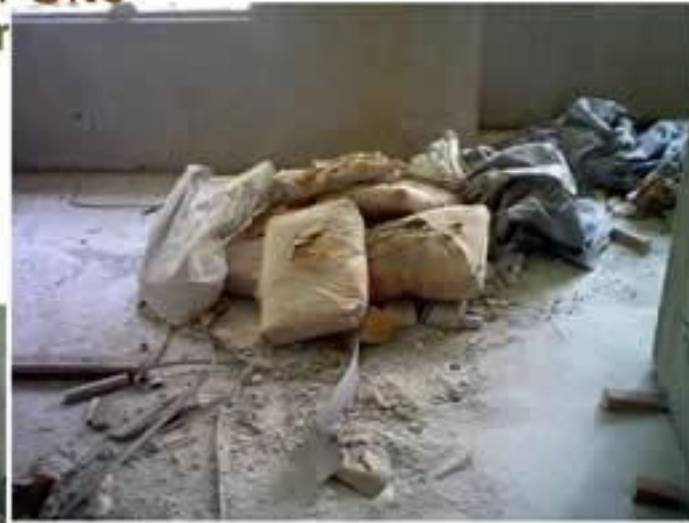
Housekeeping on Site

Poor storage manner

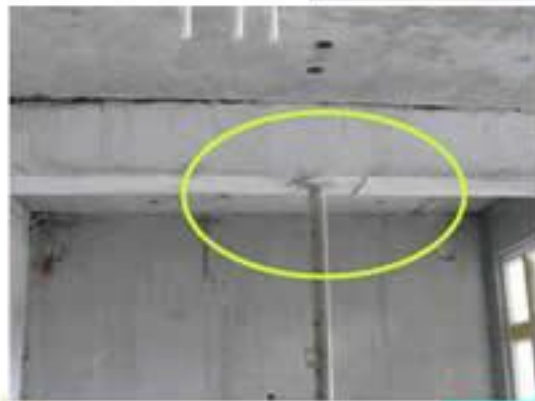
Re-propping & Early Striking of Formwork NOT allowed

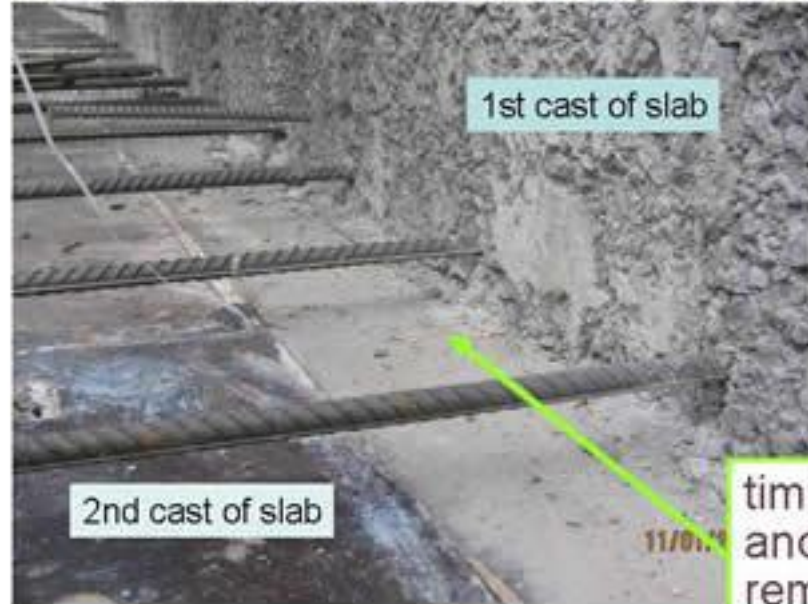
Steel Nails for Fixing Formwork

Embedded in concrete / lift lobby slab construction joint

timber strip
and nails for joint
removed after
1st cast

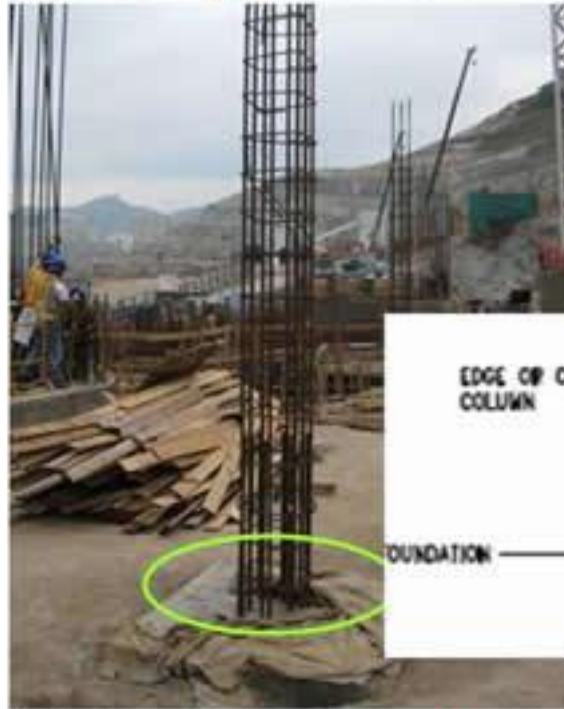
Spacing of Binder at Column

First binder exceeds 50mm above structural level

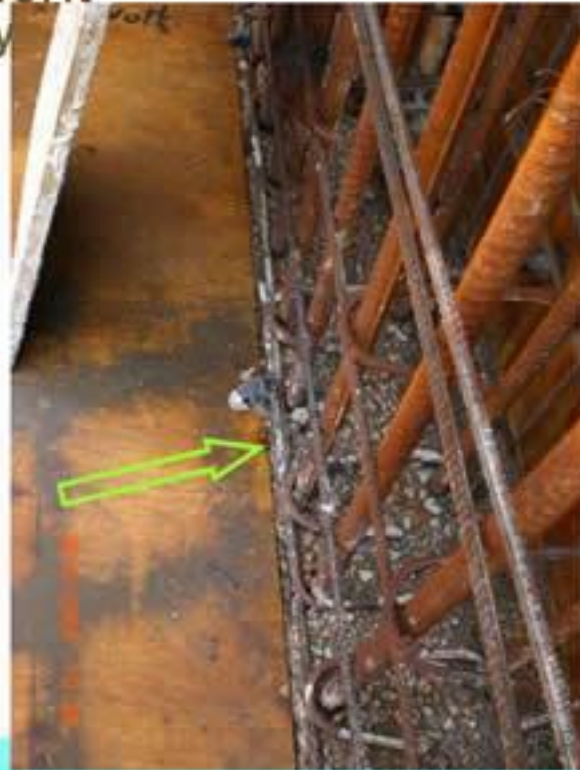
Cover to Reinforcement To be controlled properly

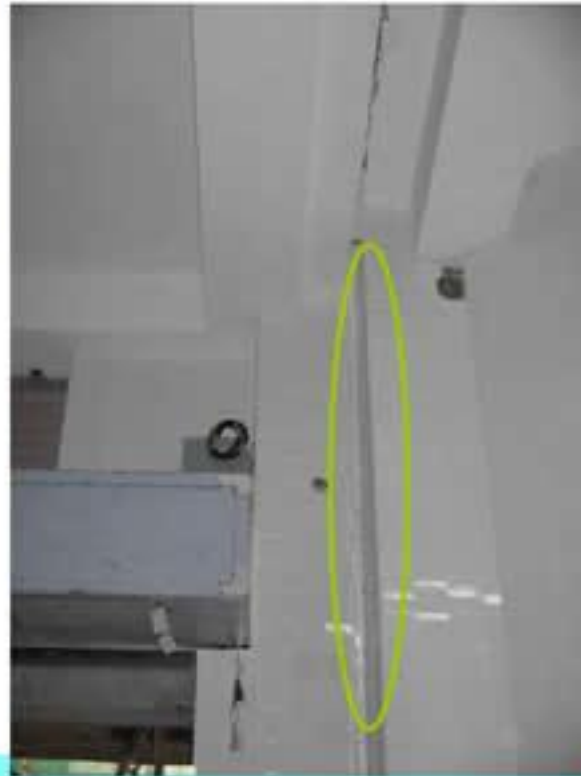
Expansion Joint

Covered up
by wall tiles

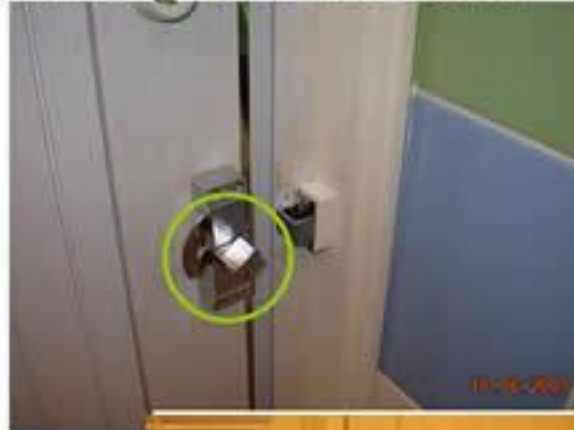
Bathroom Folding Door Turning knob too small

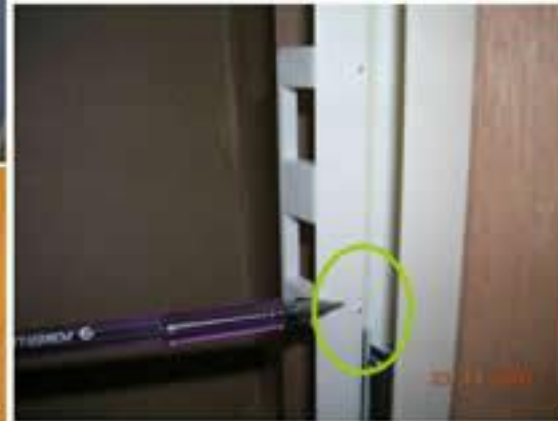
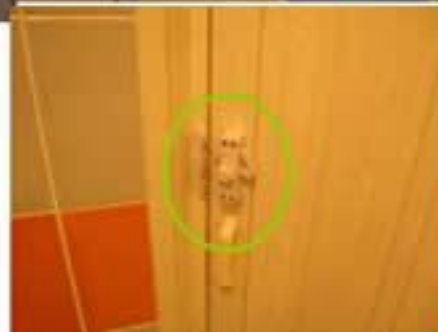
Catch not
securely fixed

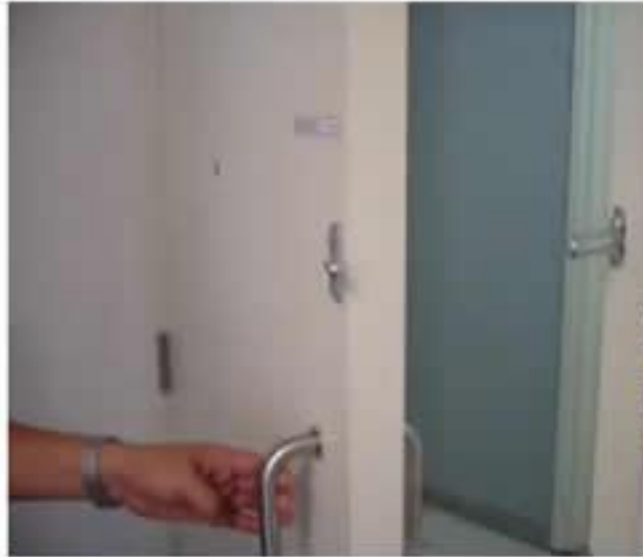
Door Guard at Entrance Door

Insufficient **clearance** between interlocking parts may accidentally lock the door when leaving the flat.
Tenant will be locked out

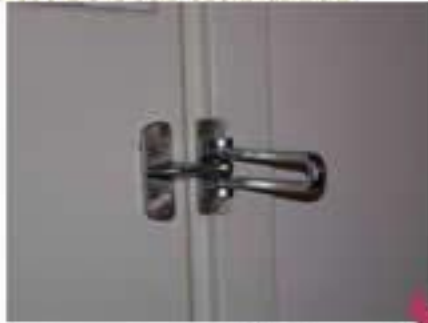
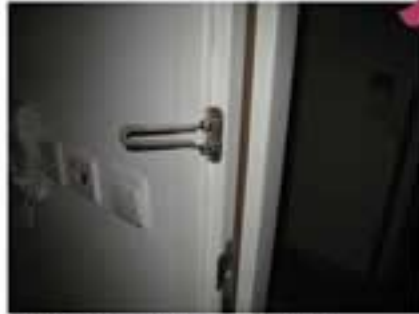
Door Guard at Entrance Door Different models

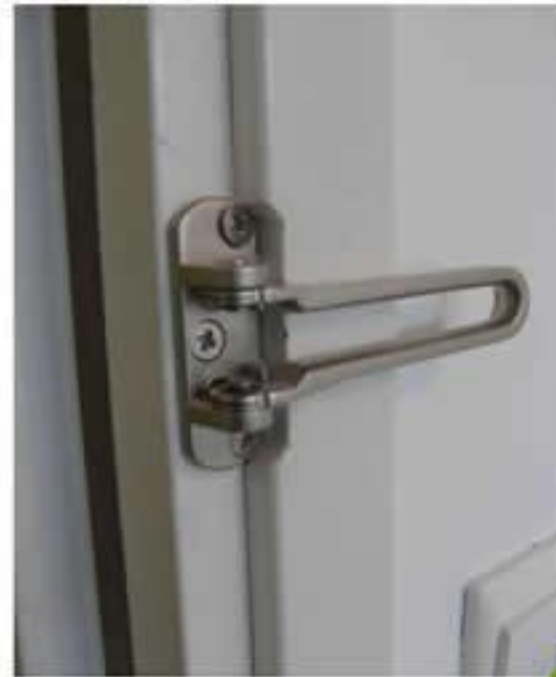
Maximum swing
slightly over 90°

Can swing flat
Against architrave
