# **SITE SAFETY Focus Seminar**

on New Works of  
Housing Department

**Site Safety** issues at -

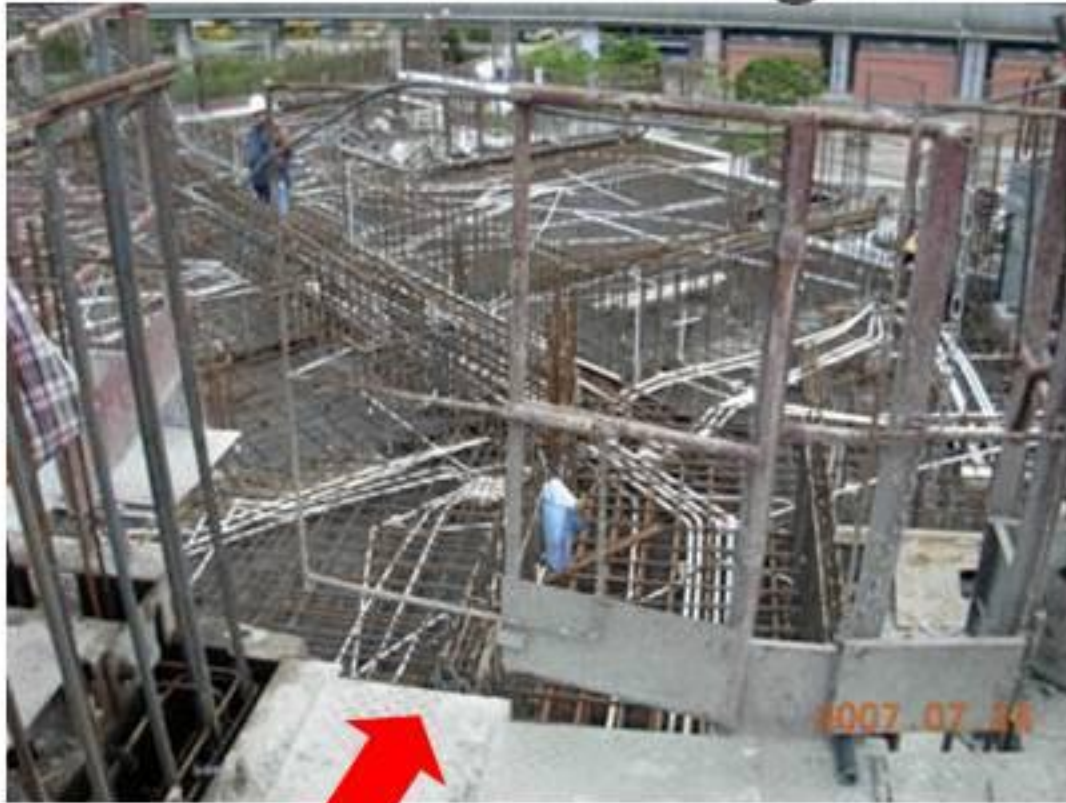
# Steel Working Platform

**NO toe board**

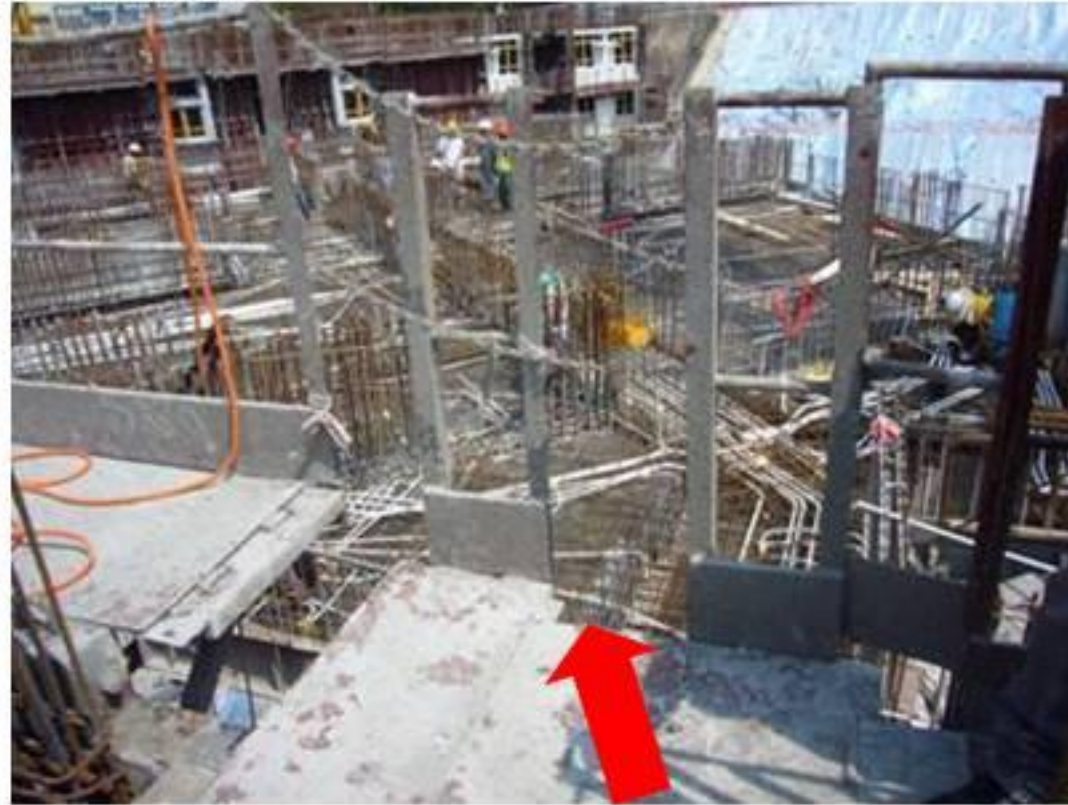
**NO close boarding  
at floor opening**

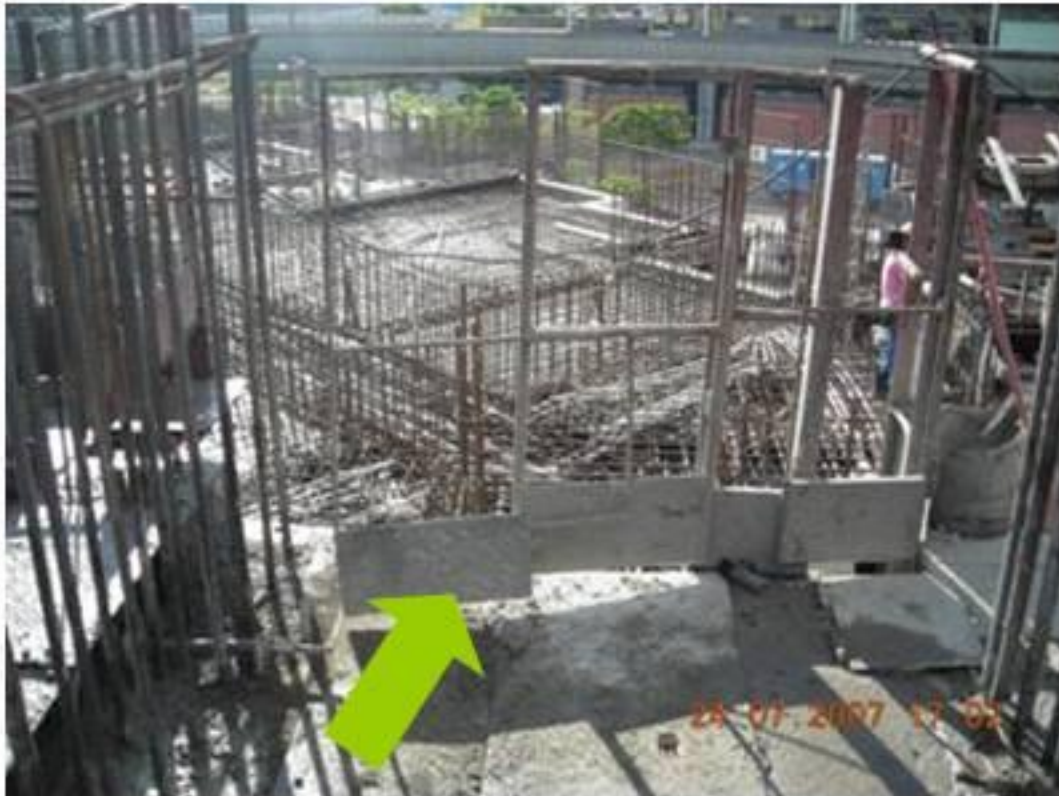
toe board

# Steel Working Platform cases rectified

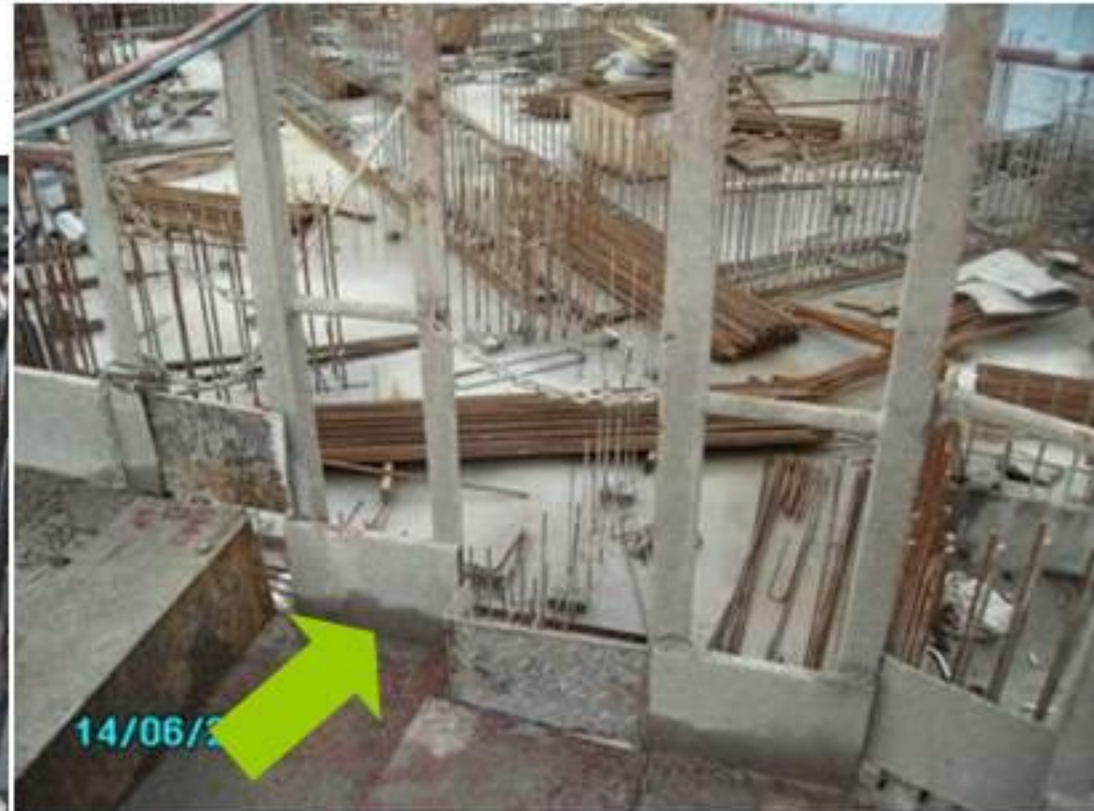
close boarding  
at floor opening

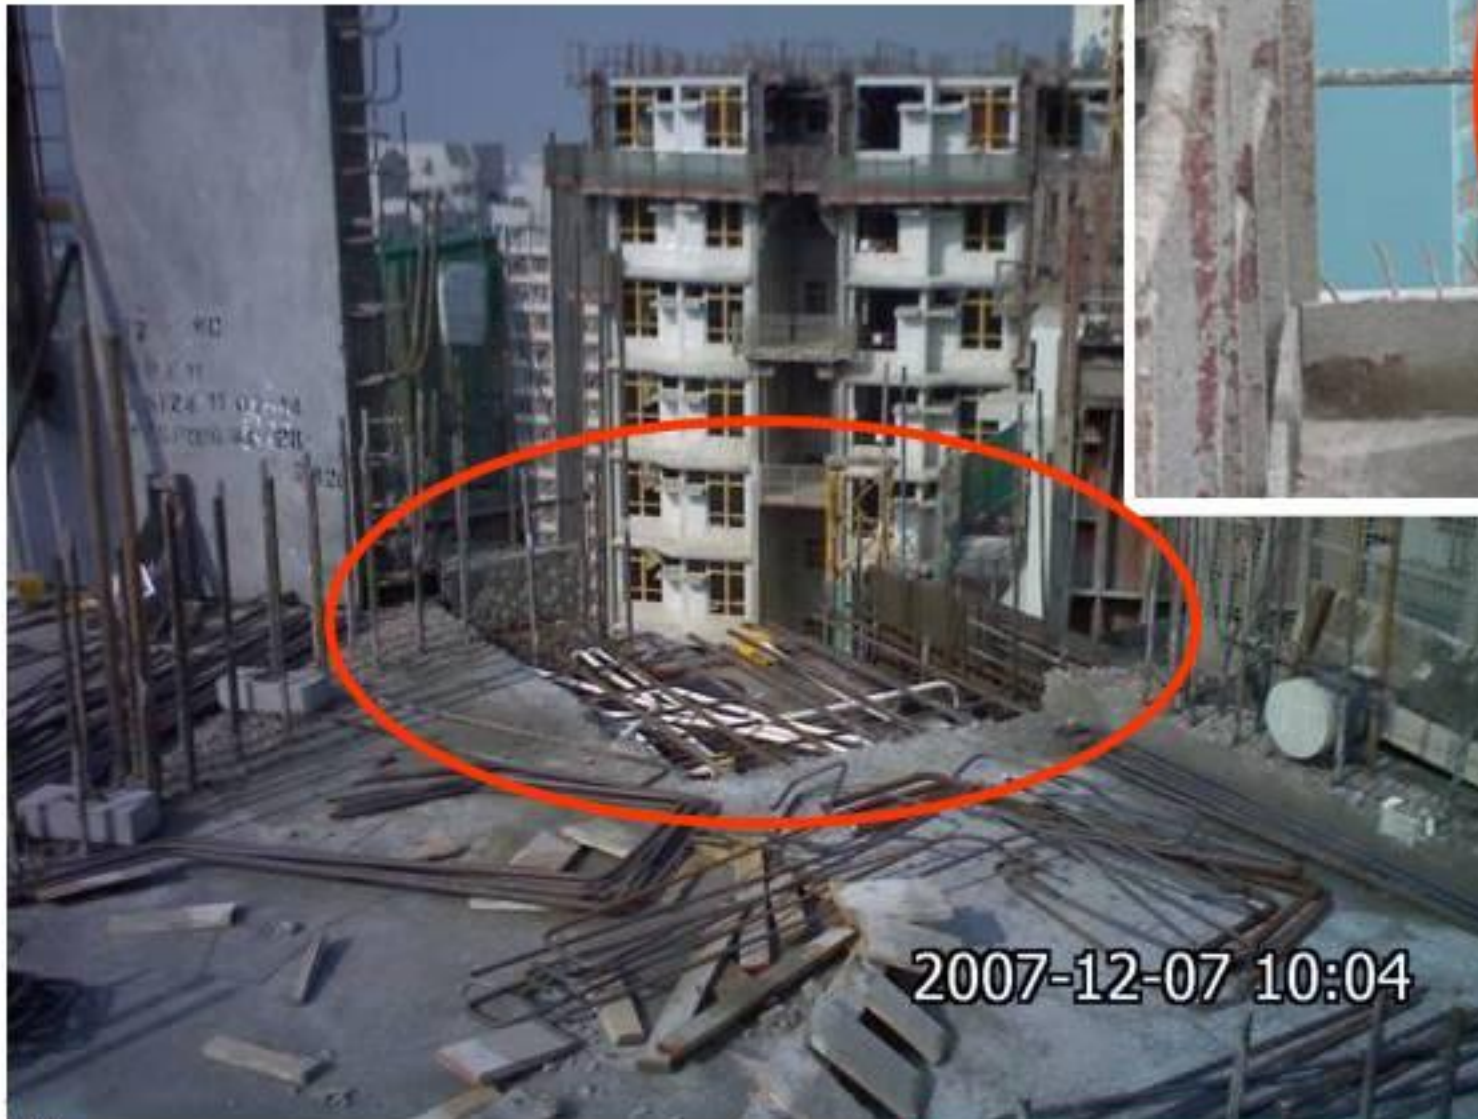
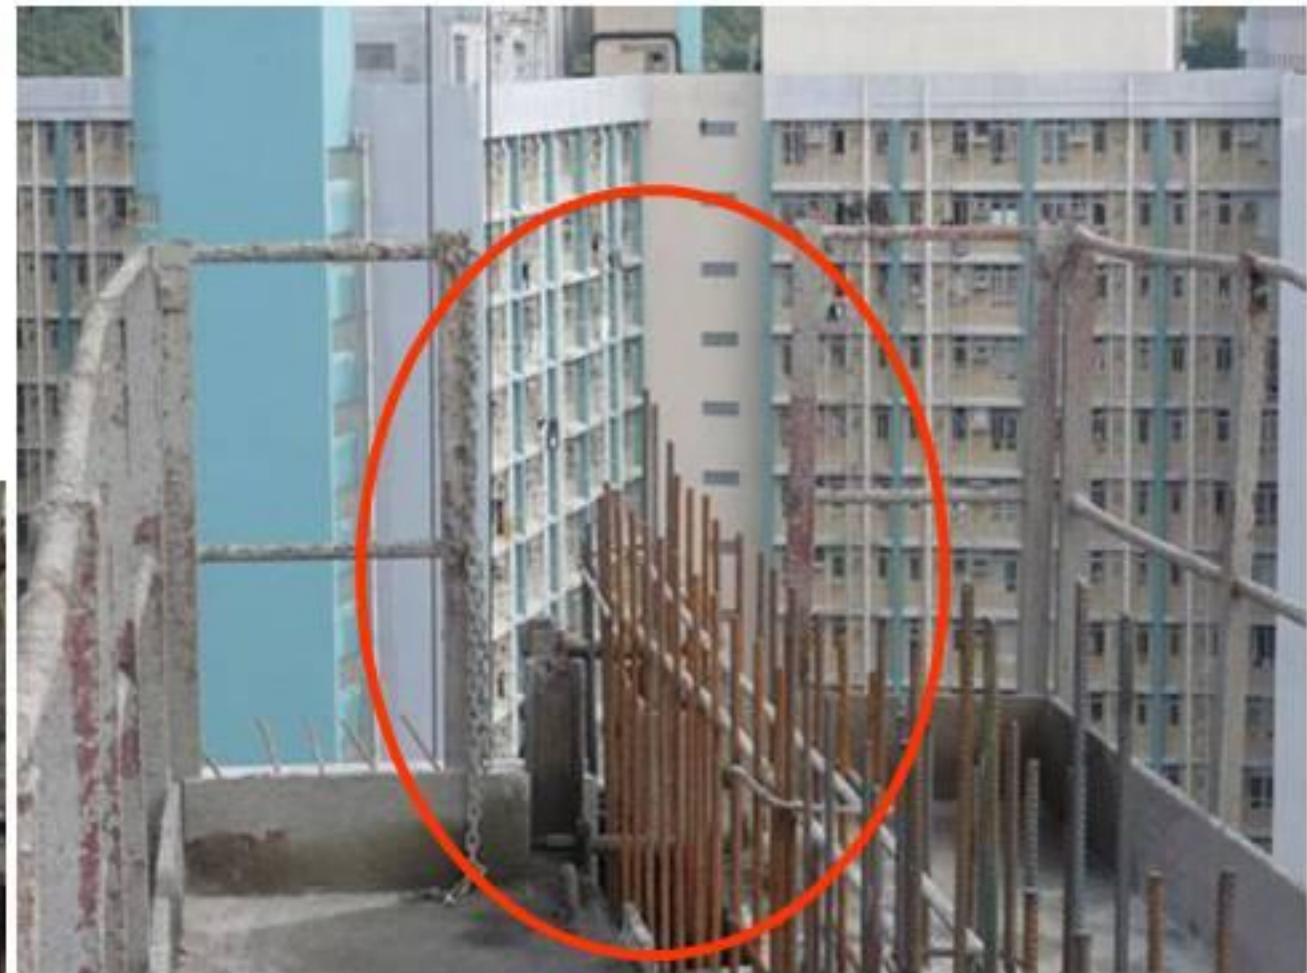
# External Railing

## NO railing provided

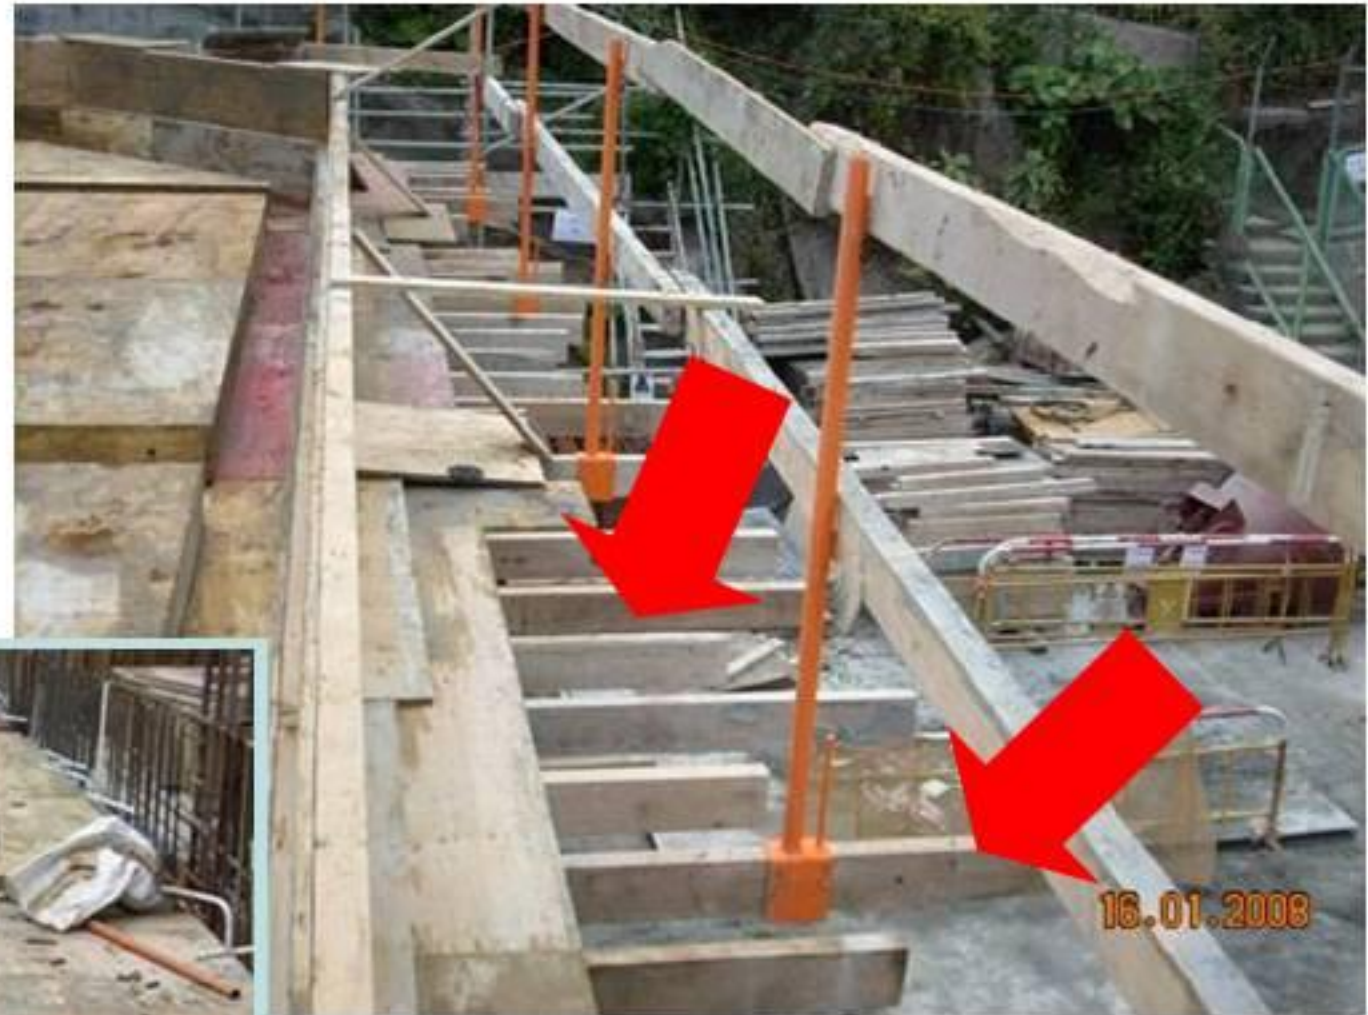
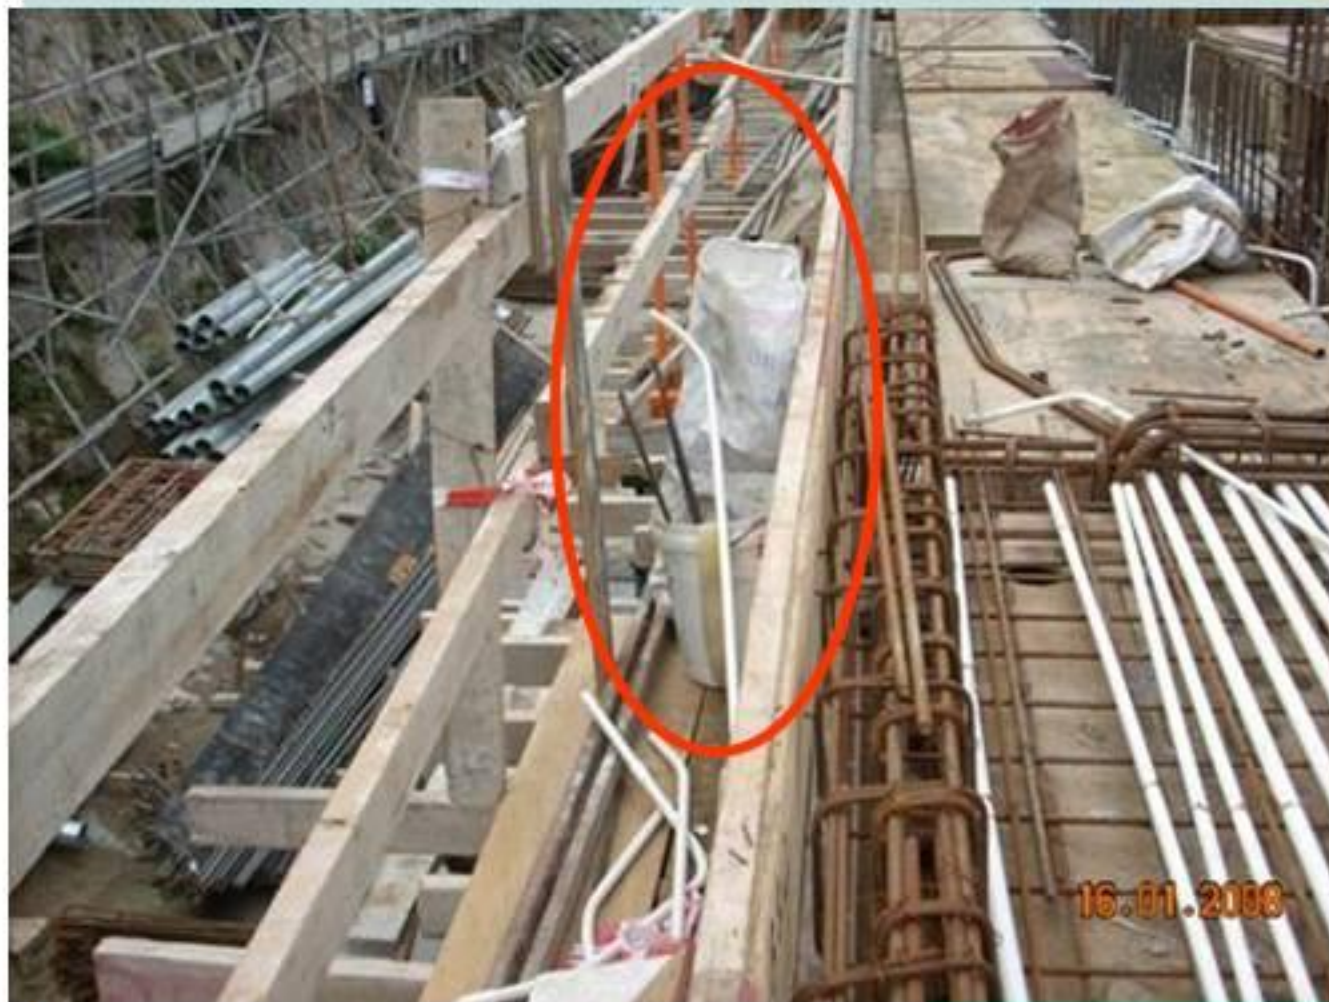
# Working Floor

**building  
materials  
stacked**

**NO planking  
& toe board**

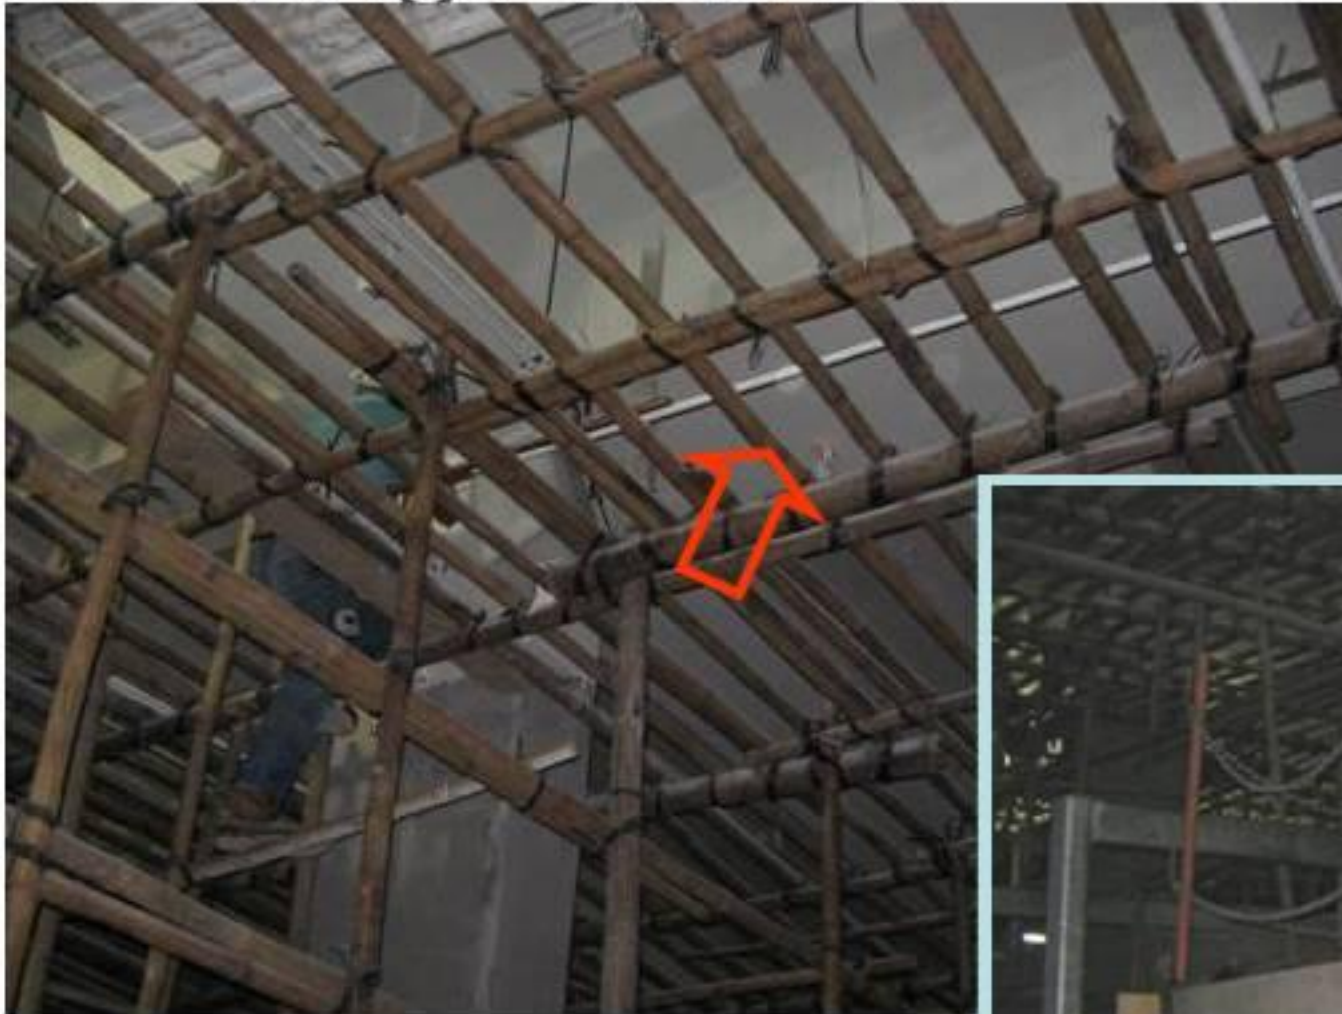
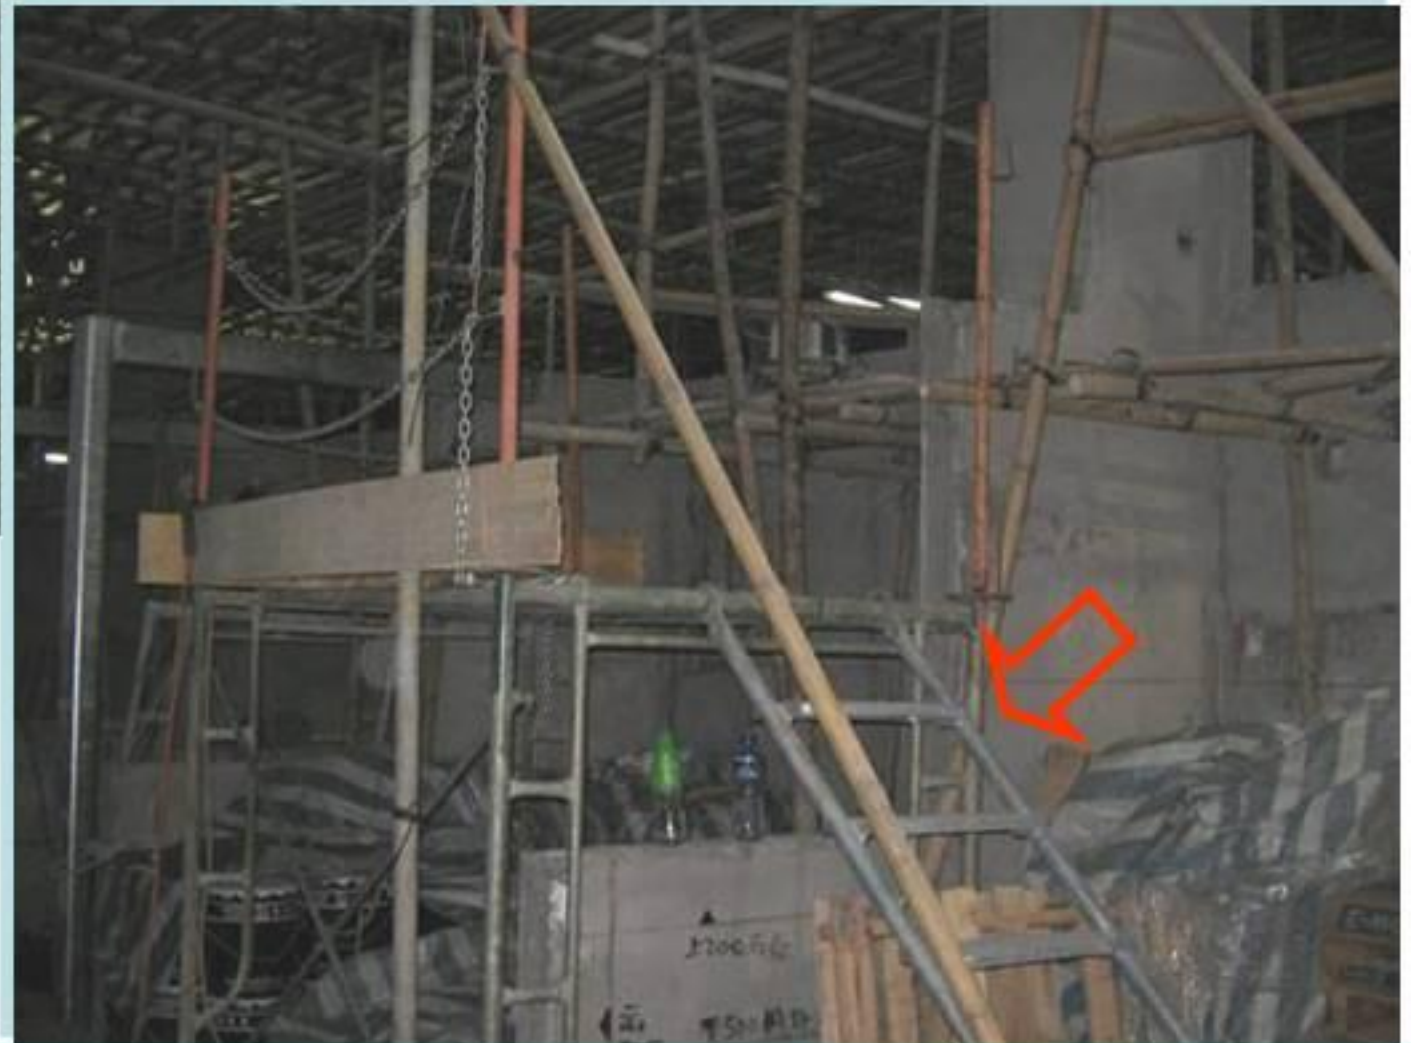
# Working Platform

**NO floor boarding**

**NO railing  
at stair**

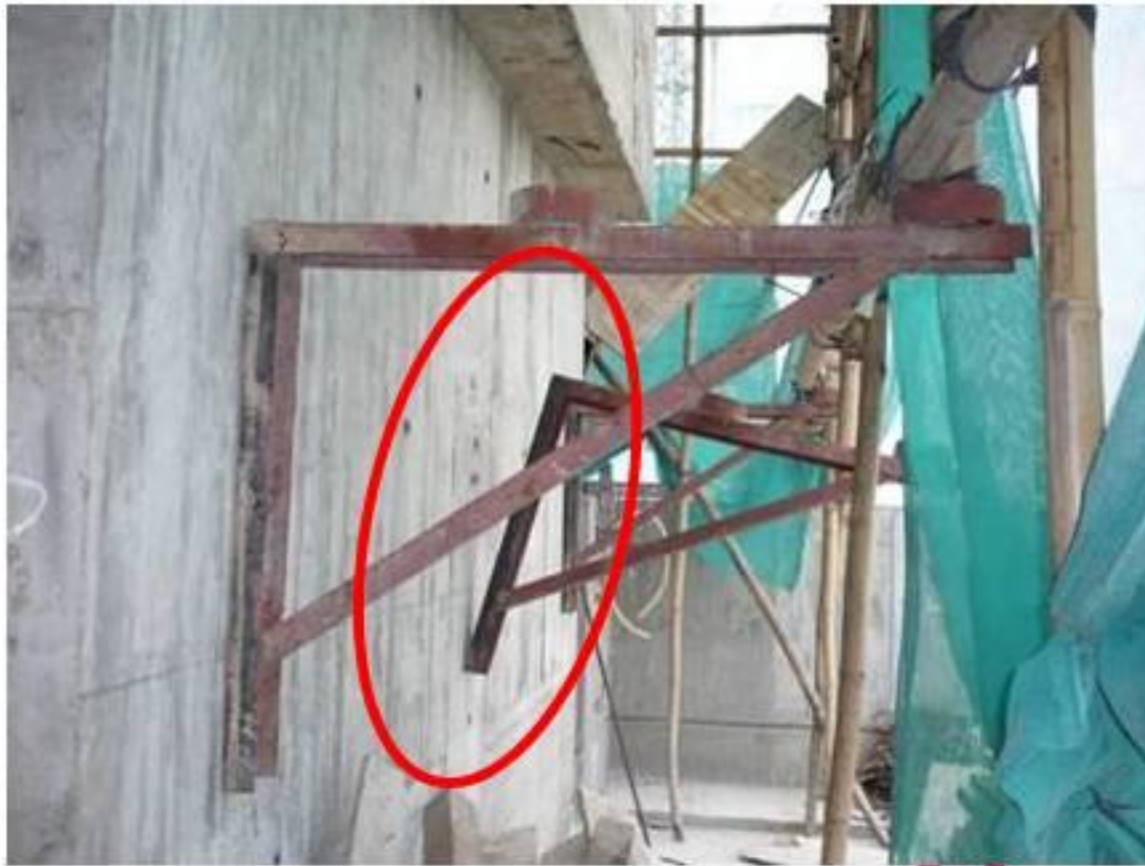
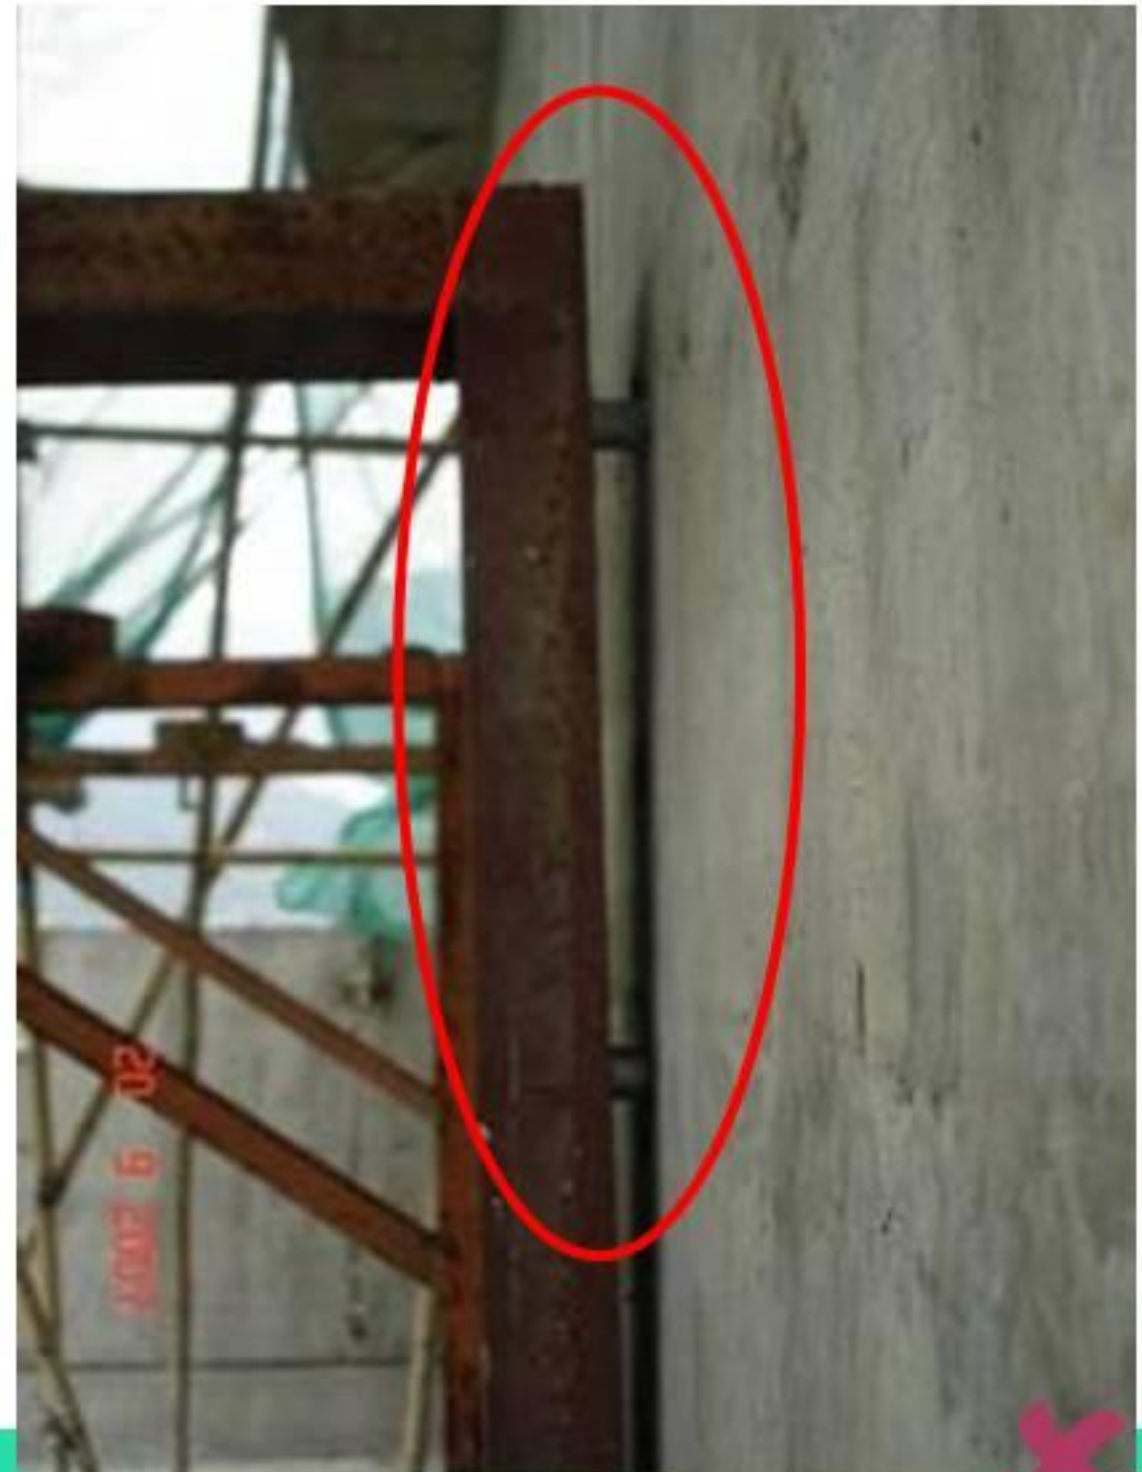
# Scaffolding Support supporting bracket for roof water tank scaffold NOT fixed properly

supporting bracket  
detached from structure

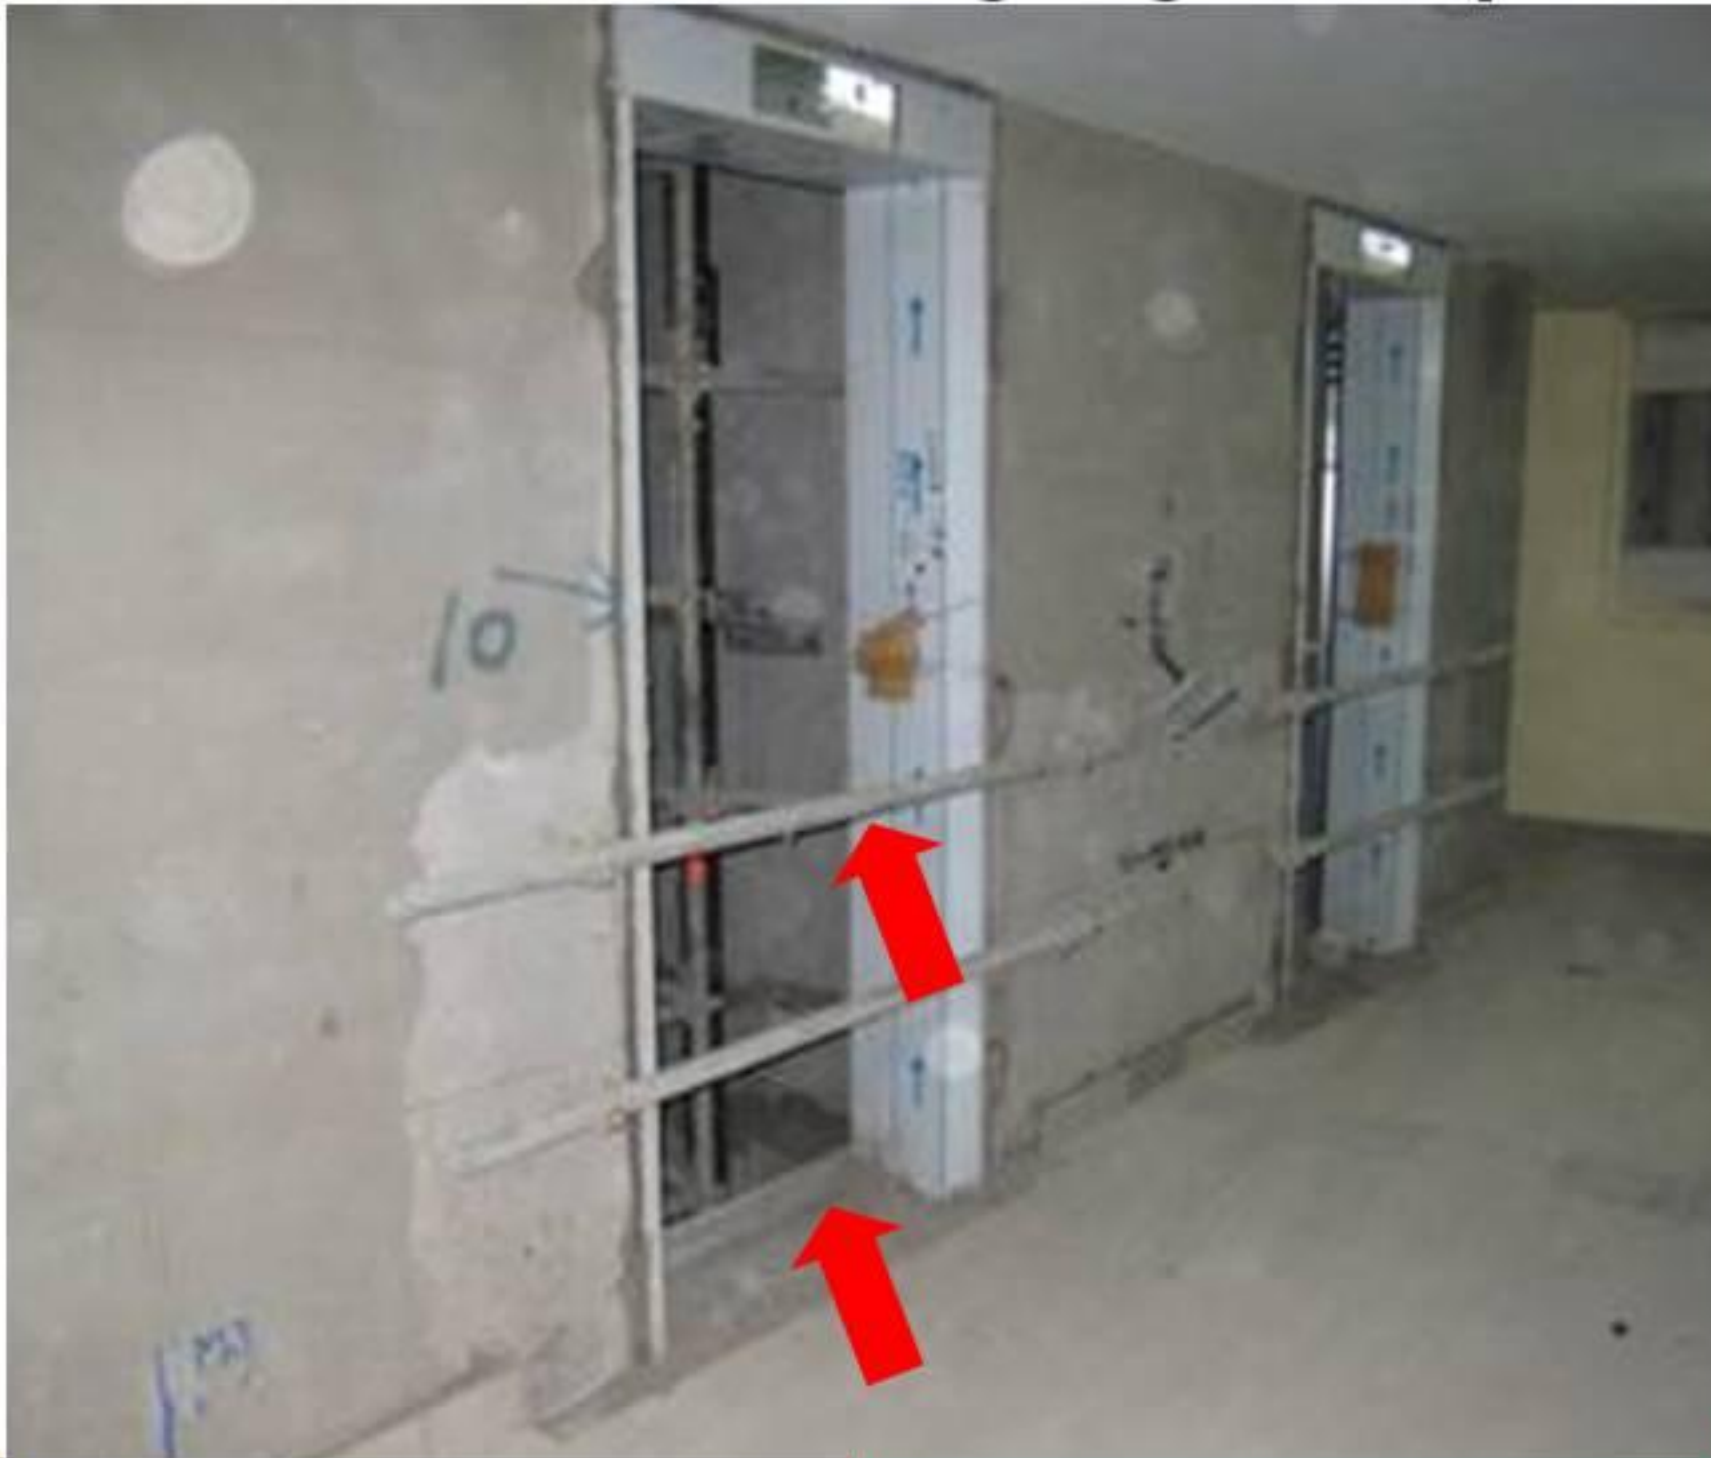
# During Lift Door Installation toe board and warning sign not provided

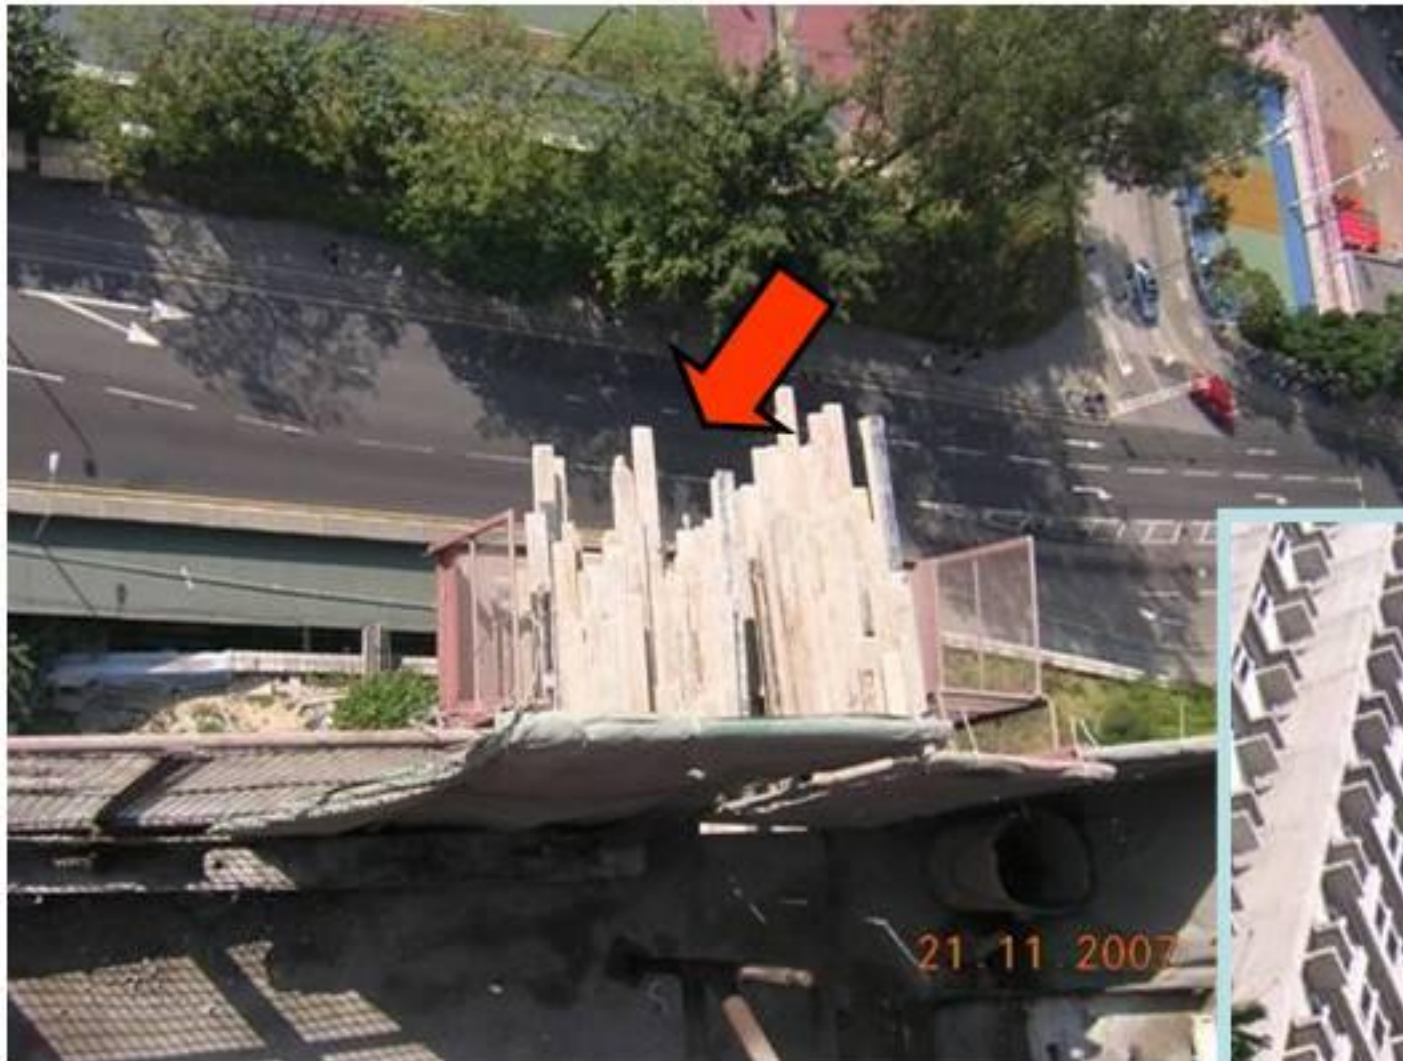
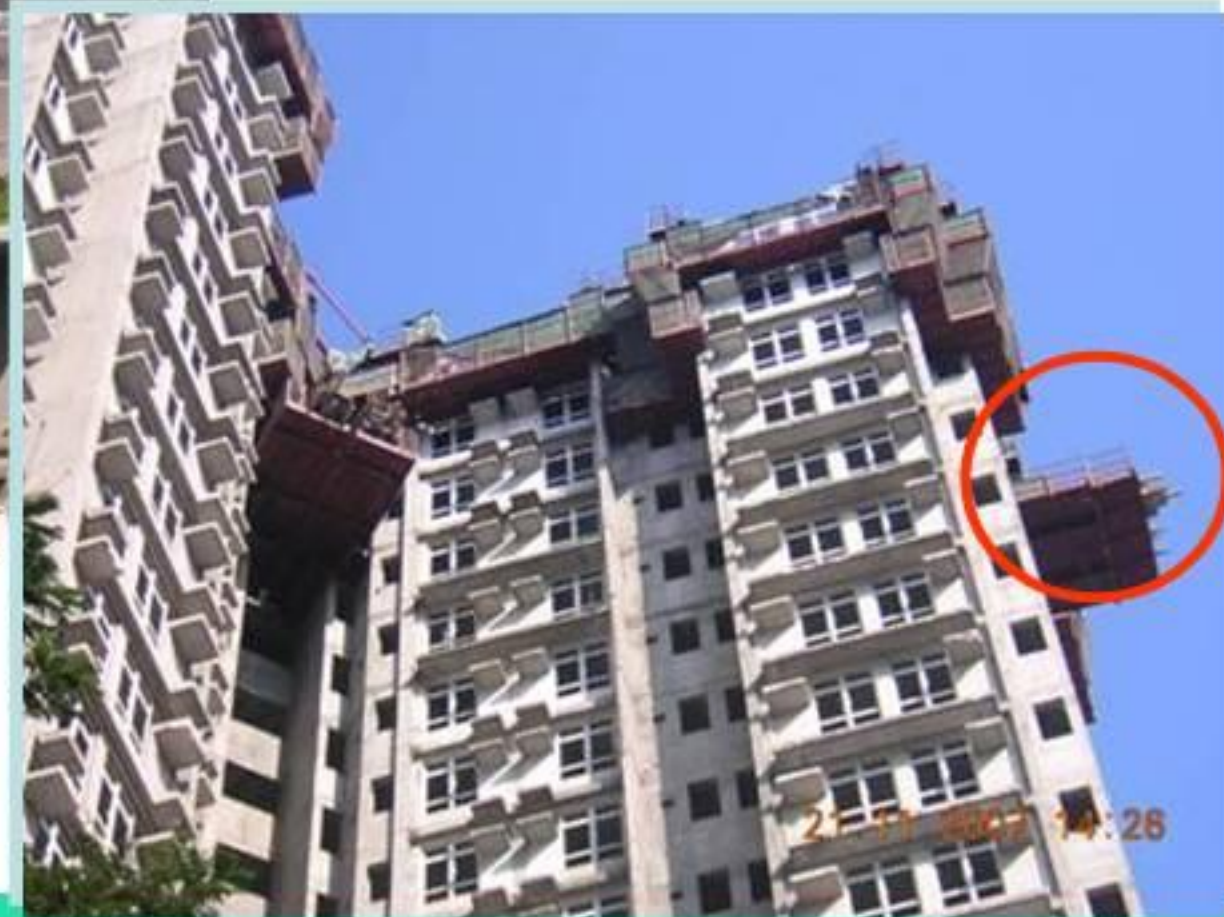
# Stacking Formwork on Temporary Platform platform over public road without end gate

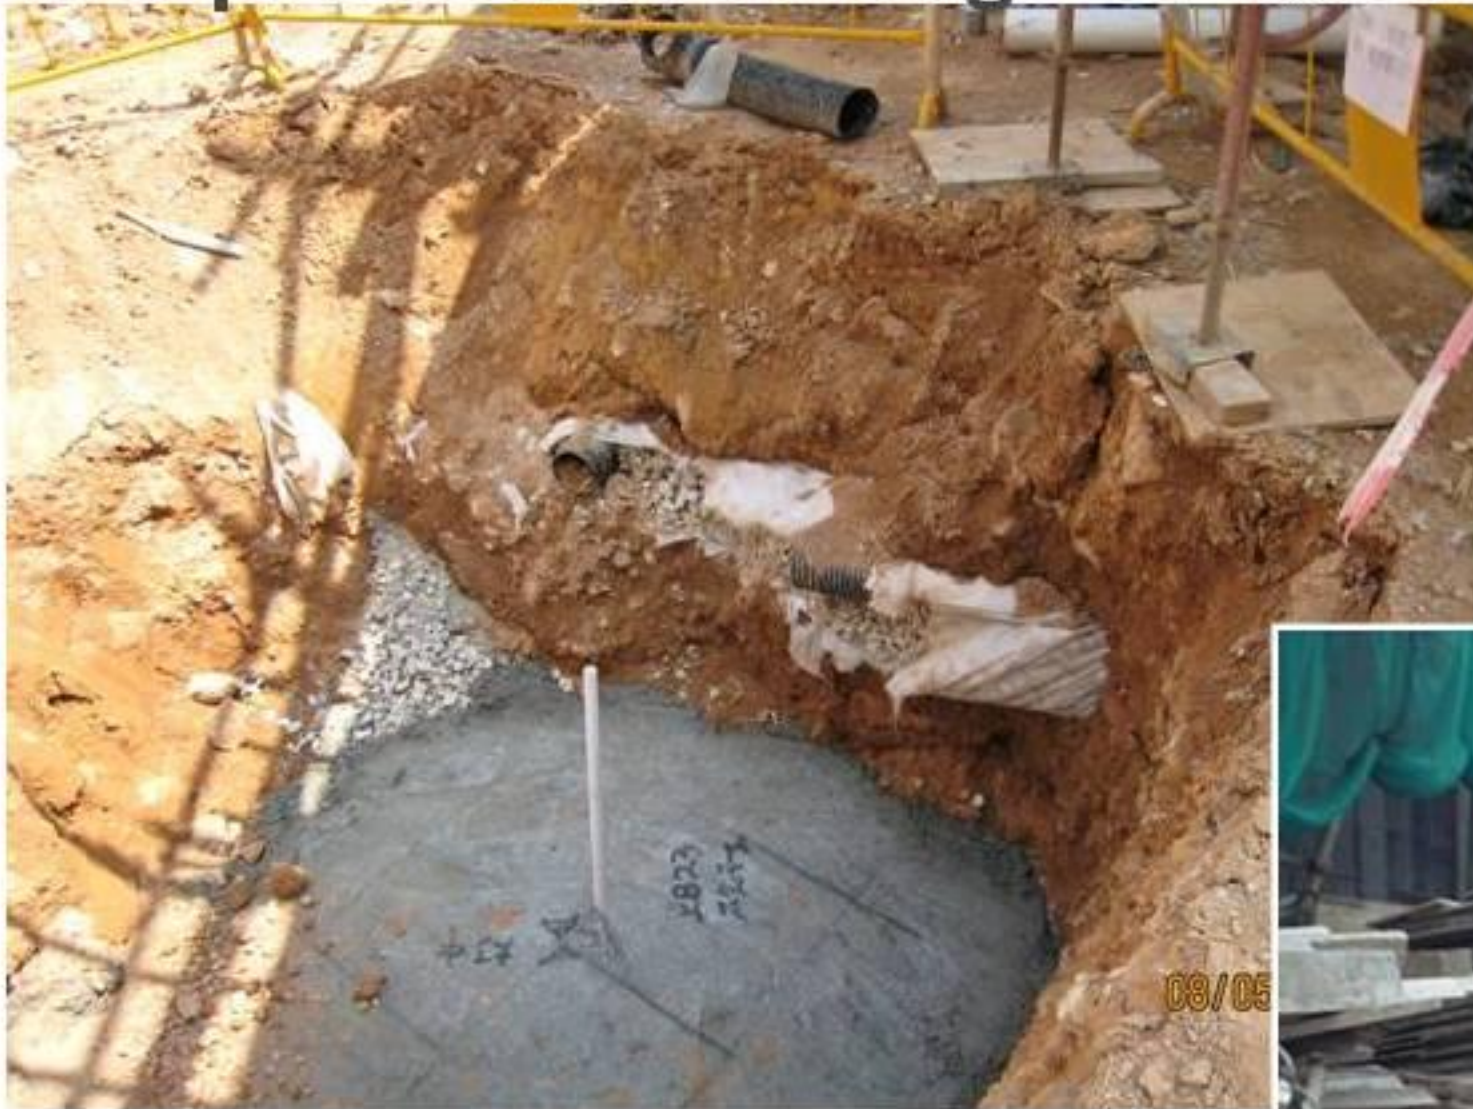
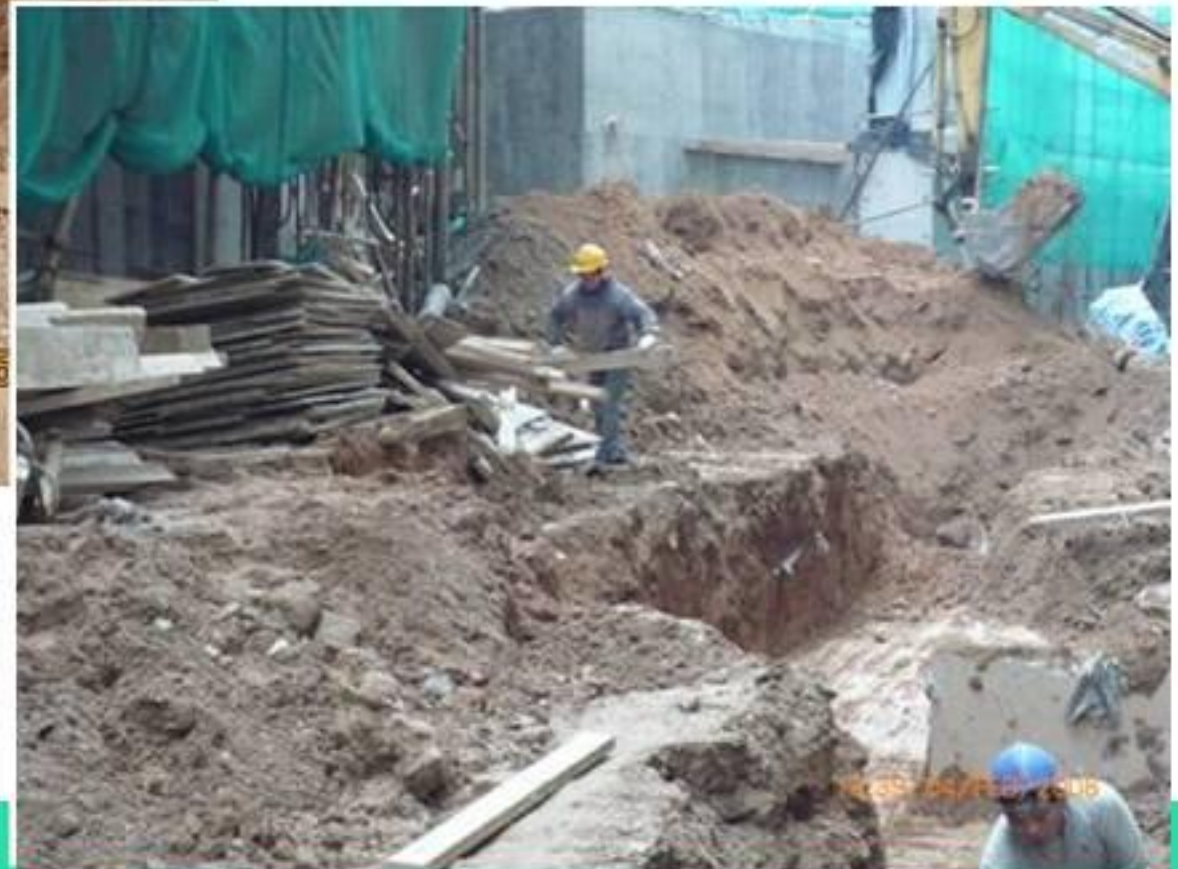
# Open Excavation

## NO protection to edge of excavation
