# **SITE SAFETY Focus Seminar**

on New Works of  
Housing Department

**Site Safety** issues at -

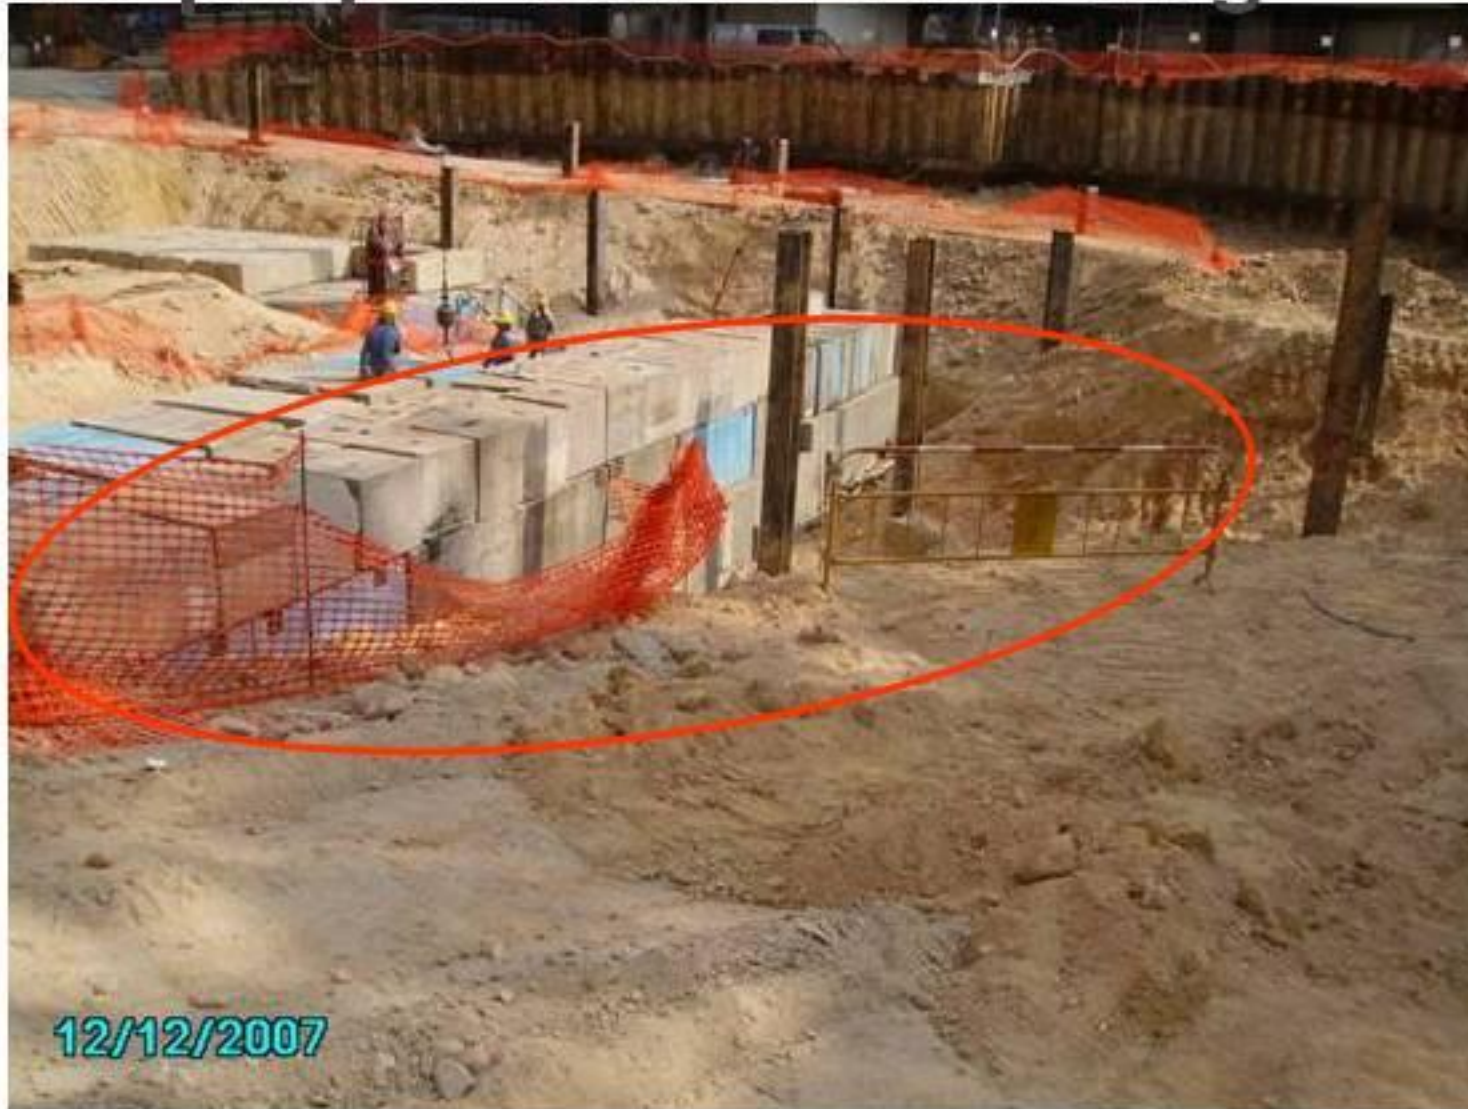
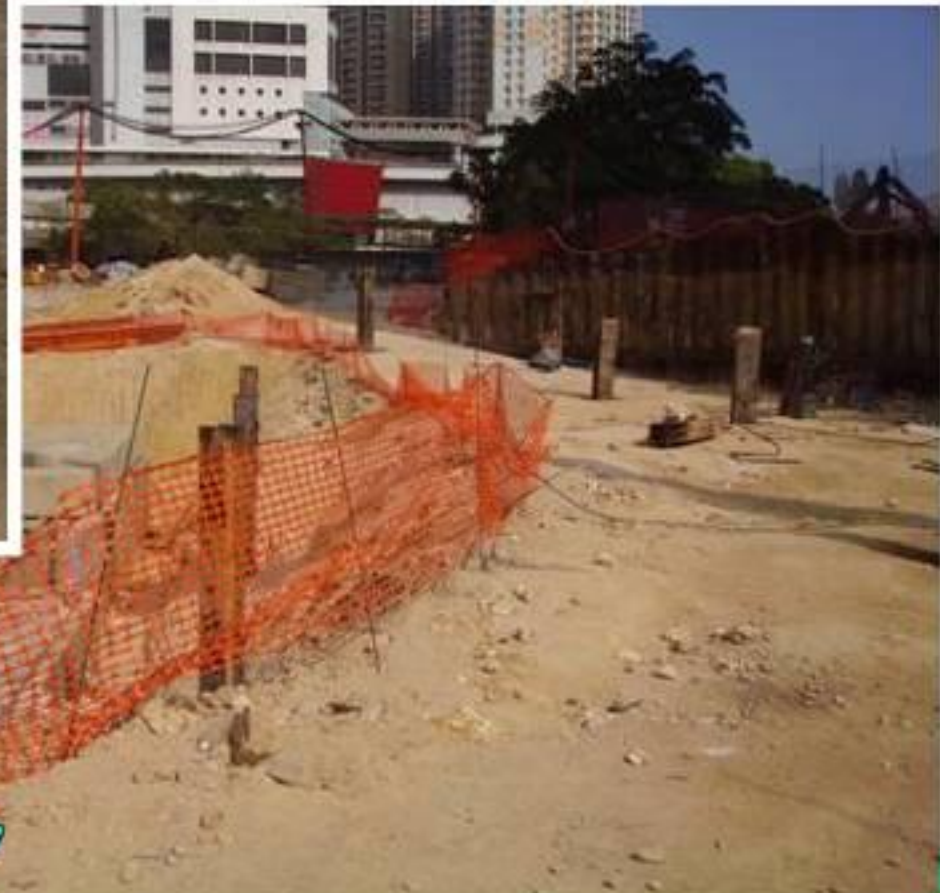
# Railing on Slope

## NO proper barrier / fencing

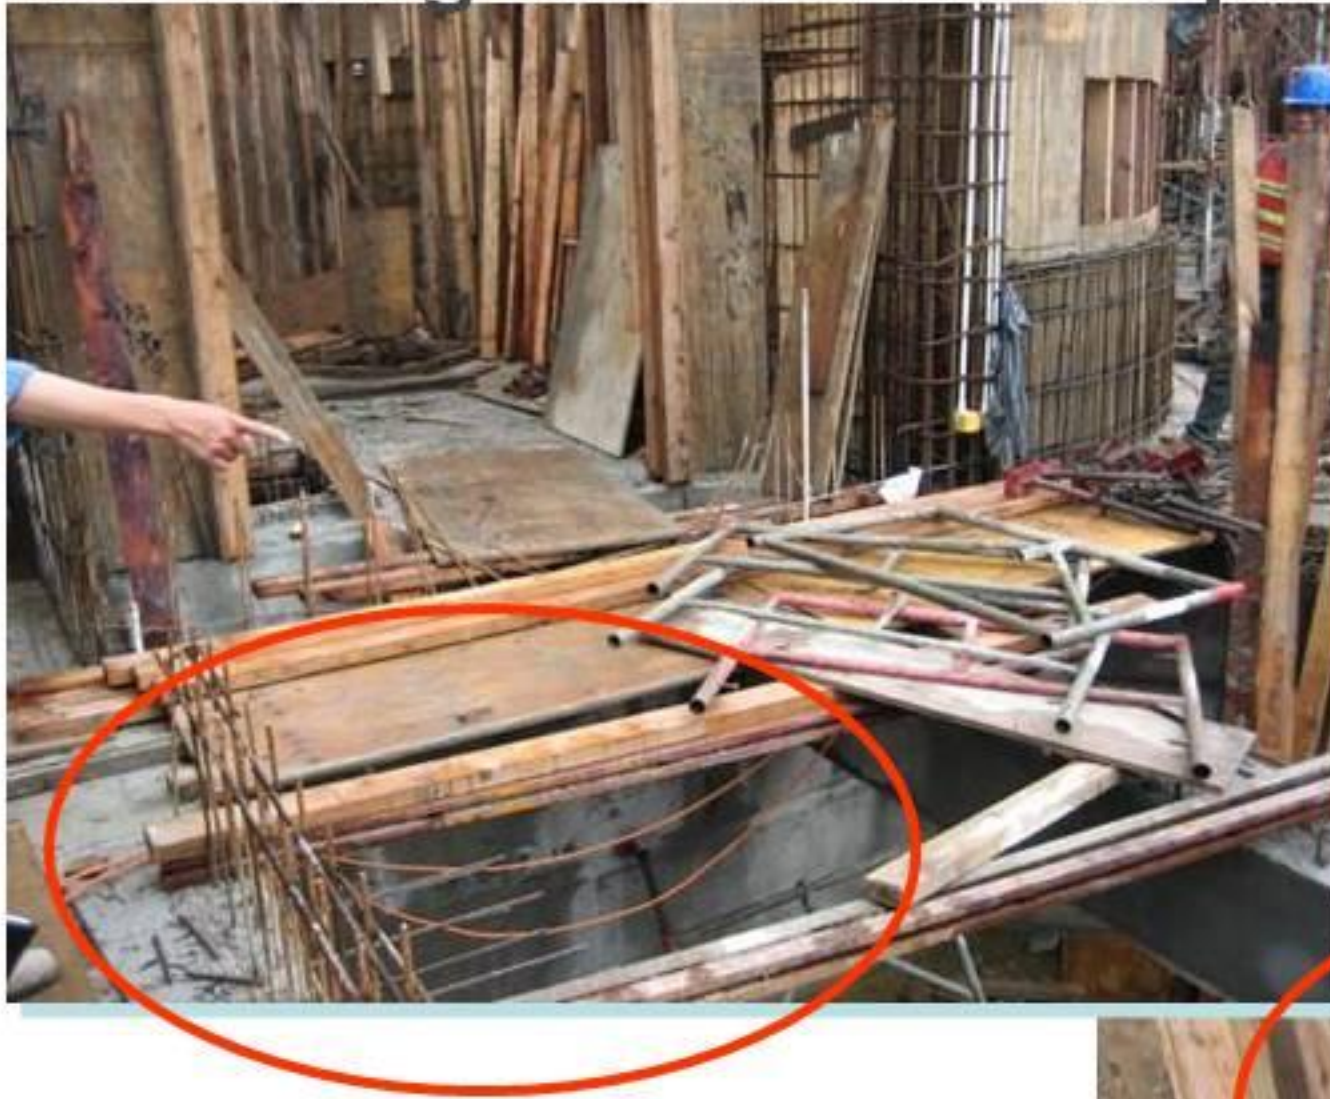
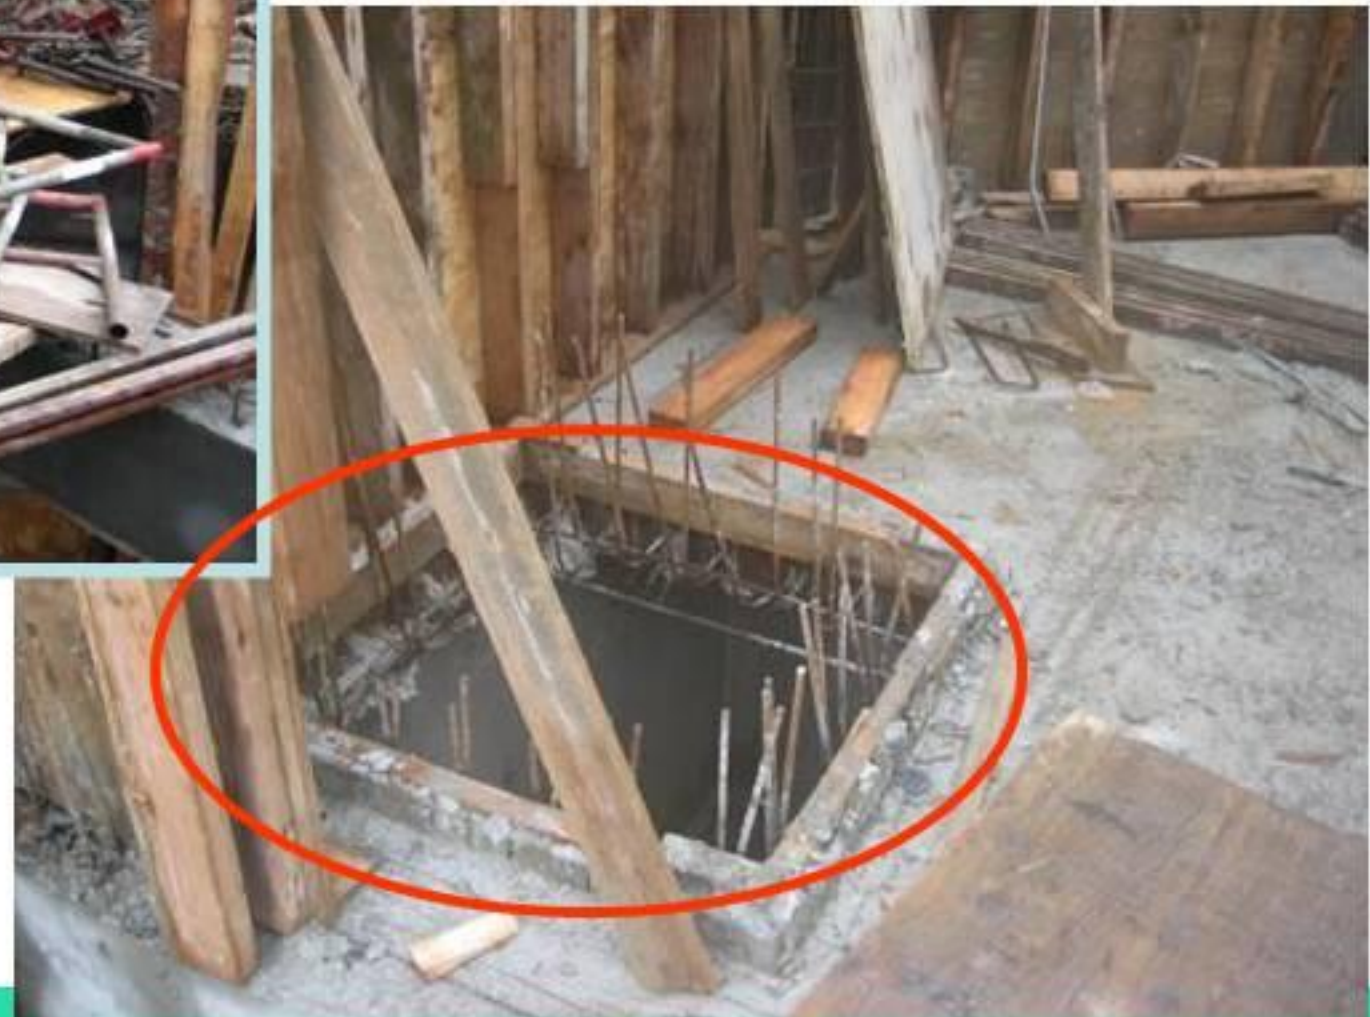
# Protection to Floor Opening

## NO railing and toe board provided

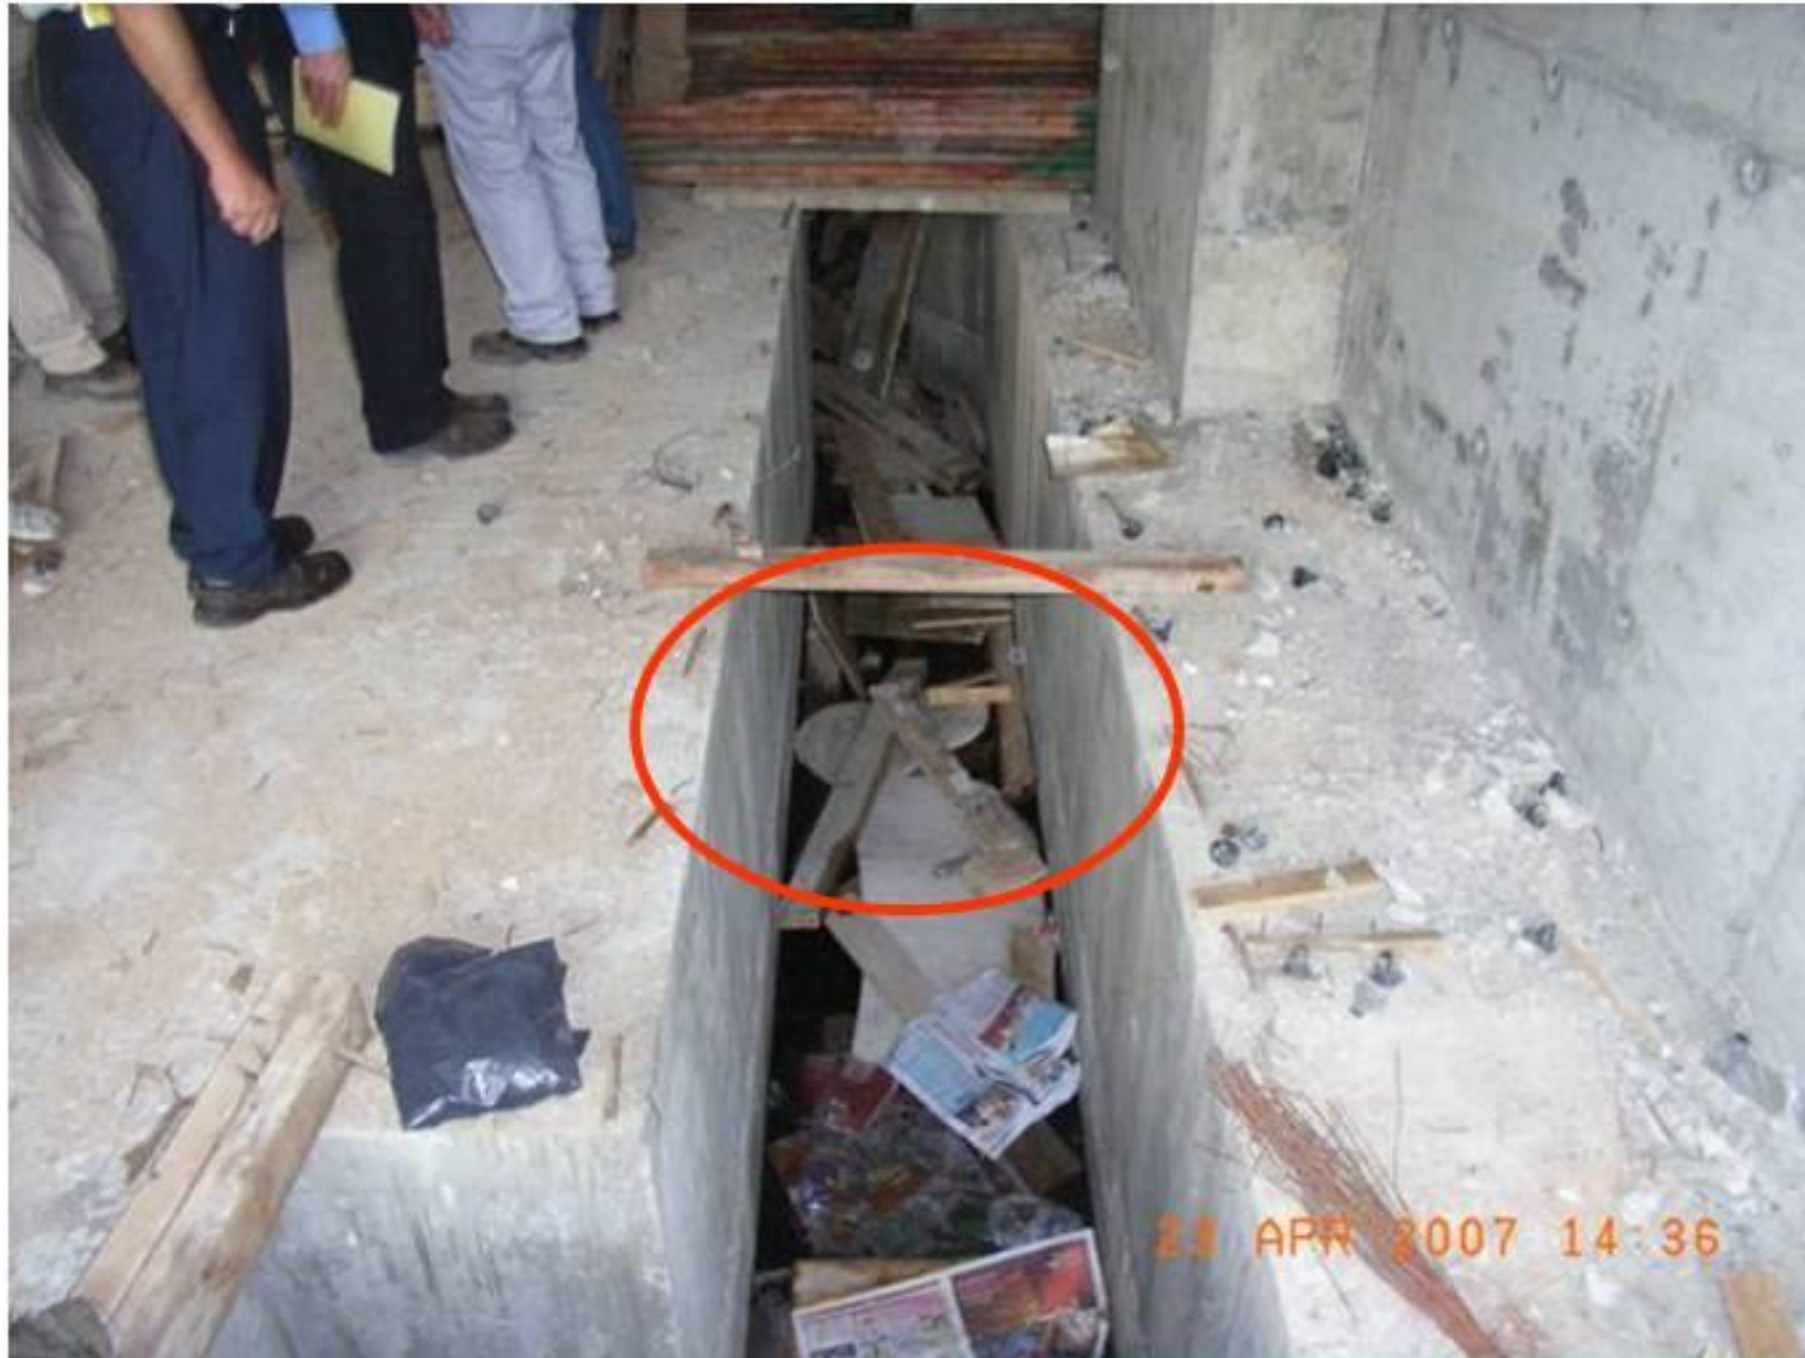
# Protection to Floor Opening

trench not covered up properly by timber boards or other suitable material

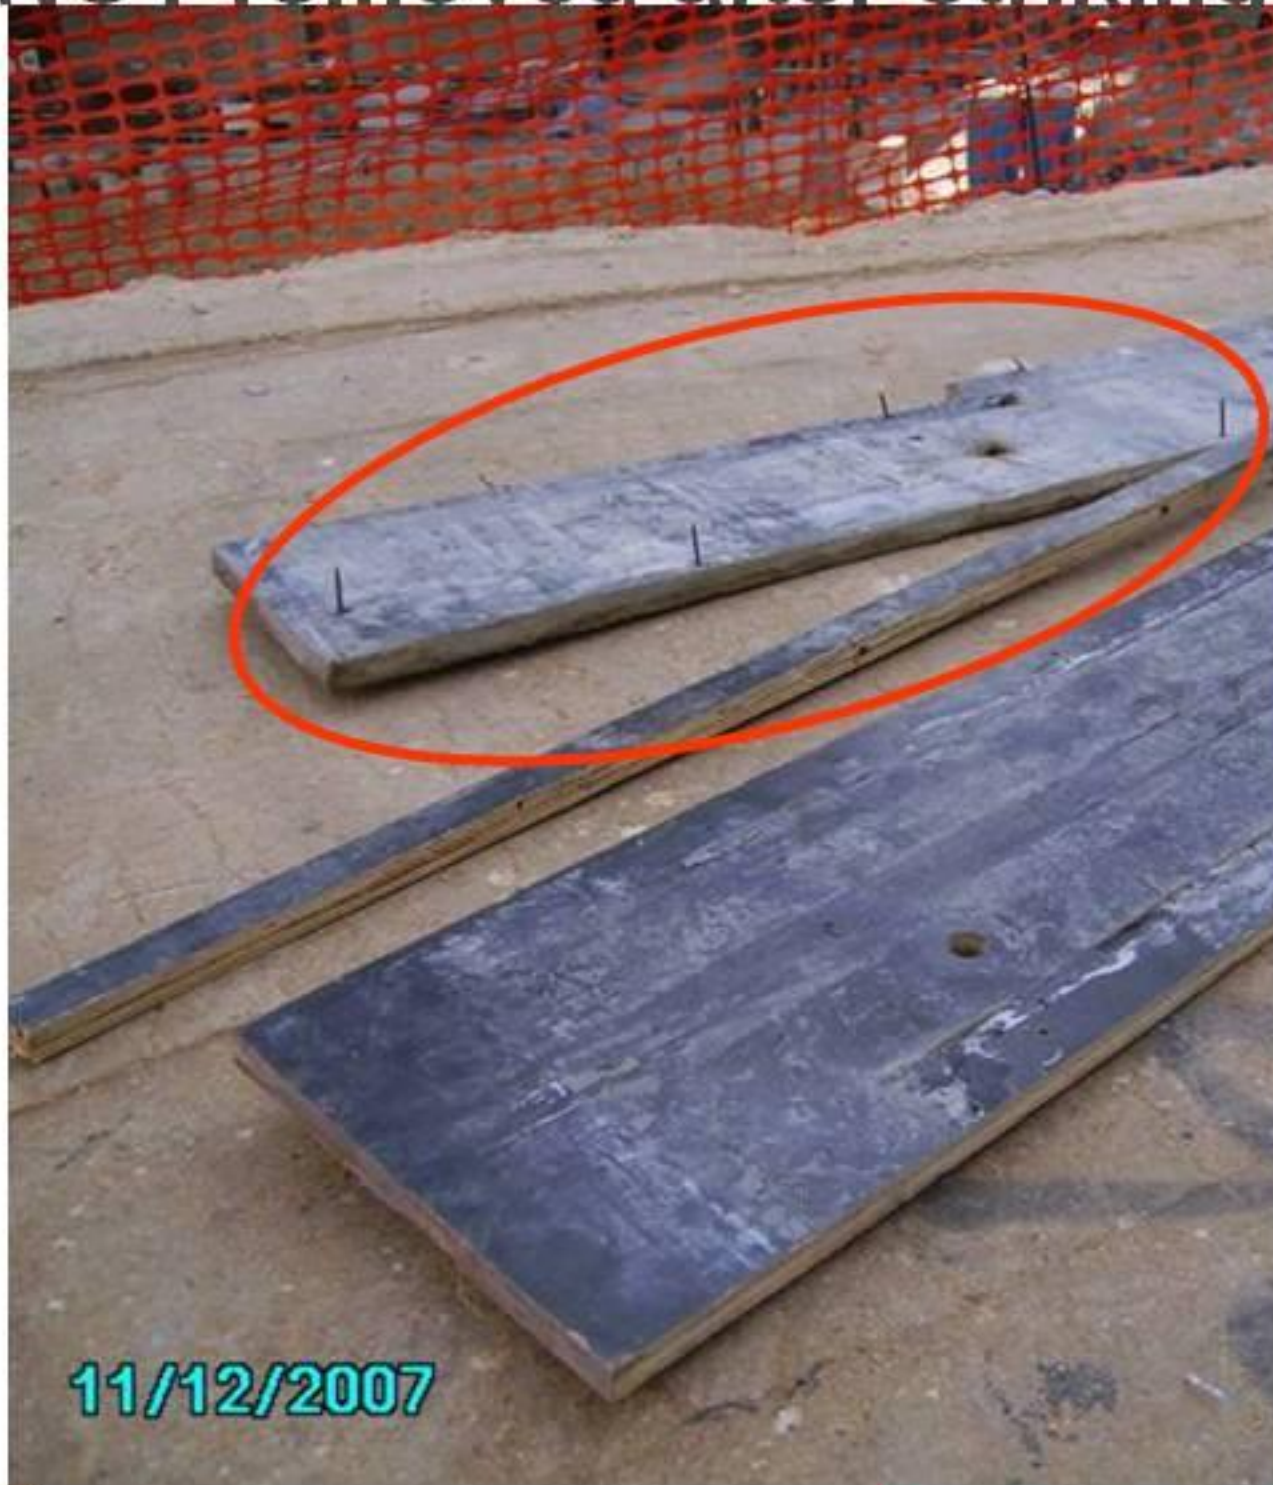
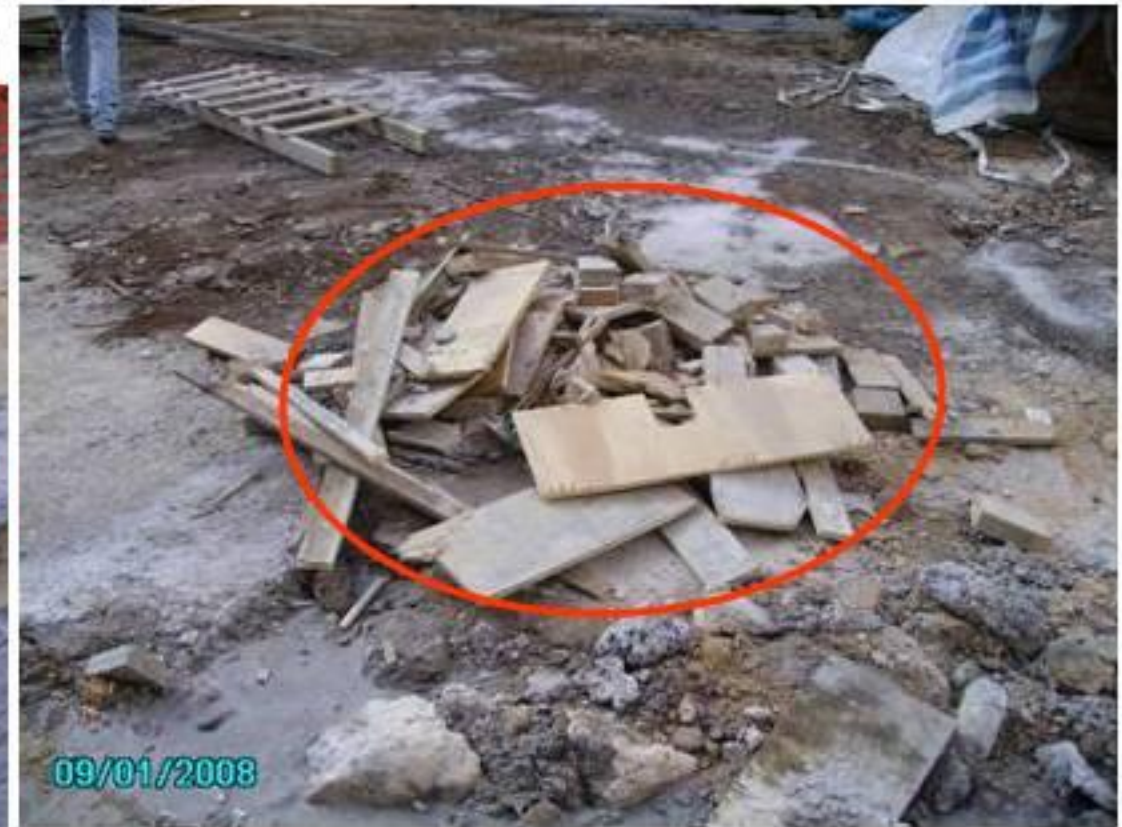
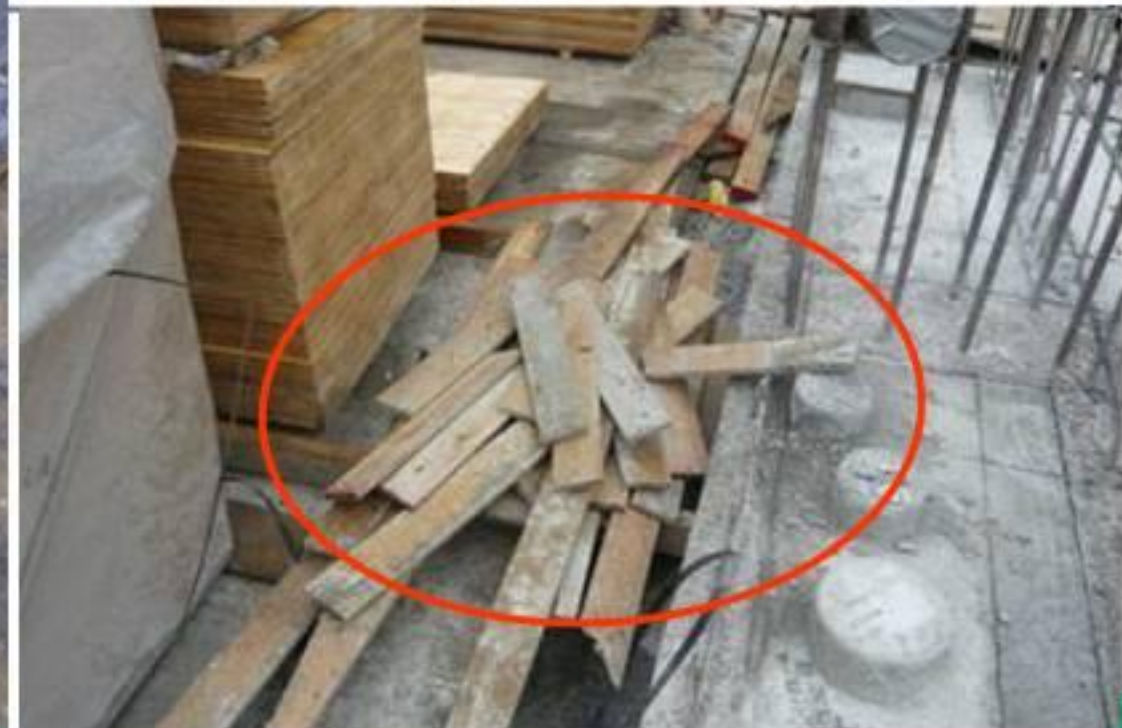
# Nails on Timber Formwork NOT removed after striking

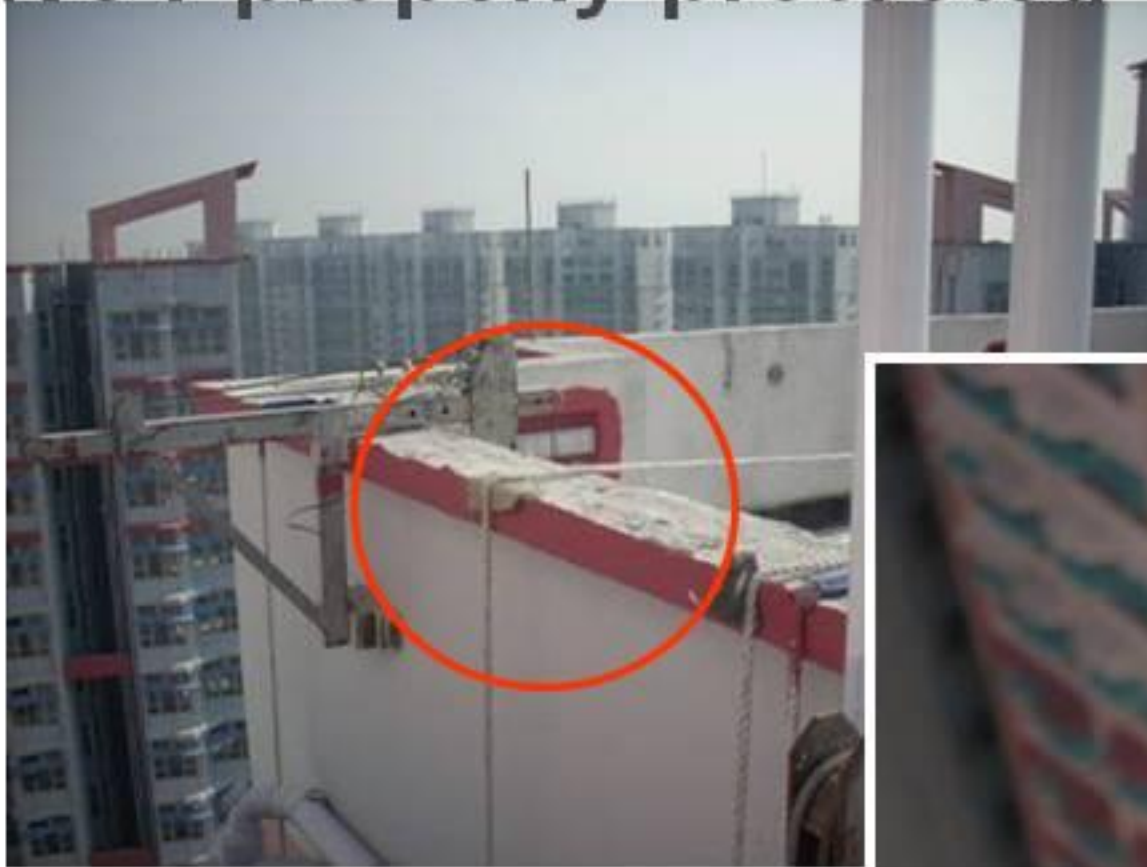
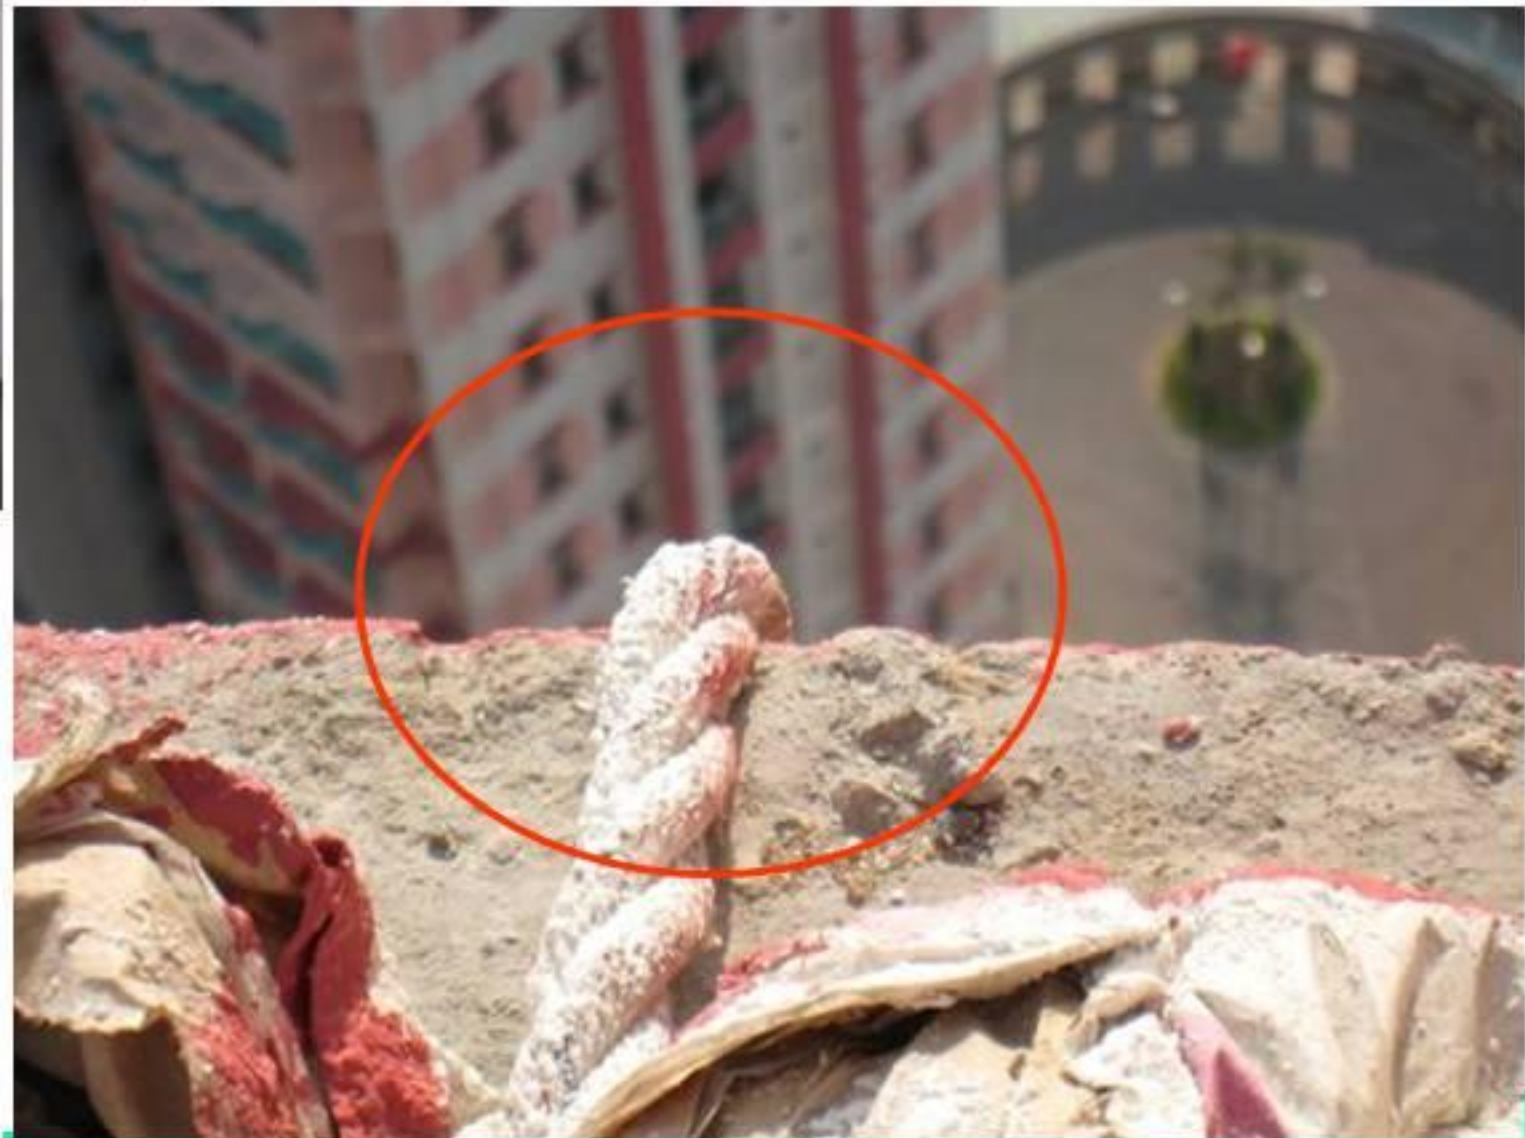
# Gondola Wire / Safety NOT properly protected

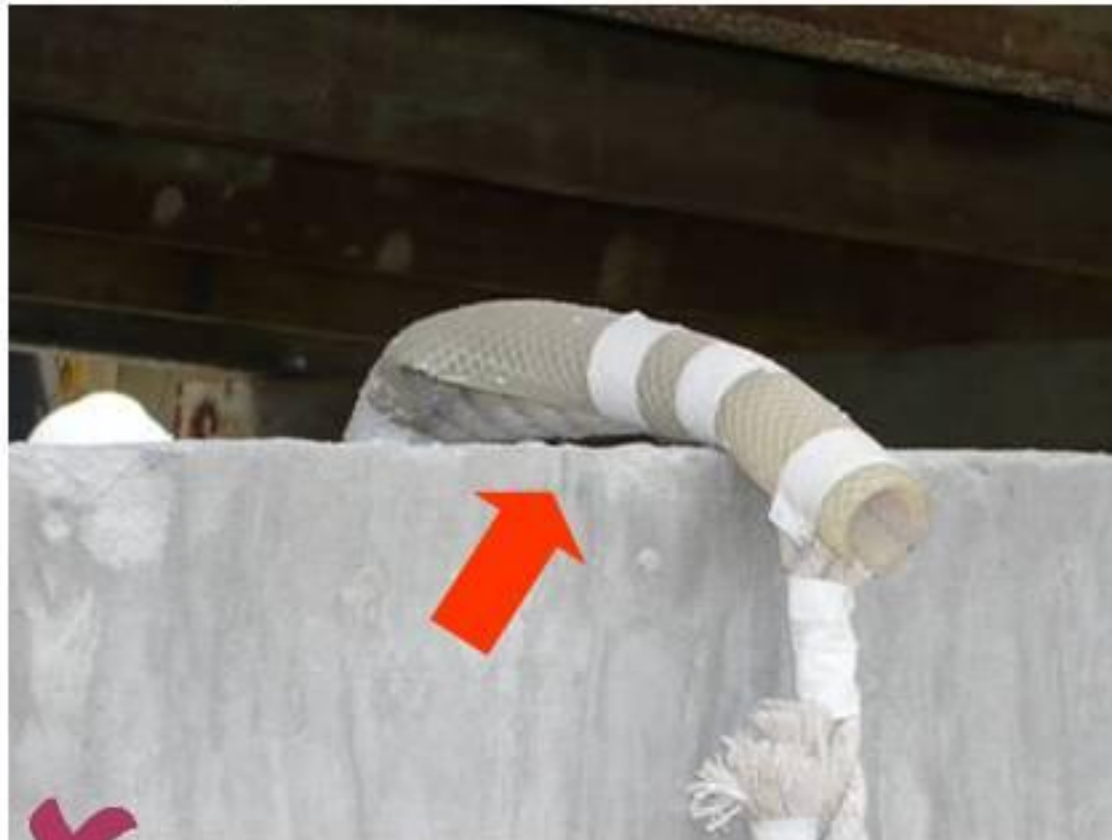
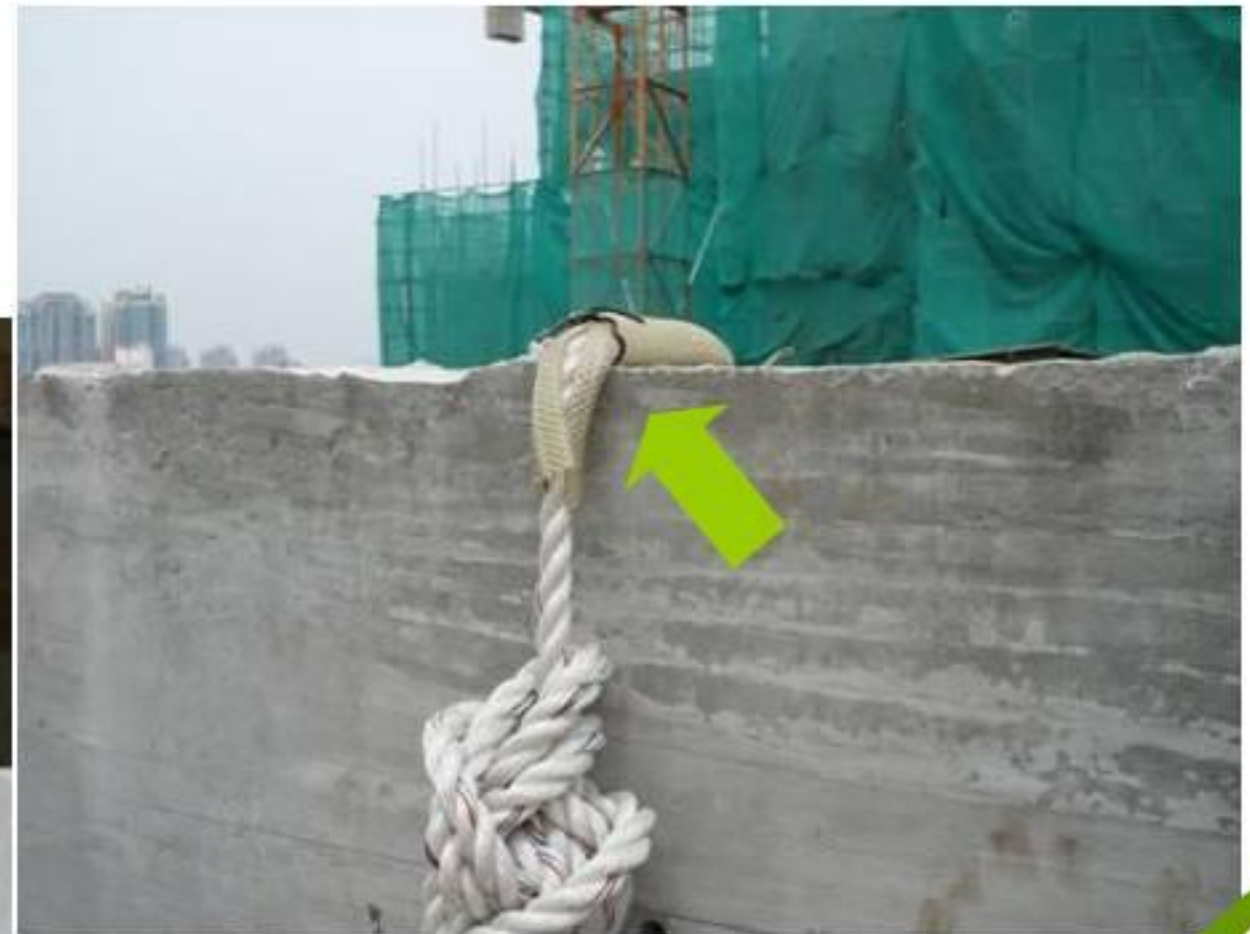
# Gondola Wire / Safety protective rubber wrong way installed

cut end of tubing  
not protecting  
the wire from the  
sharp corner

cut end of tubing  
facing upwards  
can protect  
the wire from the  
sharp corner

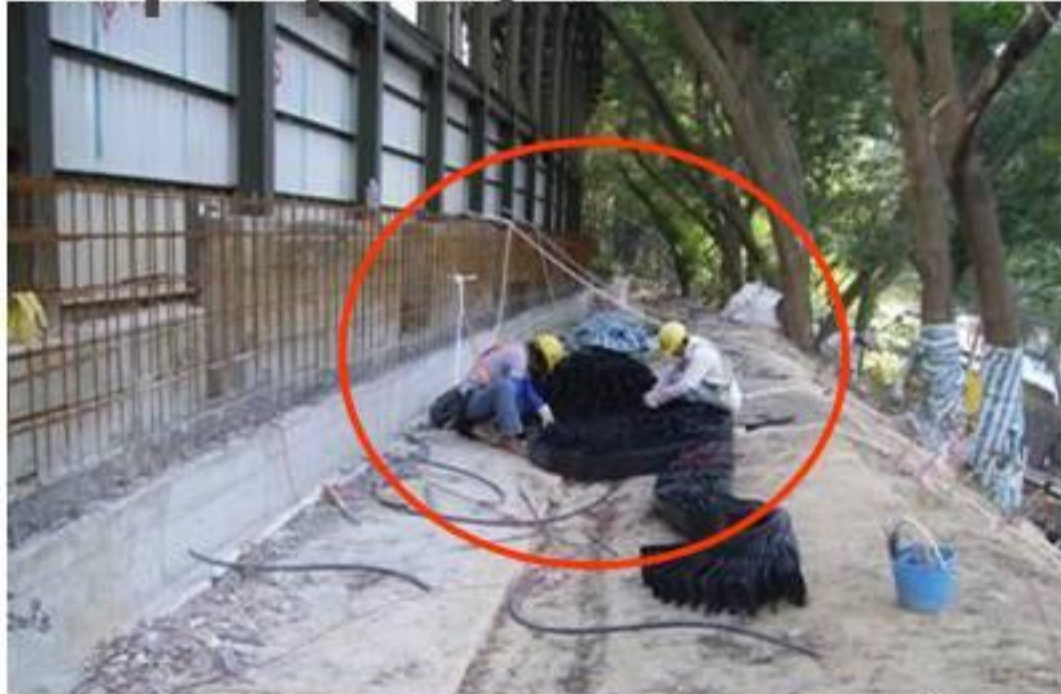
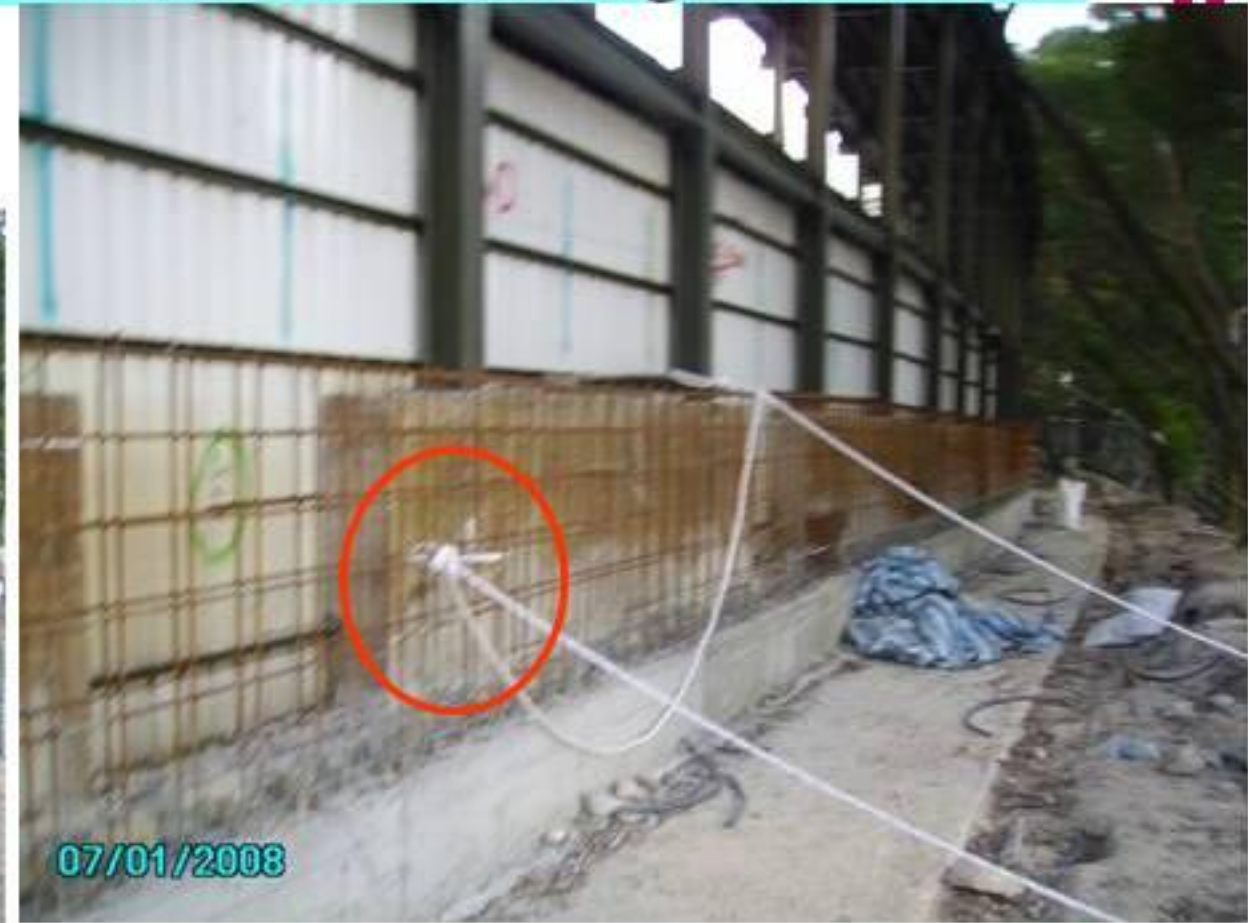
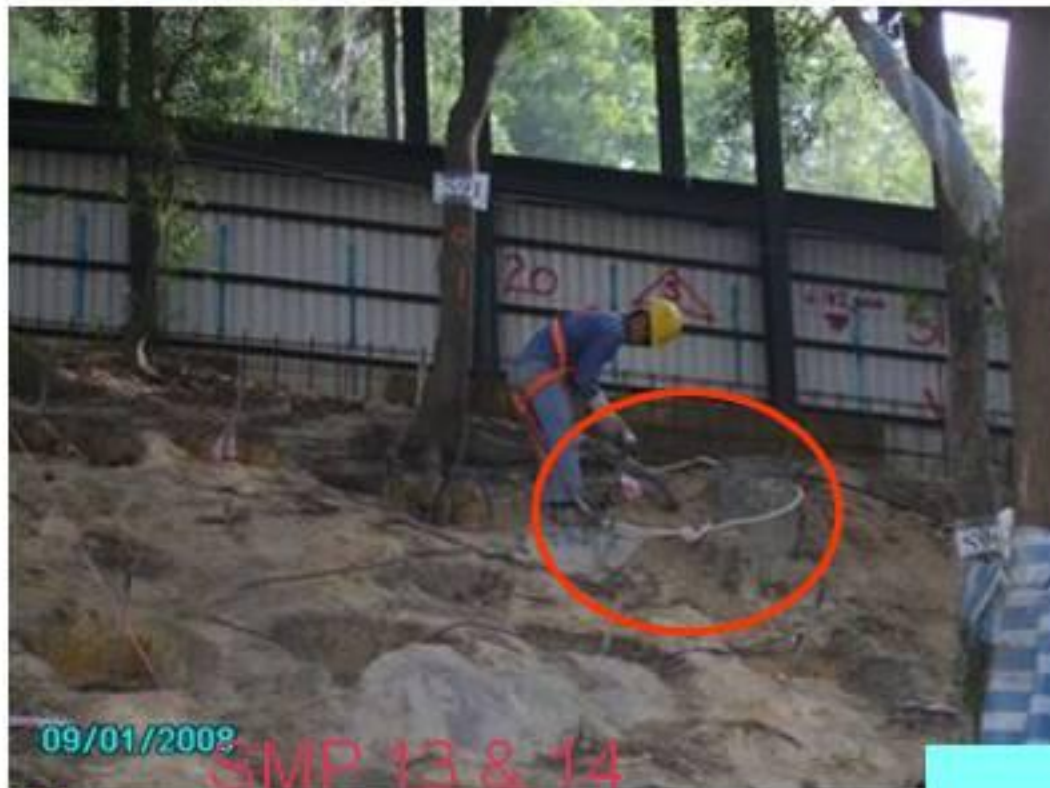
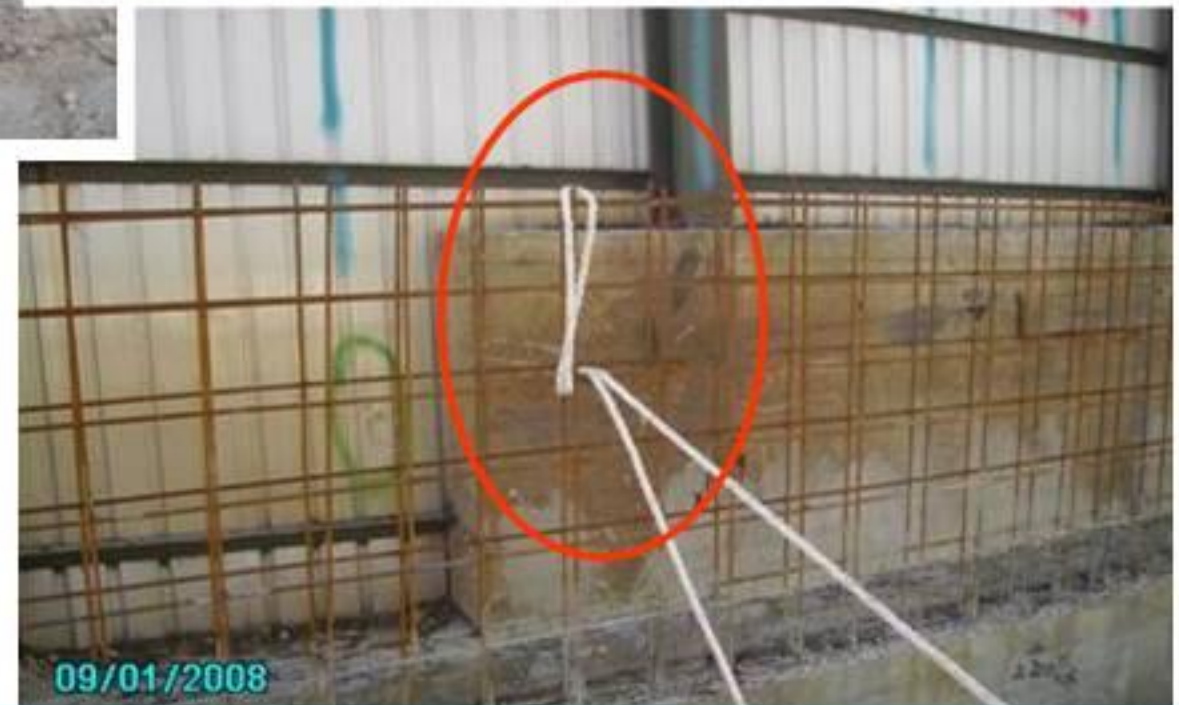
# Safety Lifeline NOT properly fixed

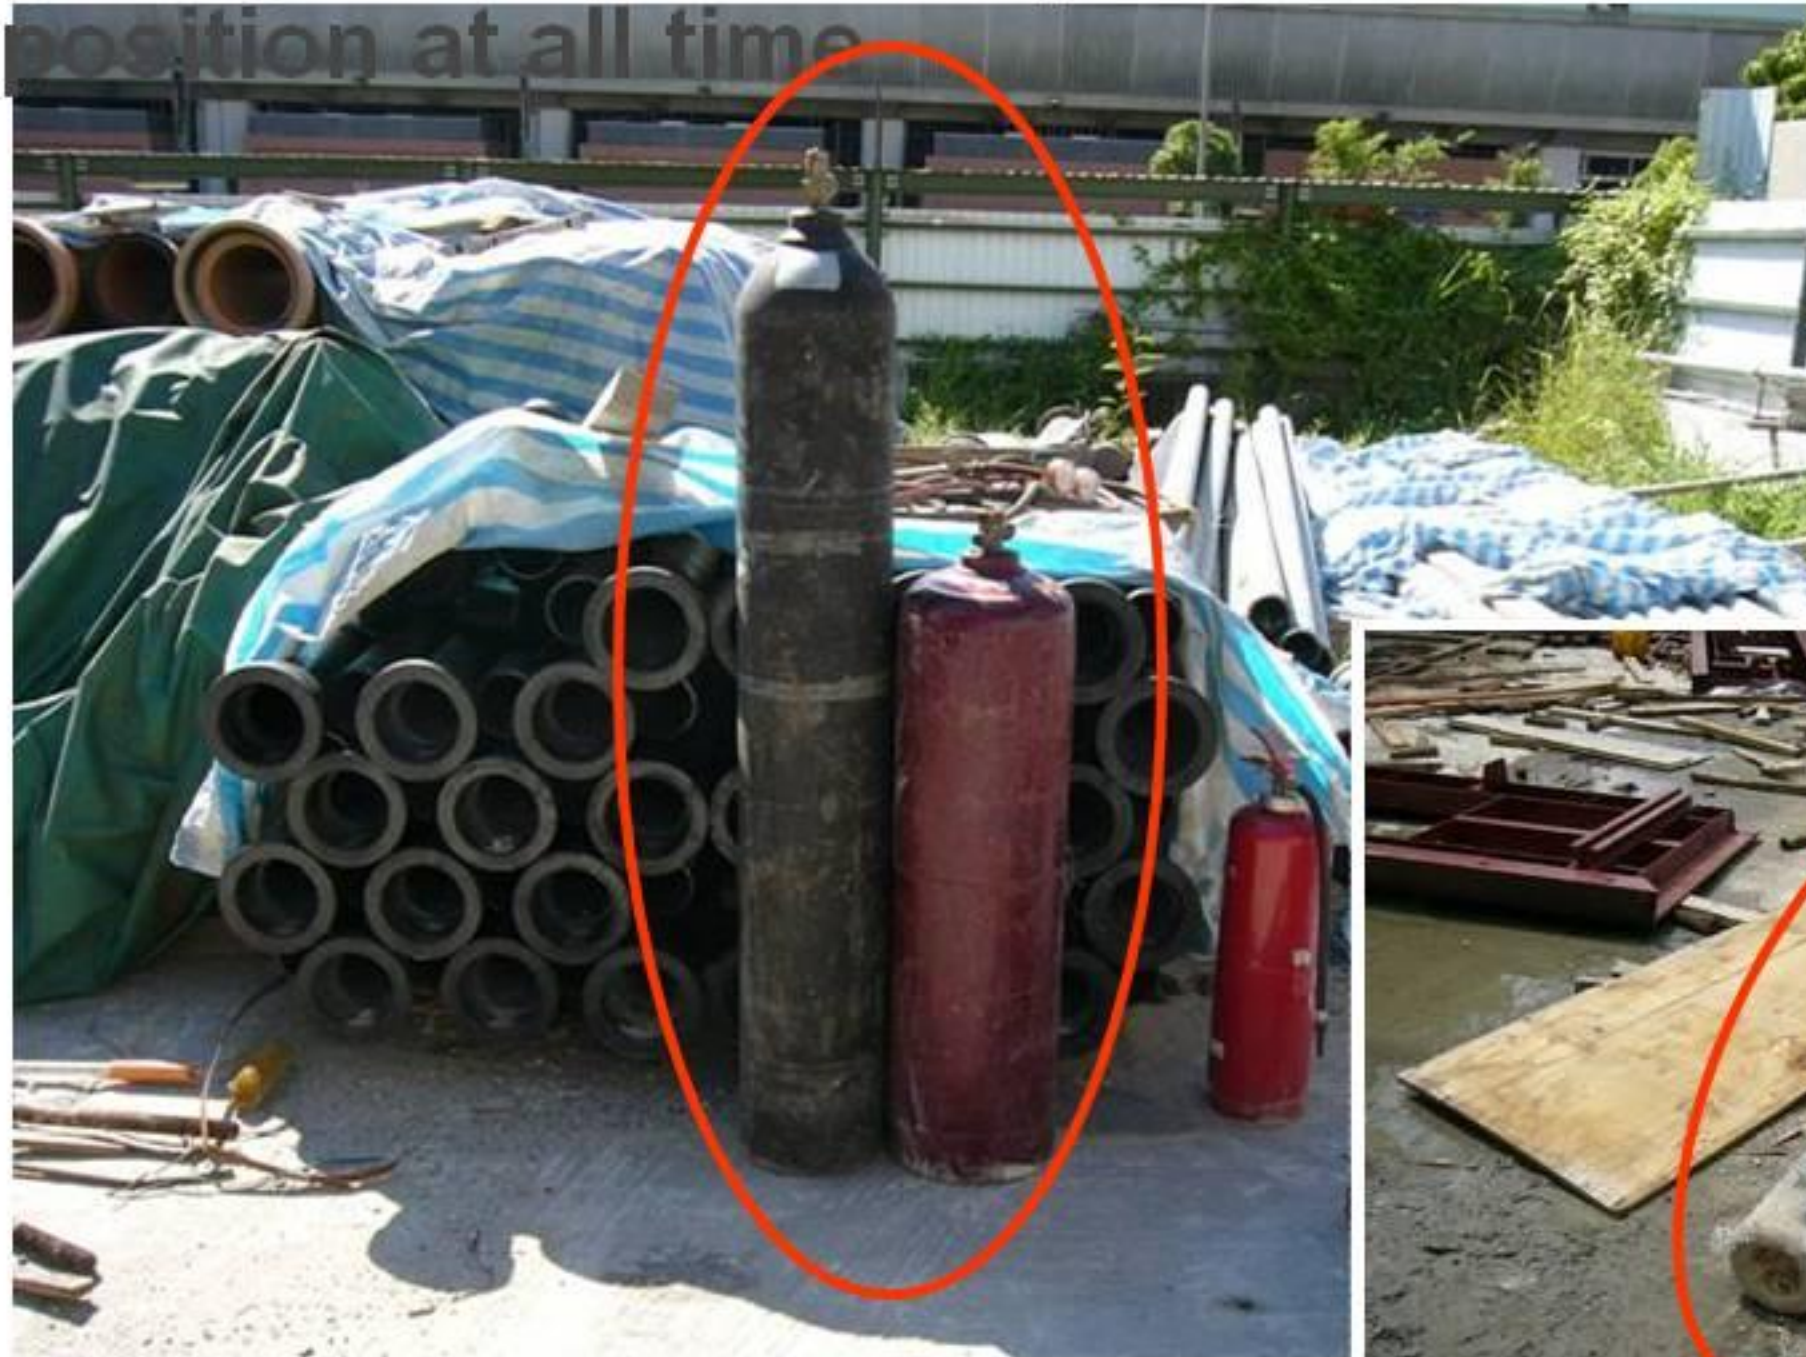
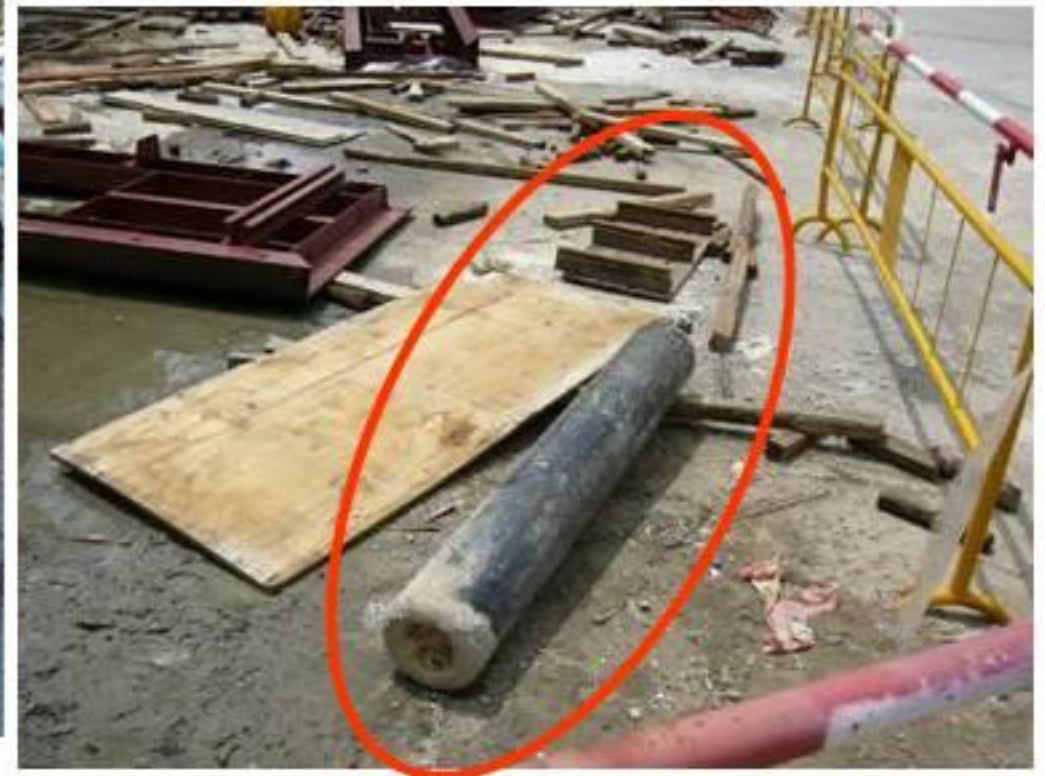
# Protection to Dangerous Materials

gas cylinders to be kept locked and at upright
