# **SITE SAFETY Focus Seminar**

on New Works of  
Housing Department

**Site Safety** issues at -

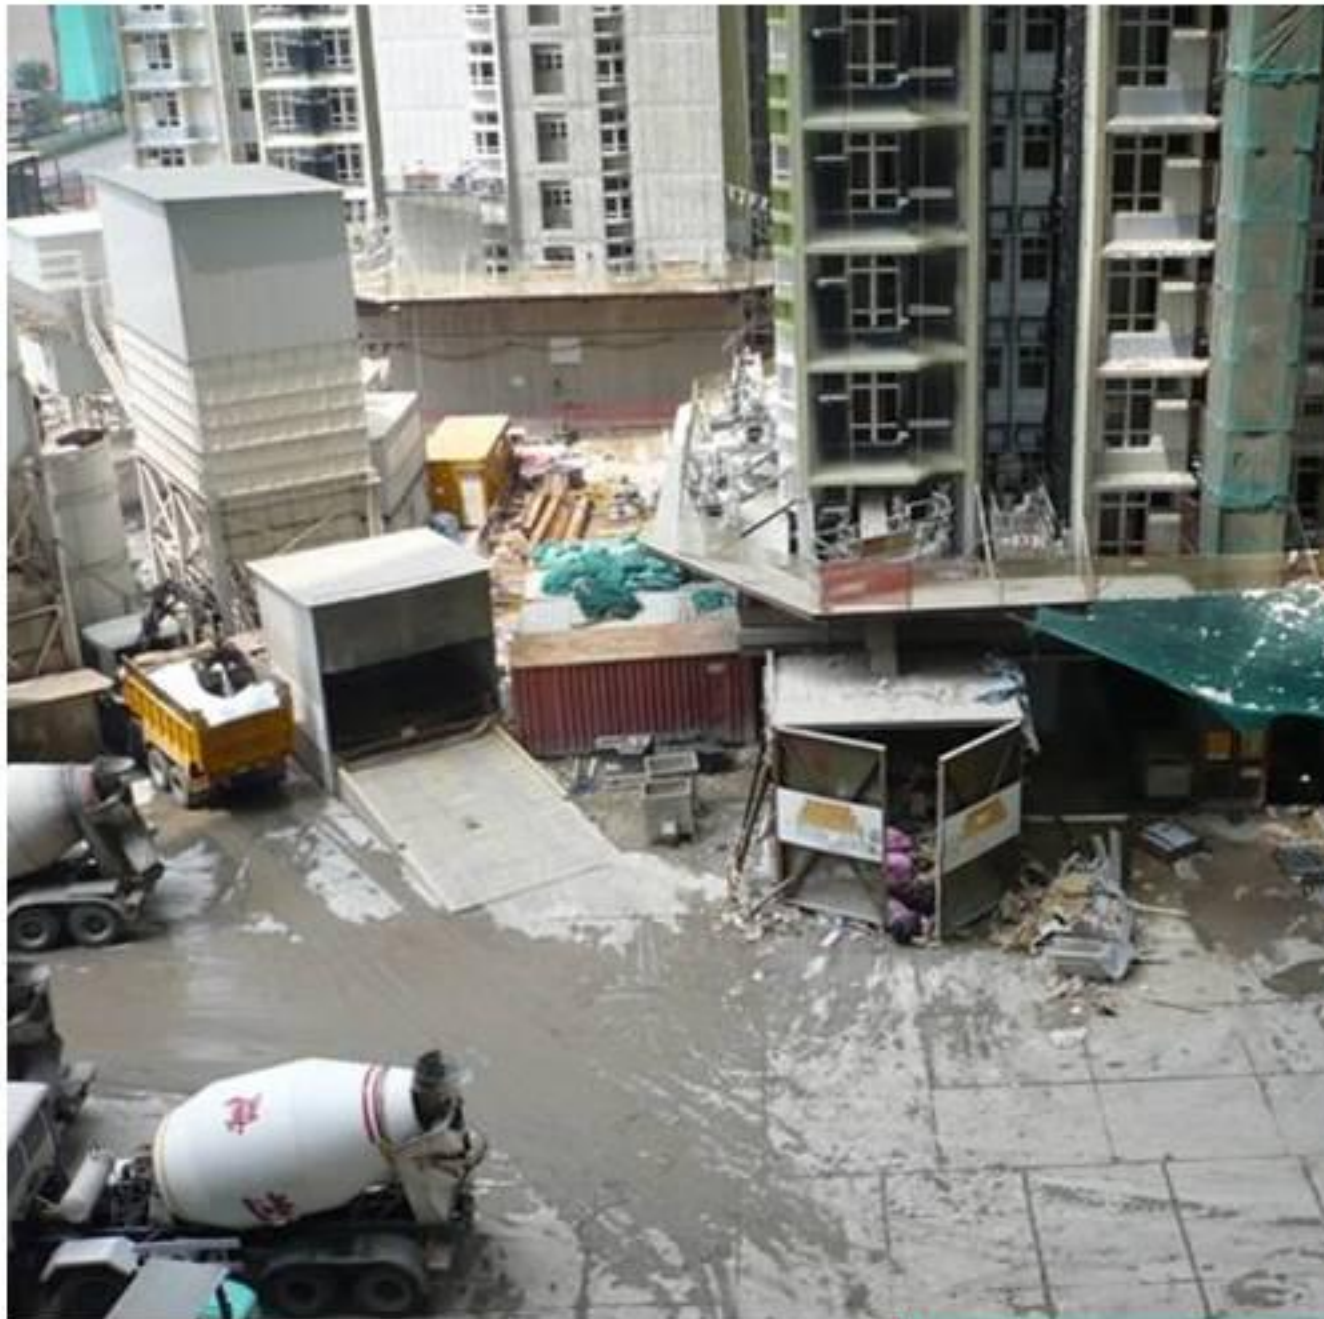
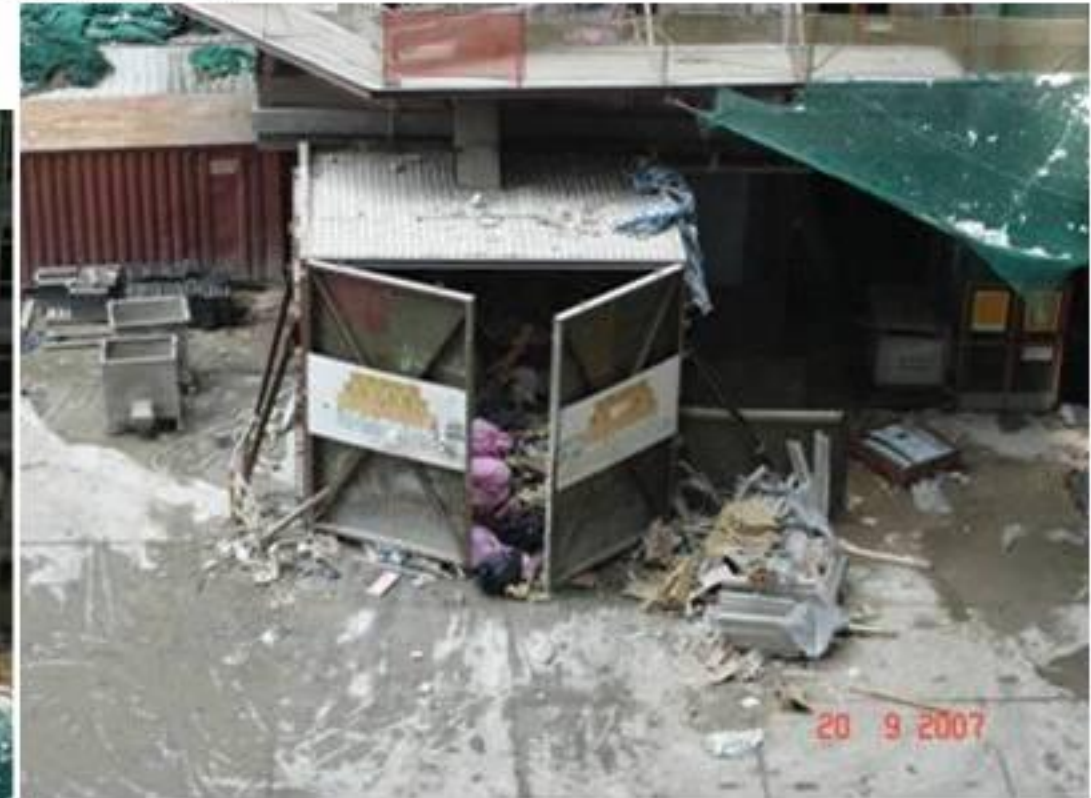
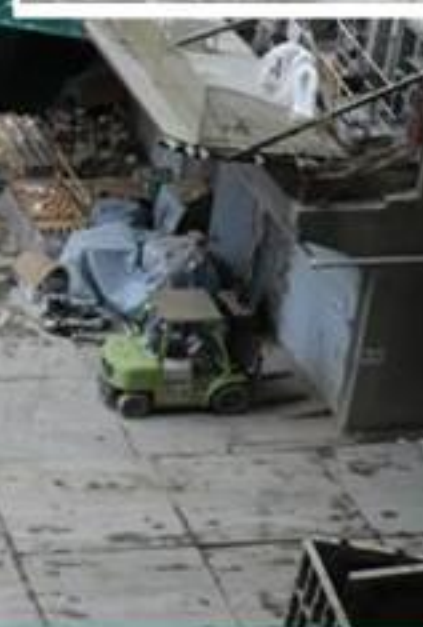
# Debris Discharge Point at GF metal door unlocked and opened

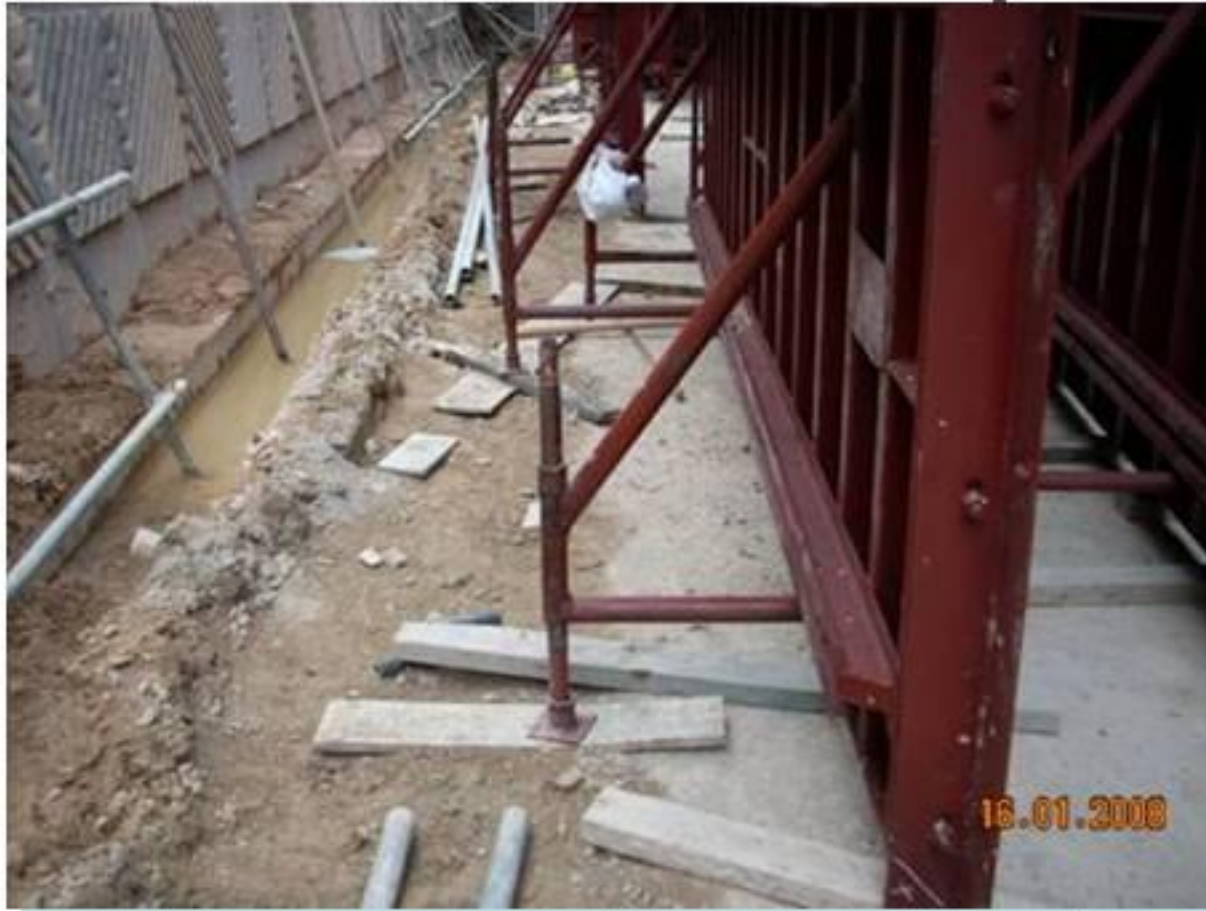
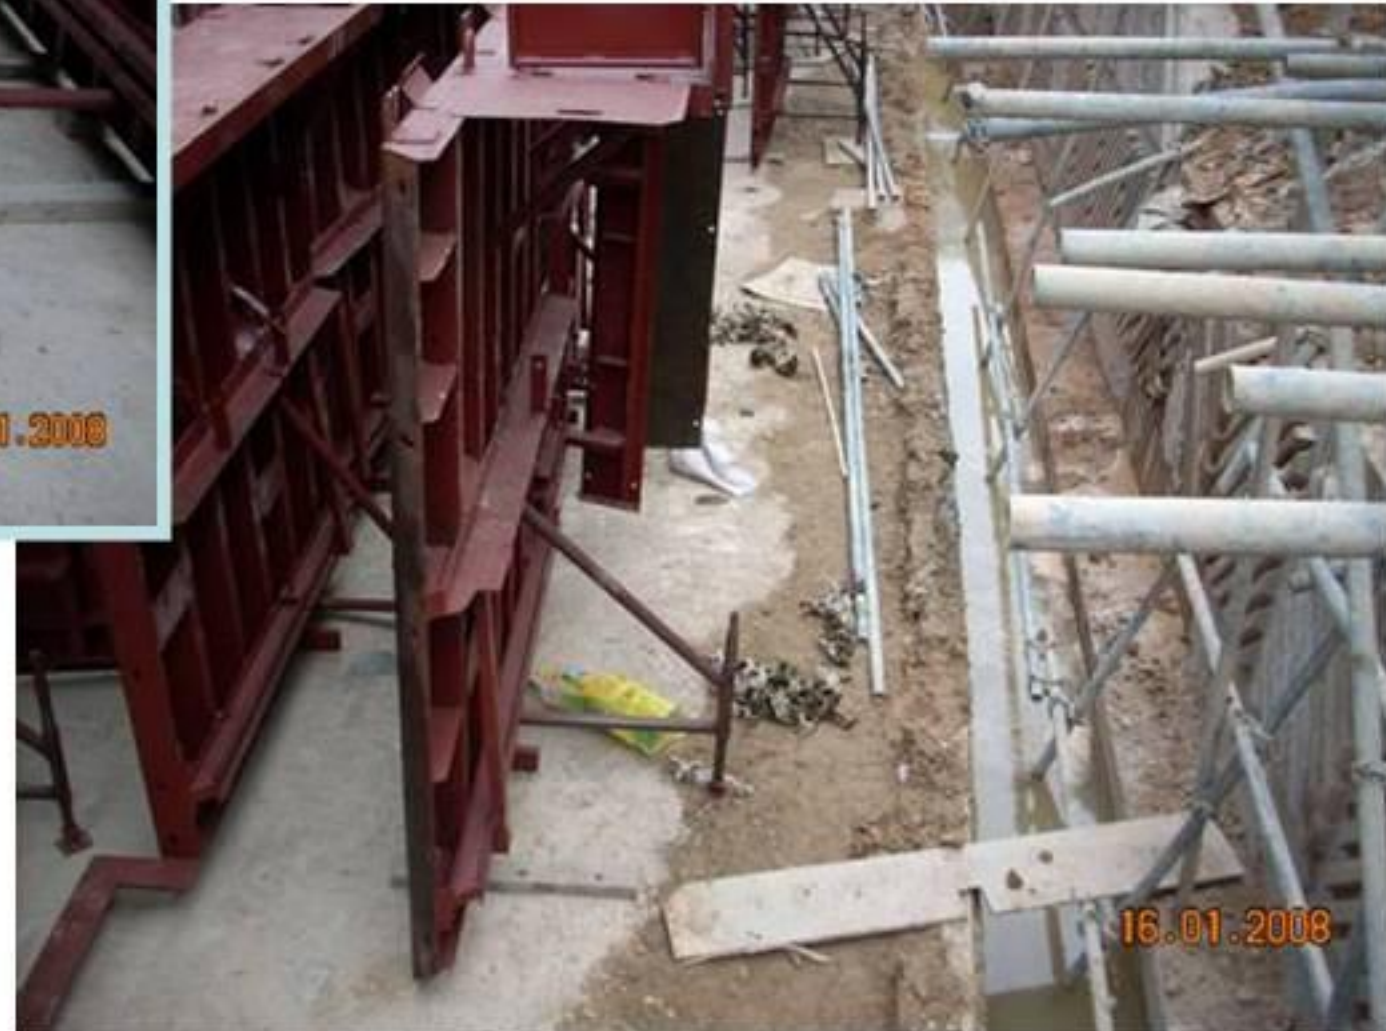
# Storage of Large Panel Formwork rested on timber strips and uneven ground

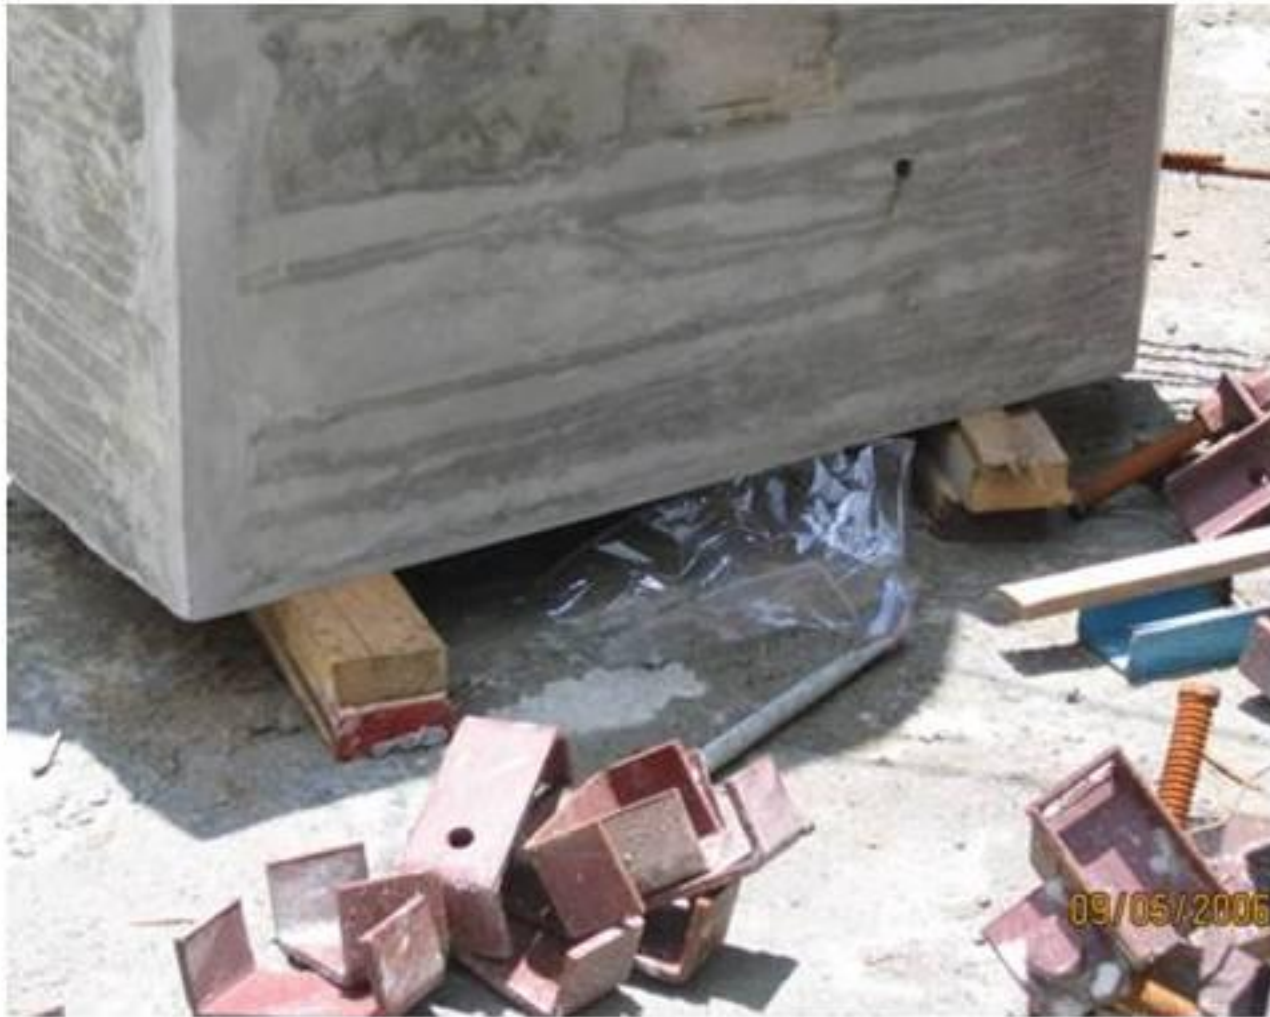
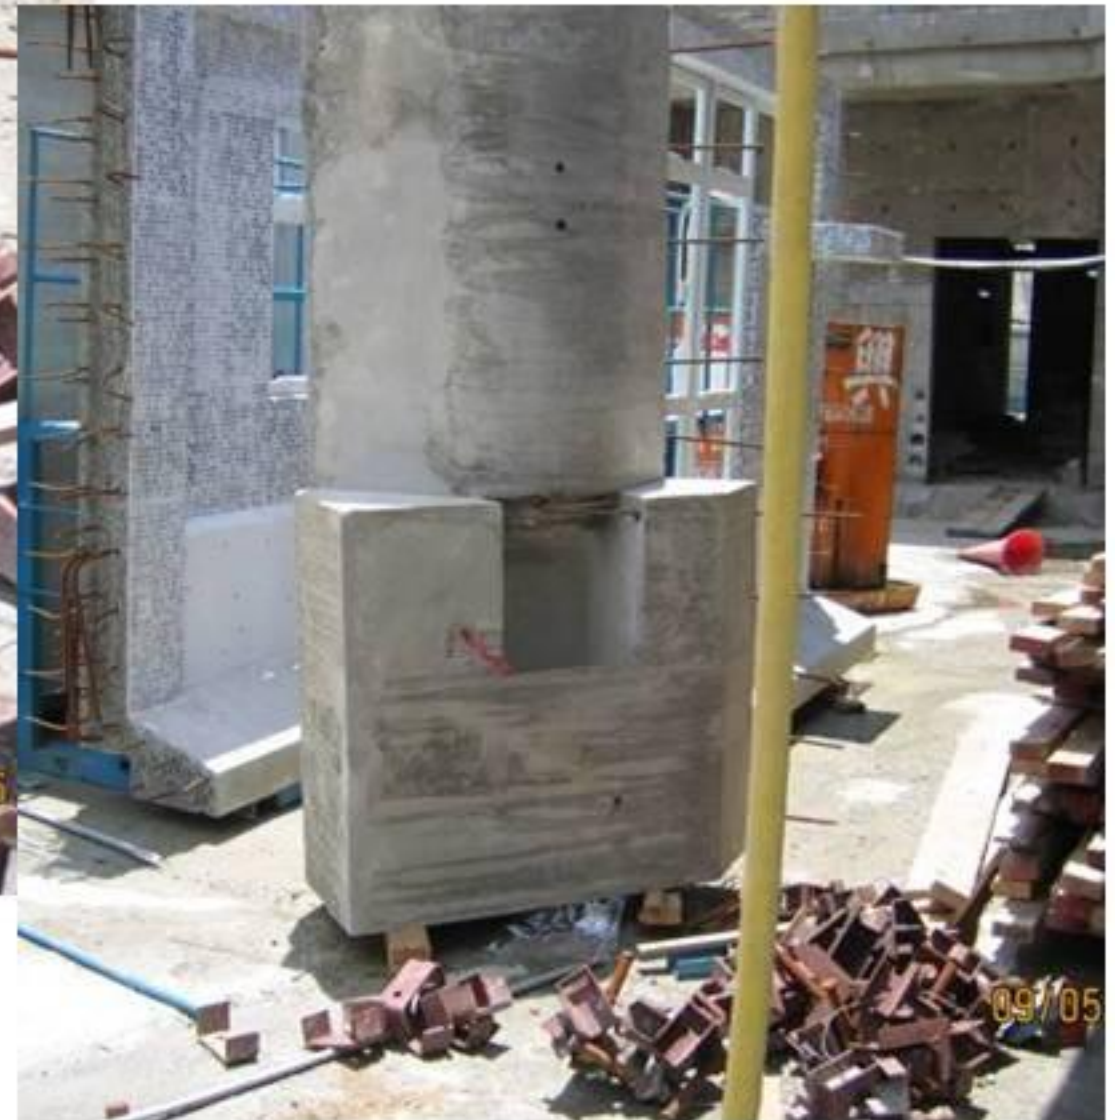
# Storage of Precast Units

## precast refuse chutes stored NOT on firm base

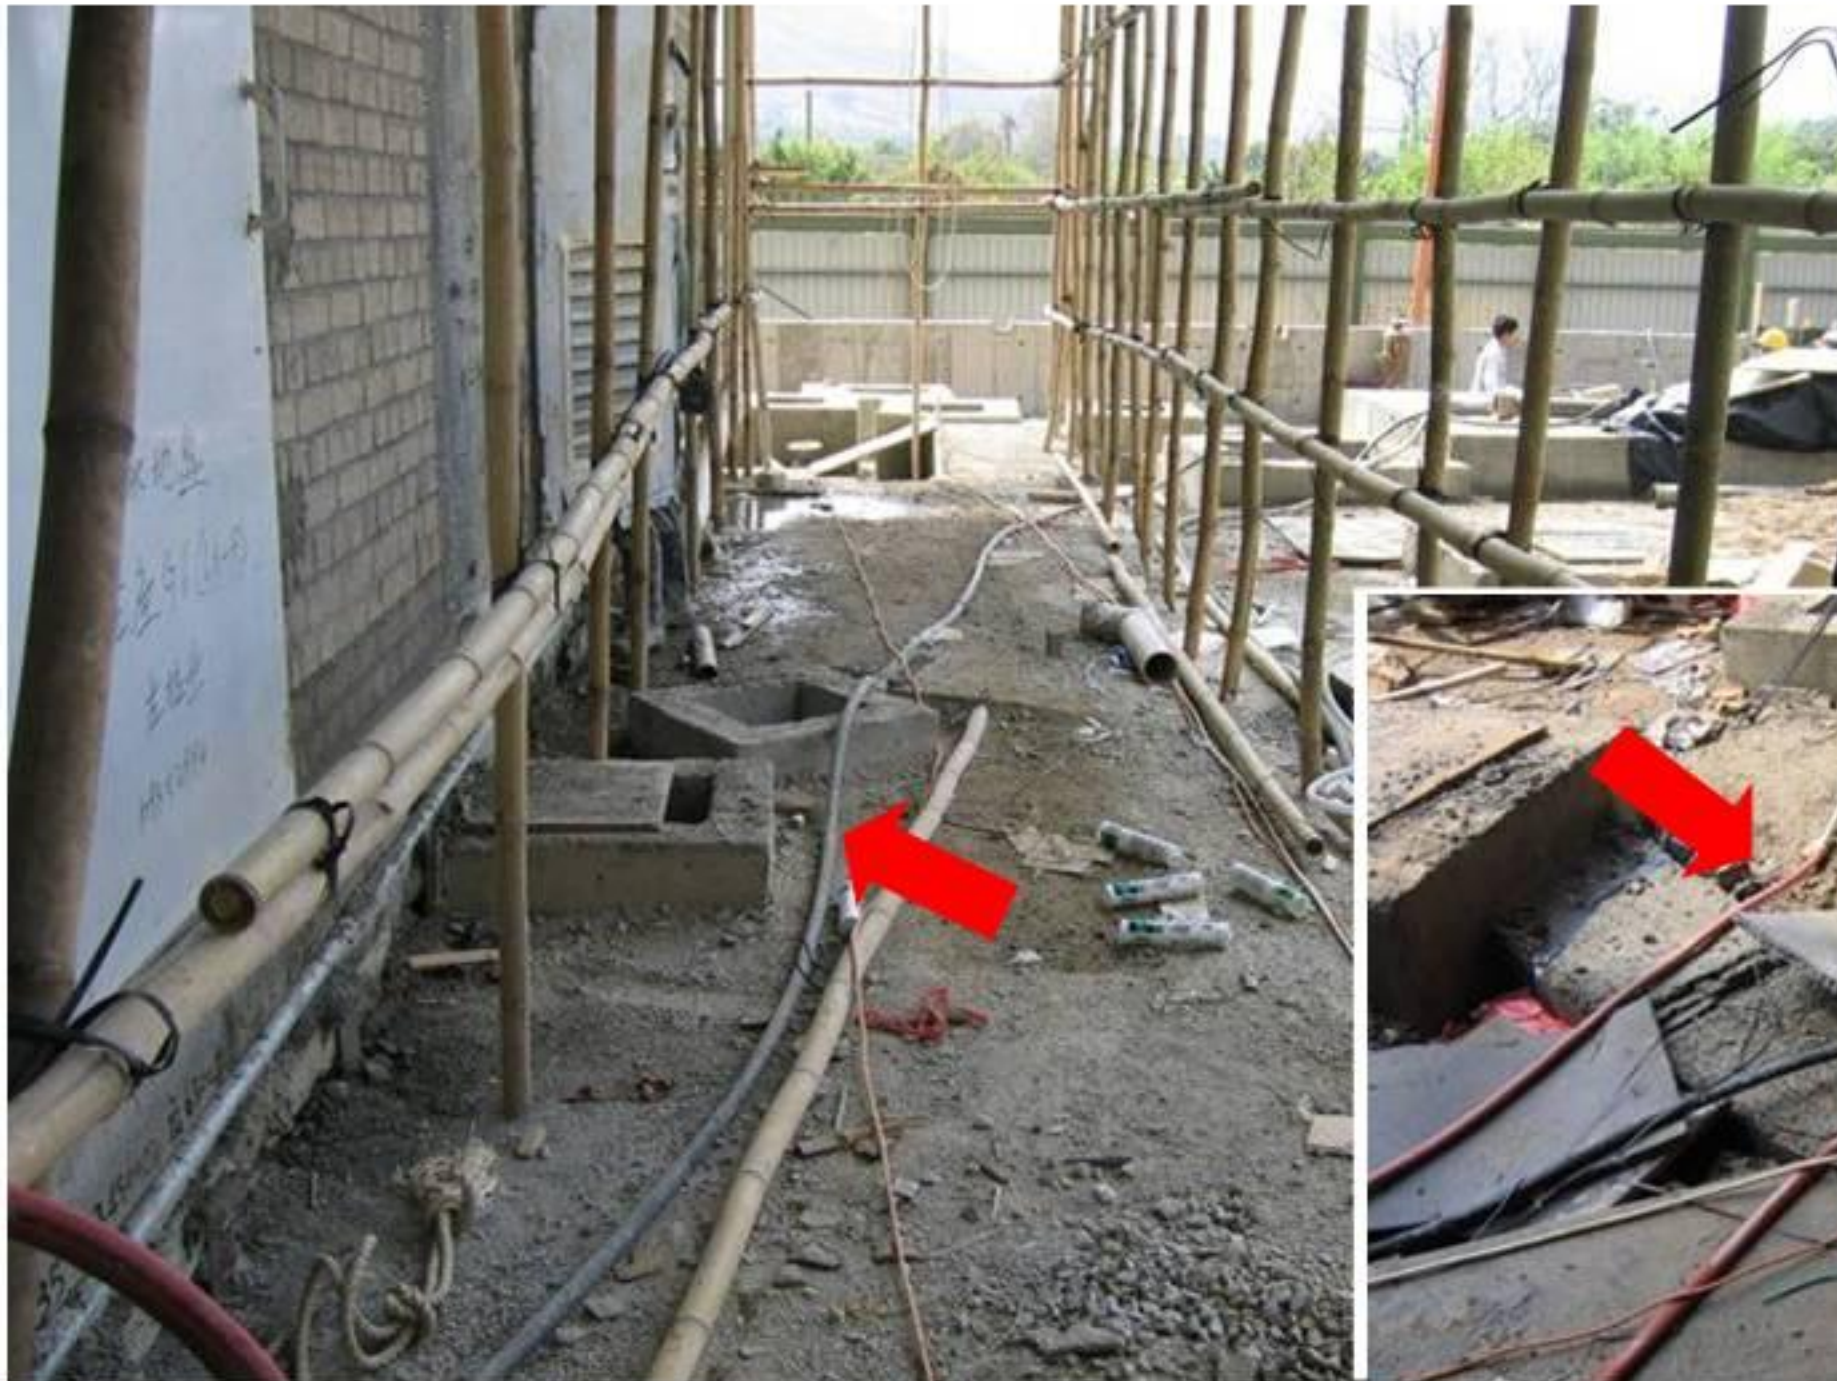
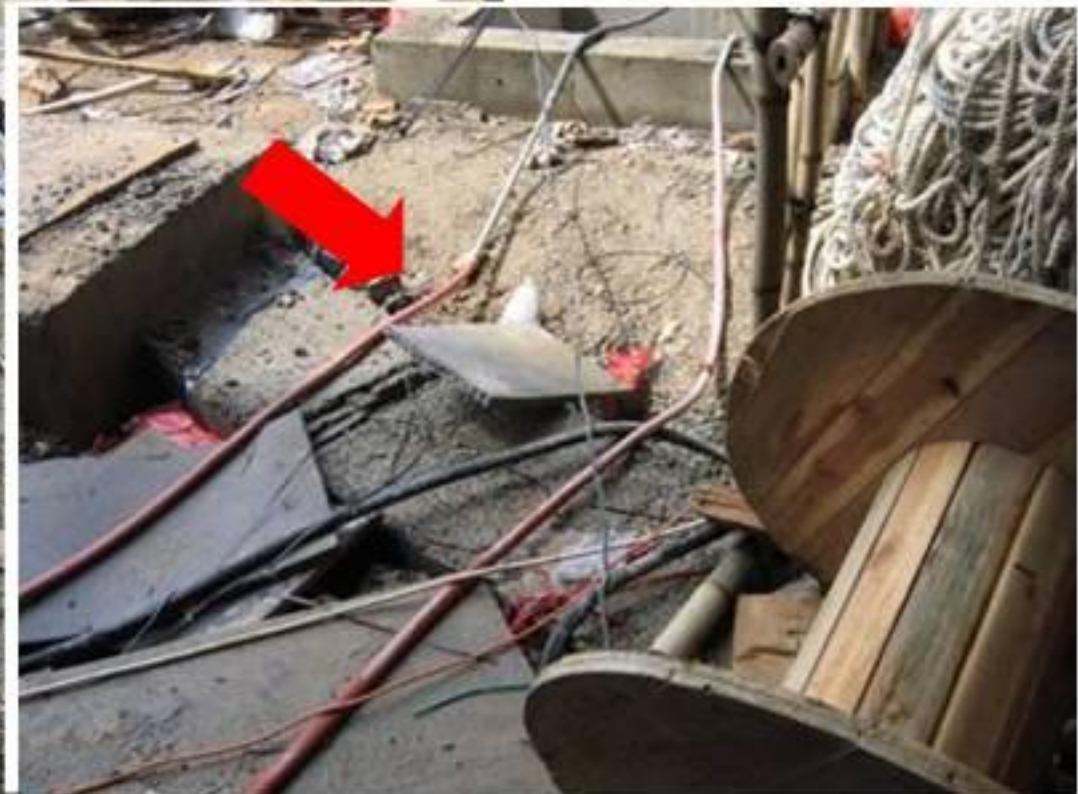
# Electric Cables Lying on Ground lying on the floor without protection

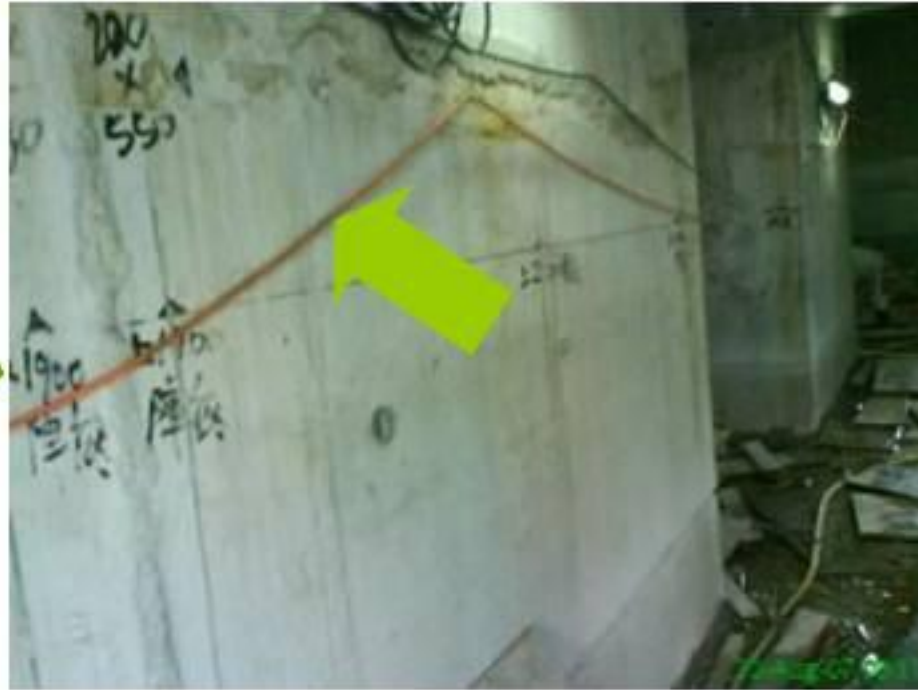
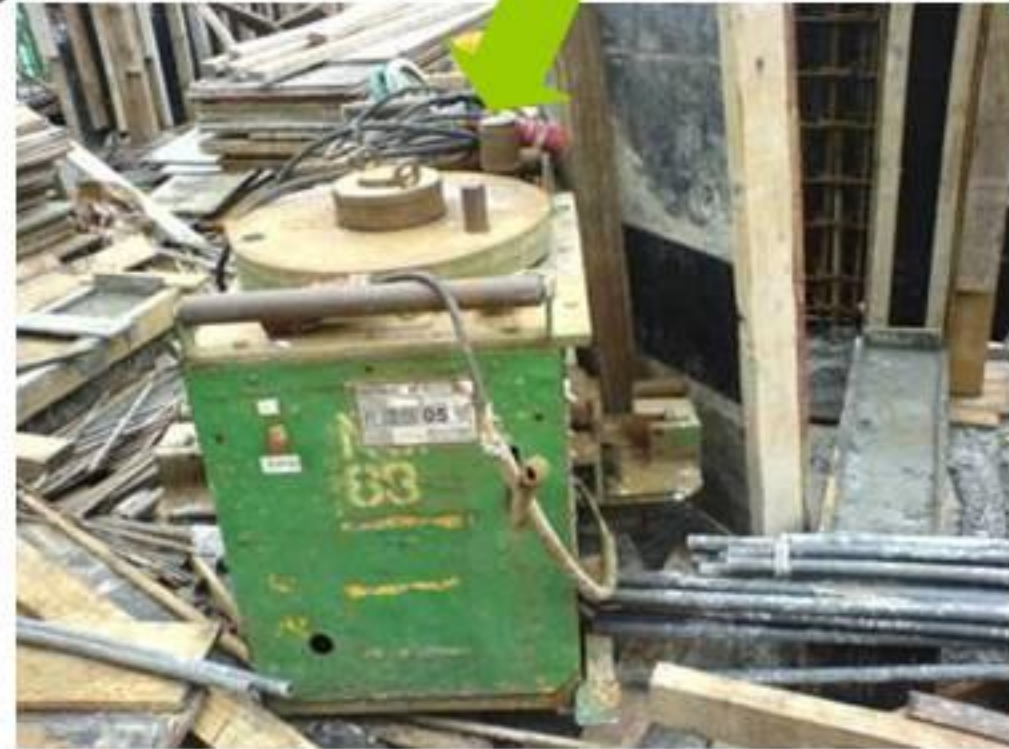
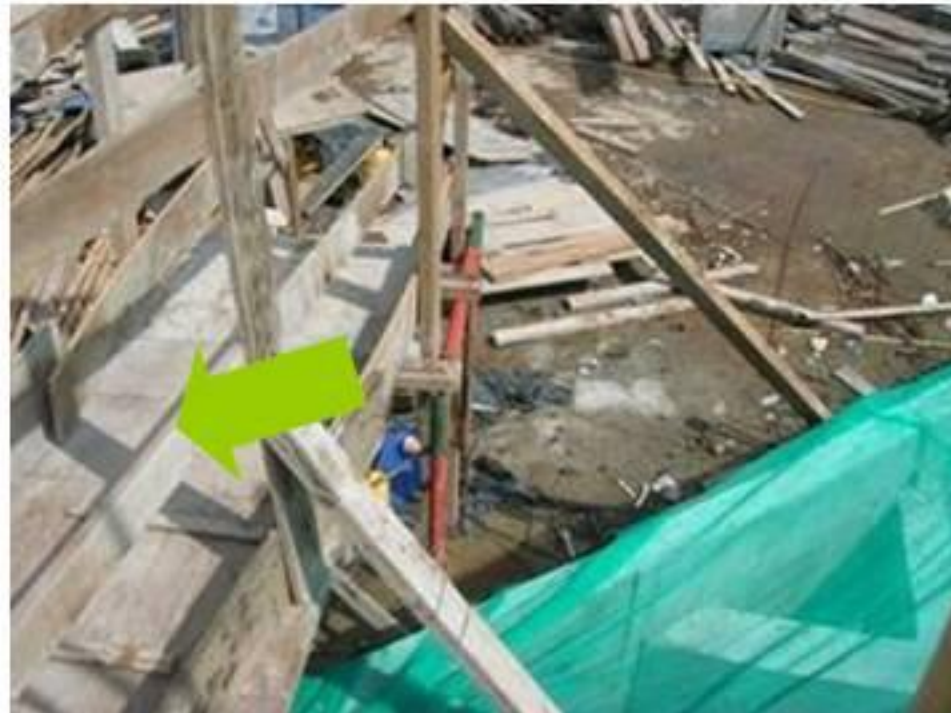
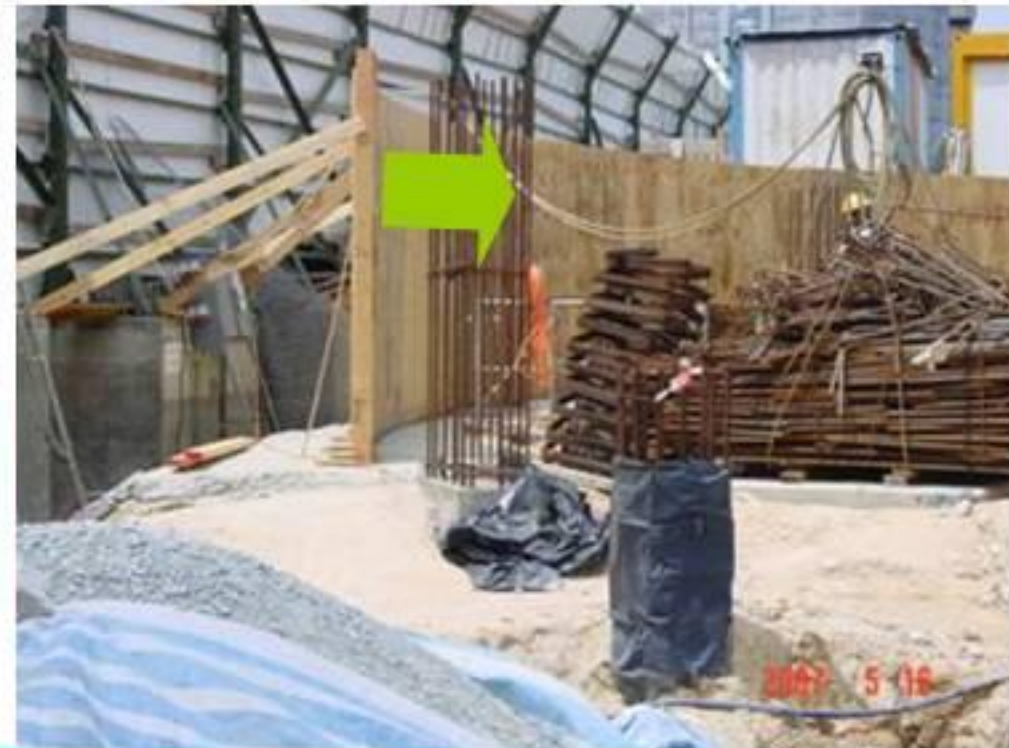
# Electric Cables Lying on Ground

cases rectified

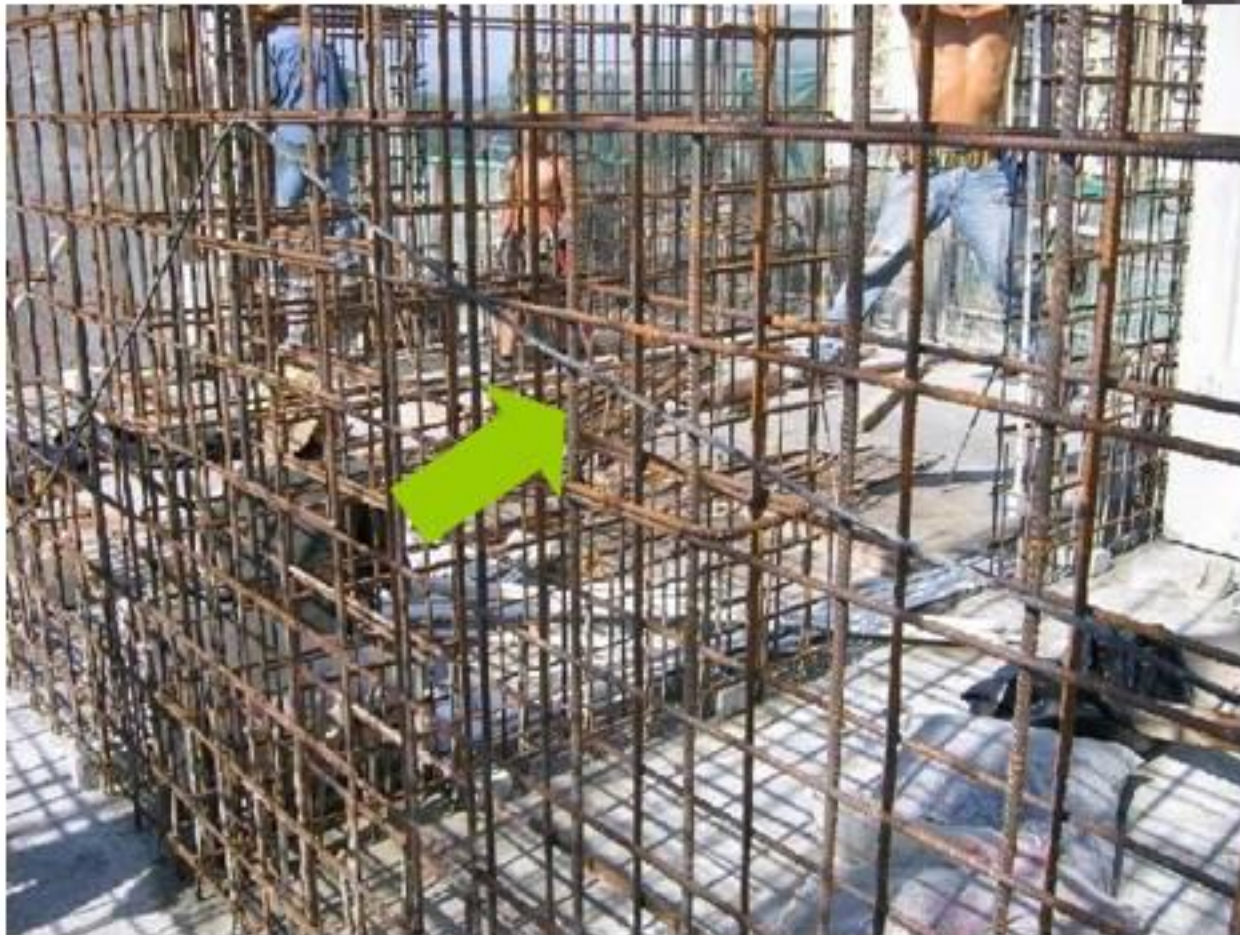
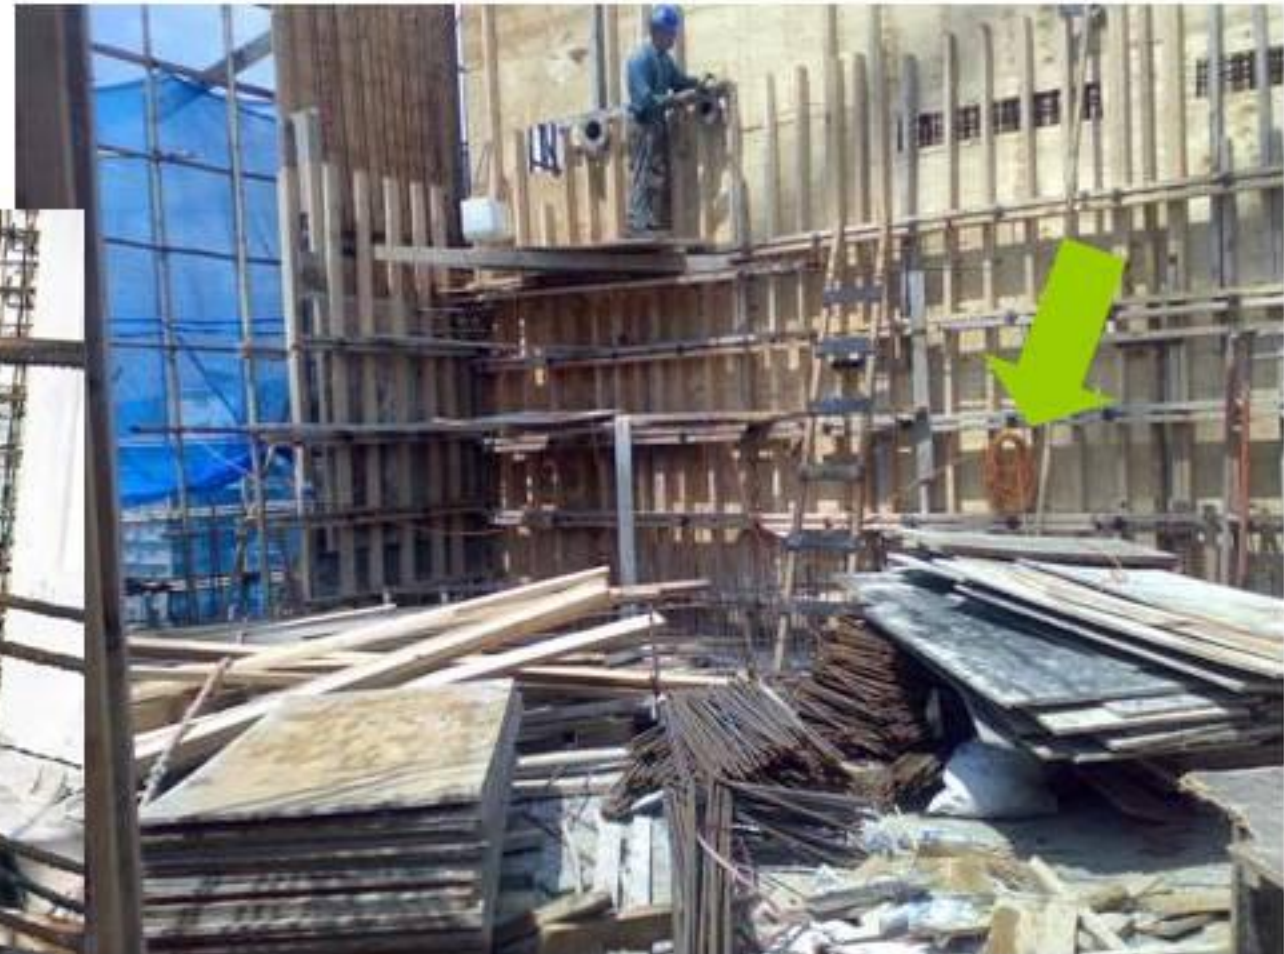
# Electric Cables Lying on Ground cases rectified
